Wrong Heat Treat Causes Expansion Joint Failure

J.M.A. Van der Horst
Surface Research, Inc.
Olean, N.Y.
and
C.R. Sloan
Sloan Engineering
Olean, N.Y.

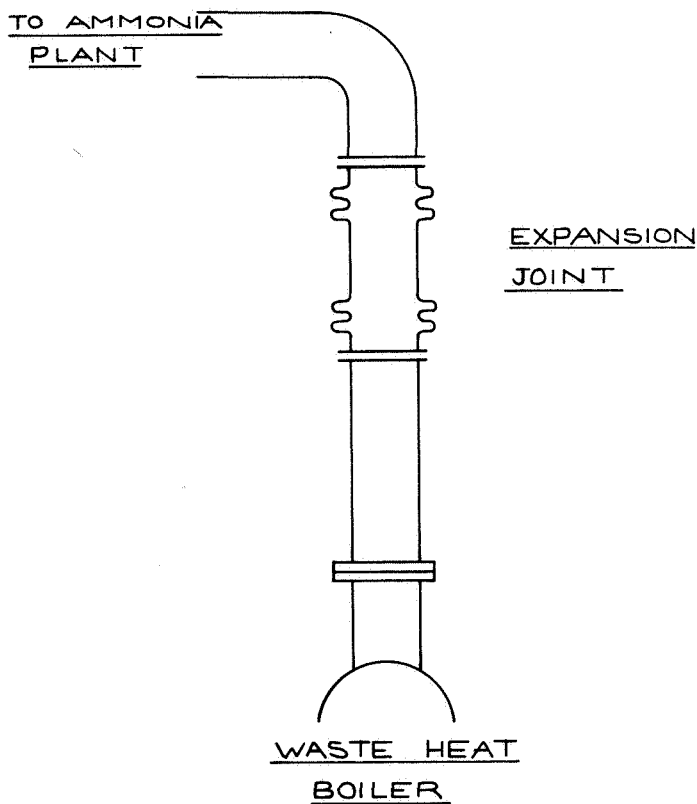
Figure 1. Location of bellows.

In an ammonia plant the hot gas line between the waste heat boiler and the next heat exchanger was subject to excessive stresses. First, the expansion joint of the heat exchanger failed. Then, the flange on the waste heat boiler started to crack. As a result of this, management installed an expansion joint in the line (Figure 1).

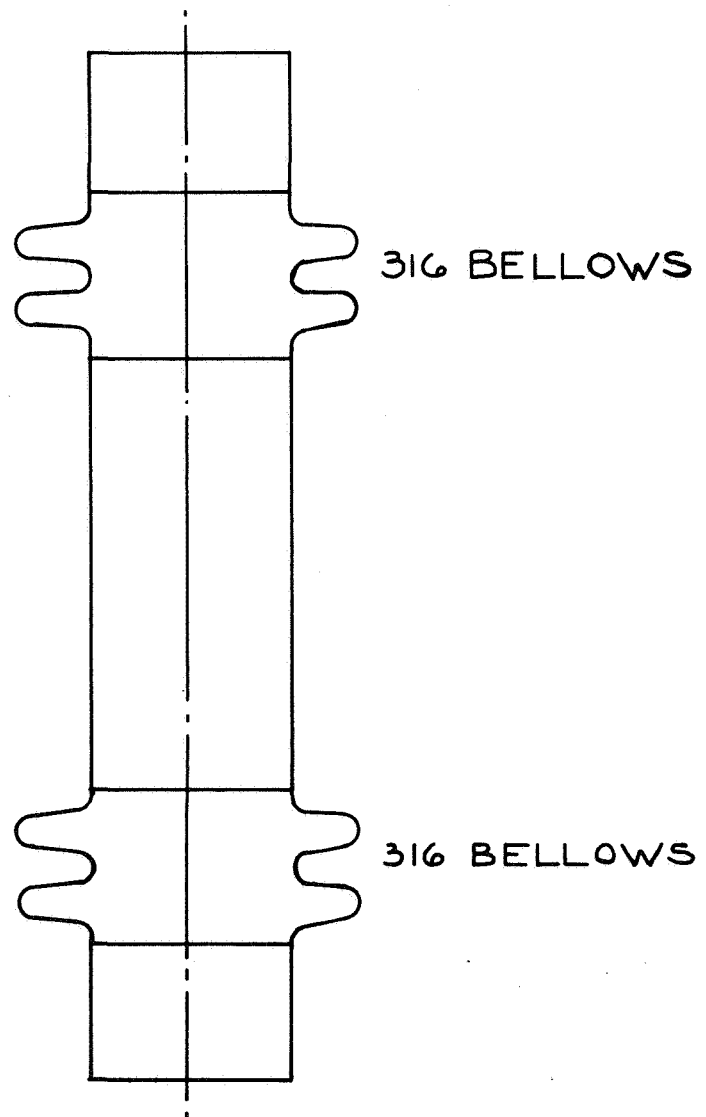
The joint consisted of two times two convolutions connected by a piece of pipe (Figure 2). The original expansion joint functioned well but twice developed pinhole leaks in one of the welds in the bellows. Alerted about this matter the expansion joint manufacturer supplied a spare joint, which was installed at the next shutdown. Within 45 days after start-up, the joint failed due to a long brittle fracture

Figure 2. Expansion bellows.

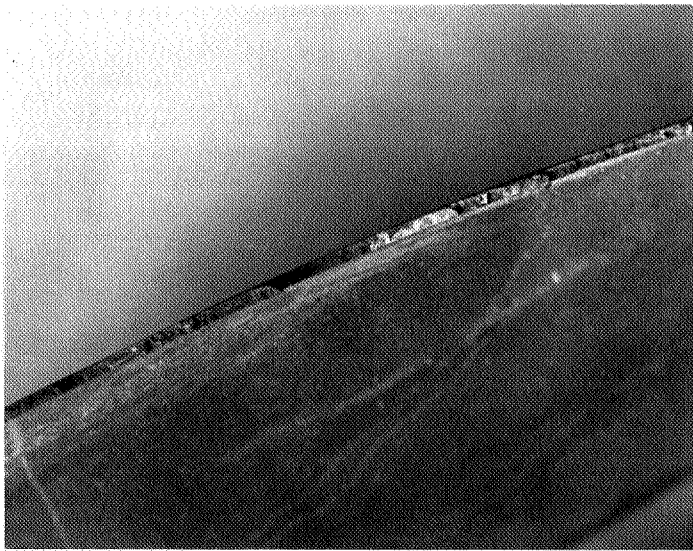
Analysis of the material showed that it was within the type 316 steel specification. The edge of the fracture had a sawtooth-like appearance, indicating numerous cracks,

Figure 3. Portion of the fracture showing saw teeth.

shown in Figure 3. This was confirmed by a cross section, shown in Figure 4. In fact, further investigation showed that the material was so full of cracks that it was surprising it stood up as long as 45 days (see Figure 5). It was clear that the material was completely embrittled.

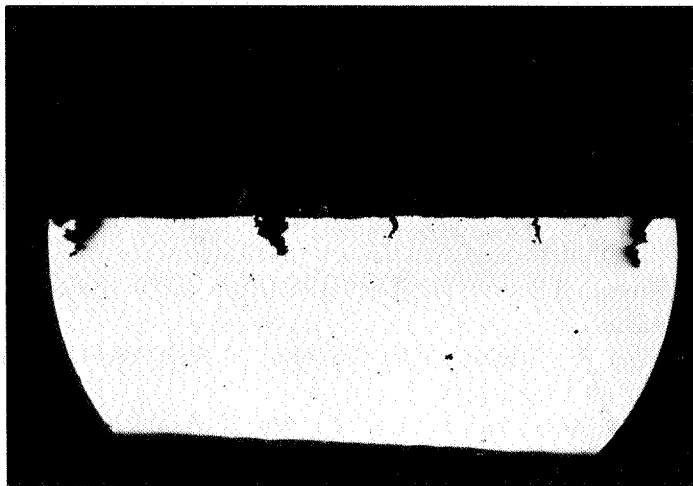
Figure 4. Multiple cracks in bellows surface (Mag. 50X).

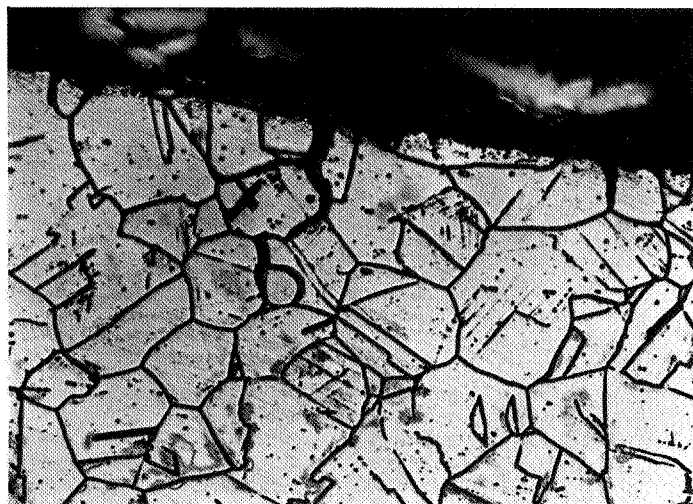
Figure 5. Surface of bellows with crack; 30-sec. oxalic acid electrolytic etch (Mag. 500X).

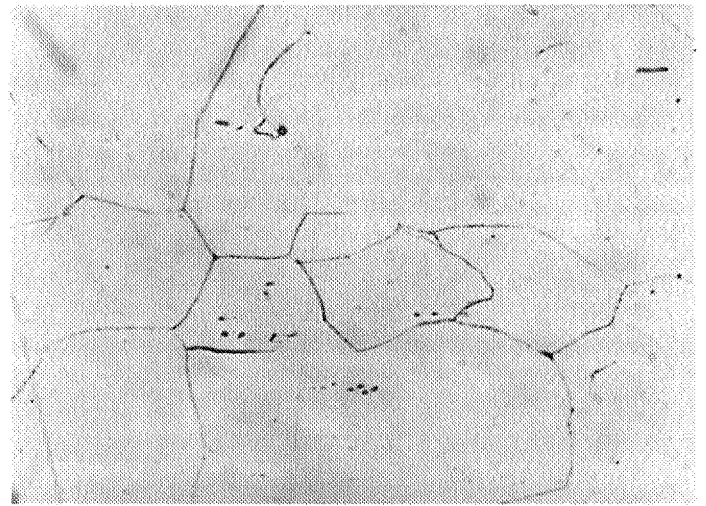
Figure 6. Bellows cross section; 1-min. NaCN electrolytic etch (Mag. 1000X).

tion whatsoever. Sigma phase shows up as bluish gray islands after 10 seconds electrolytic etching in NaCN. However, in the present material the structure has hardly become visible after 1 minute etching in NaCN (see Figure 6). Similarly a 1-minute, picral-HCl etch, another specific for sigma phase, hardly shows any structure (see Figure 7); while the same area etched electrolytically in oxalic acid, a specific for carbide precipitation, shows very severe grain boundary etching (See Figure 8). Apparently, therefore, the embrittlement was caused by grain boundary precipitation of carbides.

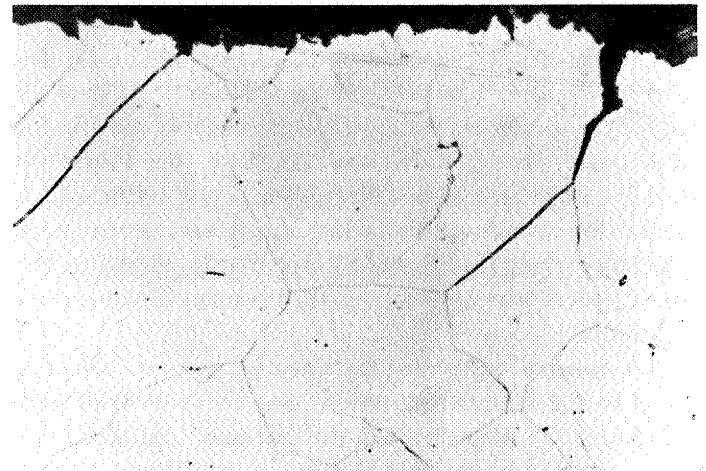
Figure 7. Surface cross section of bellows; 1-min. picral-HCl etch (Mag. 1000X).

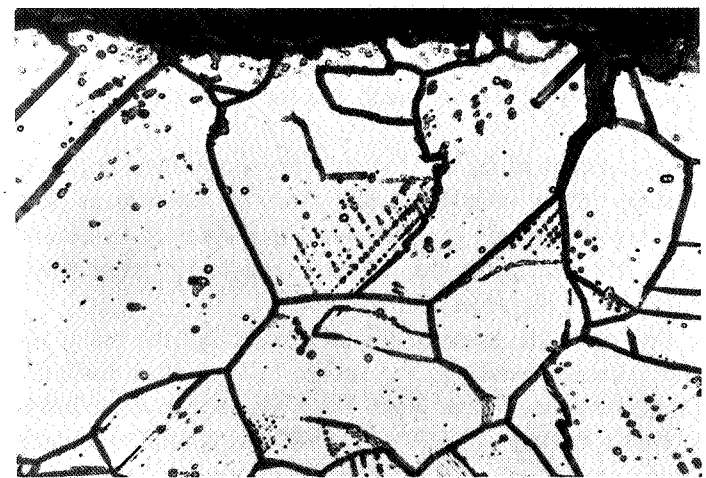
Figure 8. Same as Figure 7; 30-sec. oxalic acid electrolytic etch (Mag. 1000X).

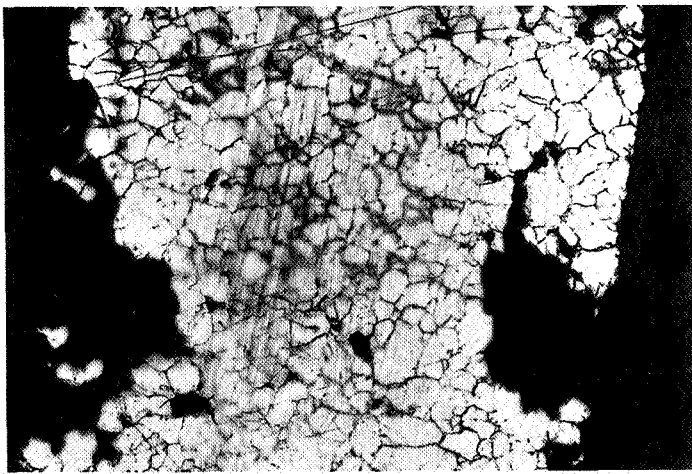
Figure 9. Disintegrating bellows material after Strauss test (Mag. 100X).

This became quite obvious when a specimen was submitted to the Strauss test, which dissolves Cr-depleted grain boundaries. (1) After this test the specimen crumbled practically completely, so that it was quite difficult to save a piece large enough to make a cross section, shown in Figure 9.

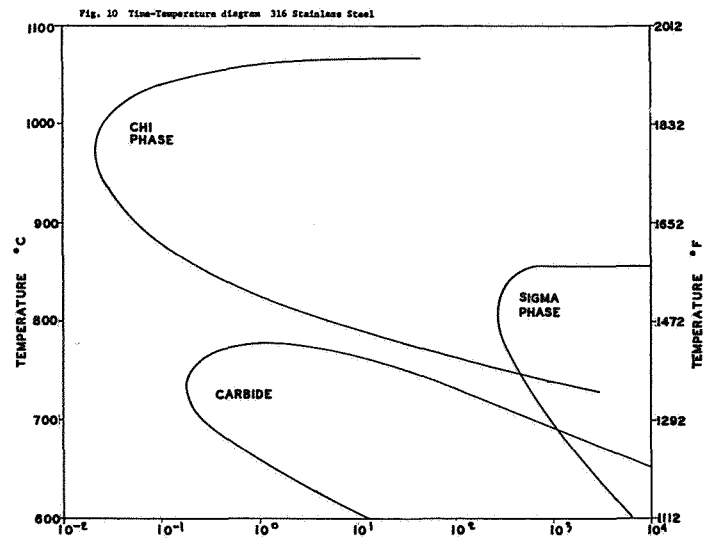
The time-temperature curves for formation of sigma phase (in pure austenitic material) for formation of chi phase and for precipitation of carbides at the grain boundaries (see Figure 10) show that the danger of carbide precipitation is indeed much greater than that of sigma phase. (2)(3)

As a matter of fact, initial carbide precipitation begins at 1350°F within minutes, while after 30 minutes at that temperature carbide precipitation has progressed to a point where the corrosion rate of the metal is 400 mpy when exposed to a corrosive environment.

Figure 10. Time-temperature diagram for sigma formation in purely austenitic Type 316 stainless steel.
