An Improved Header/Transfer Line

• New design is developed for internally lining with refractory to solve problems of failures at outlet headers and transfer lines in reformer furnace service. Five case histories cited.

F. A. Ruziska
Exxon Chemical Co.,
and
A. C. Worley
Esso Research and Engineering Co.
Florham Park, N.J.

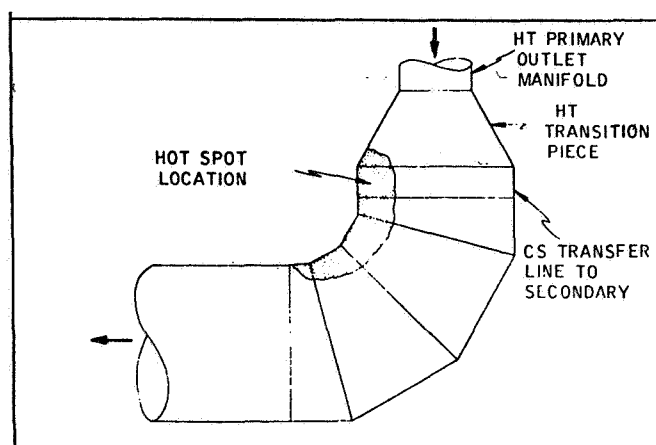
Figure 1. Transfer line hot spot—Case A.

After 3-1/2 years of operation, a "hot spot" developed in the area shown on Figure 1. It was detected by a change in color of the temperature sensitive paint. Steam cooling sprays were immediately applied to control the pipe metal temperature to below 600°F. Skin thermocouples were also installed to monitor the metal temperatures at the "hot spot" by recorder. After 14 days, the unit was shut down for other reasons, but at the same time repairs to this line were scheduled.

Inspection confirmed that the refractory layer and part of the light-weight insulating castable layer had fallen out in the overhead part of the elbow. Although no other gross lining loss was detected, the remaining lining in the transfer line appeared to be in poor condition, as evidenced by a non-uniform lining surface. Based on the appearance of the refractory, i.e. soft and hard areas, the failure was judged to be due to a poor quality initial installation, combined with the fact that the overhead of the elbow is the most sensitive to failure.

A repair was then made with locally procured castables of the same make used originally. The castables were applied by hand-packing. During the dryout operation on startup, the pipe metal temperatures again indicated loss of internal lining, forcing a second unit shutdown.

A two-man gunning team from The United States was therefore engaged. As an indication of the capability in the U.S. of such manpower, the team was on the way to the unit in Holland within 24 hr. after notification. The lining repair was completed in 12 hr., and visual inspection and

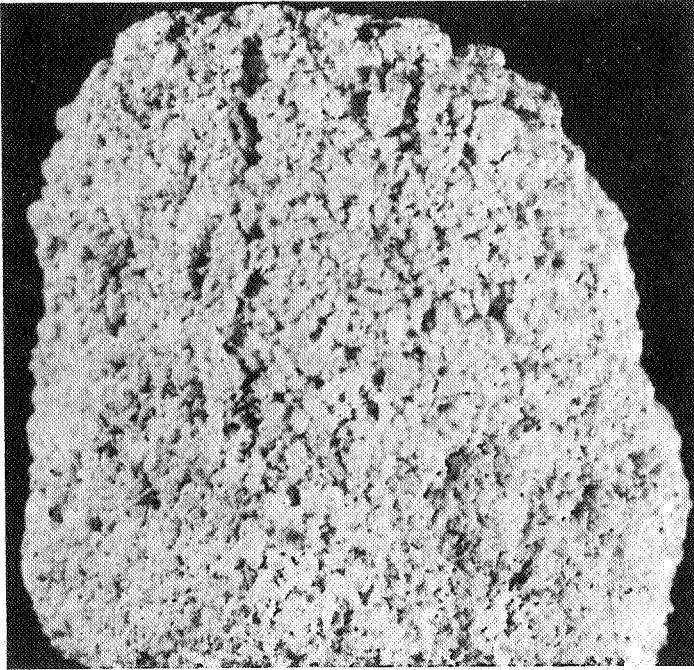
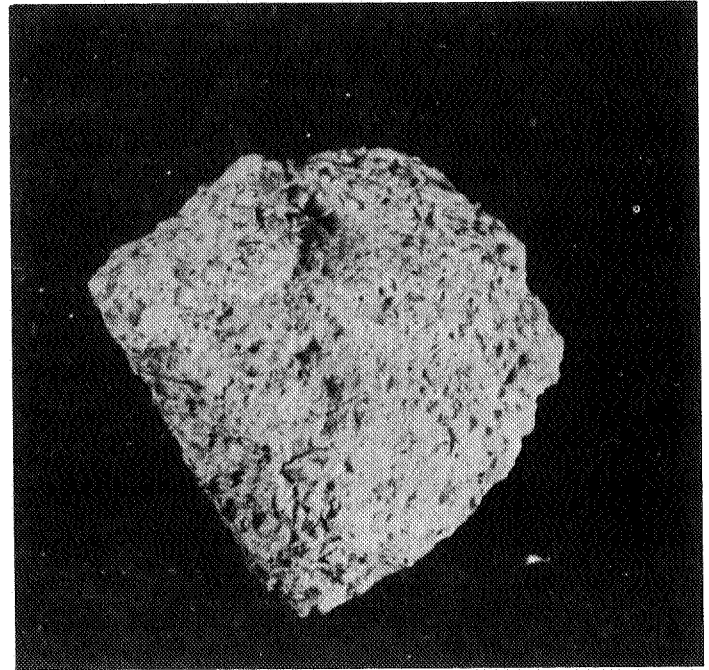
Figure 2 shows the condition of the refractory layer taken from this line vs. a normal sample of the same material. (It is apparent that the actual lining was not

Figure 2. Refractory samples showing poor quality installation at A (note voids and lack of bonding) vs. normal conditions at B (expected condition of same material.).

homogeneous, and a compressive strength test showed it to be well below the 5,000-lb./sq. in. cold crushing strength value that would be expected for the material.)

Based on the appearance of the sample, it was suspected that insufficient water was used in the application. The overhead section at the elbow may be the most difficult area to line, and it may be that reduced water was used during application to make the refractory stay in place thereby affecting strength and susceptibility to failure.

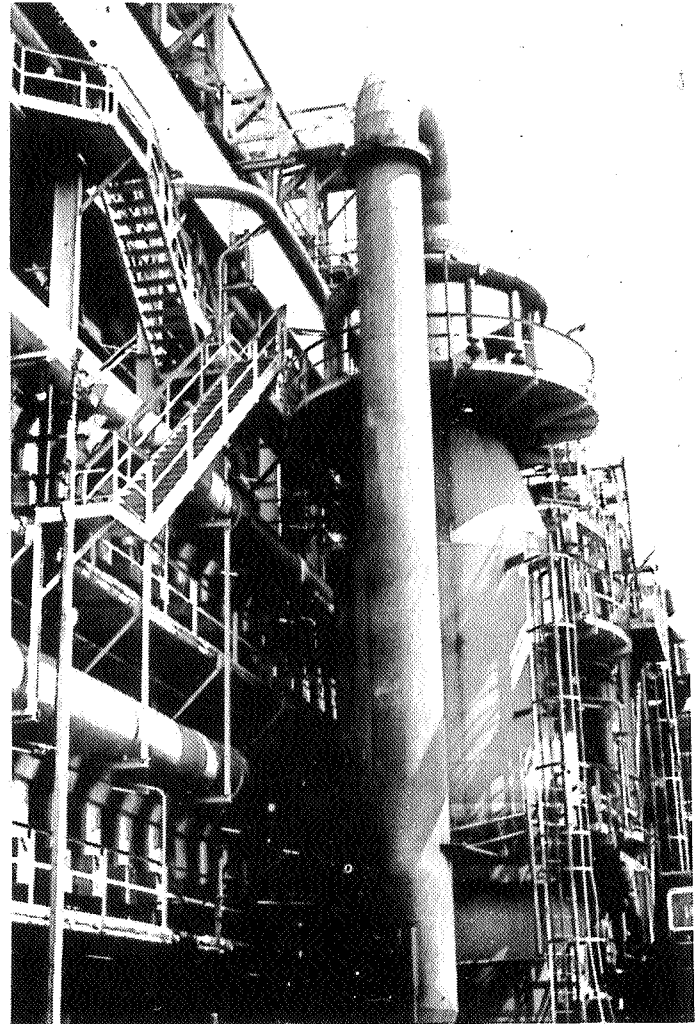
Figure 3. Primary/secondary reformer transfer line—Case A.

To avert unexpected future failures of the lined transfer line, shown in Figure 3, infra-red themography was selected by the plant as a practical method for monitoring the condition of the line. Two such photos, shown in Figures 4 and 5, cover the transition piece and elbow respectively. They were taken during the aborted startup attempt described previously.

Recent measurements on the entire line have indicated a few minor "hot spots" with maximum readings of 300°F. These are now monitored by skin thermocouples and recorder. An infra-red thermography scan is repeated on a regular basis to see if other problem areas are developing. The intent is to gain sufficient lead time to plan repairs if the existing lining deteriorates.

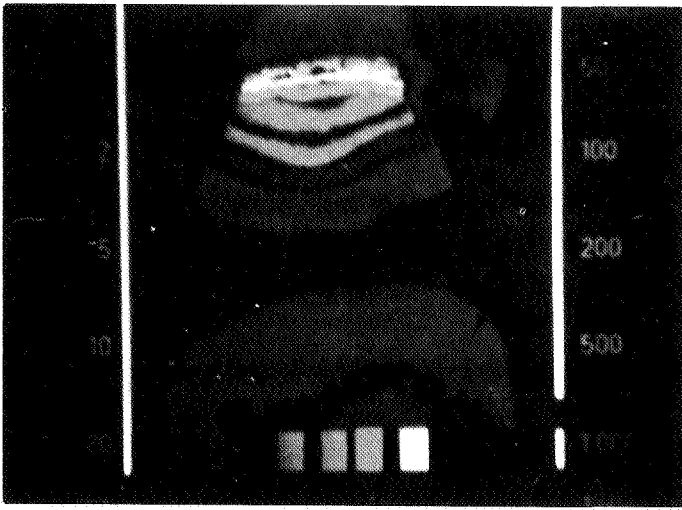
Figure 4. Infra-red thermograph of Case A transition cone. Lower portion shows beginning of No. 2 hot spot.

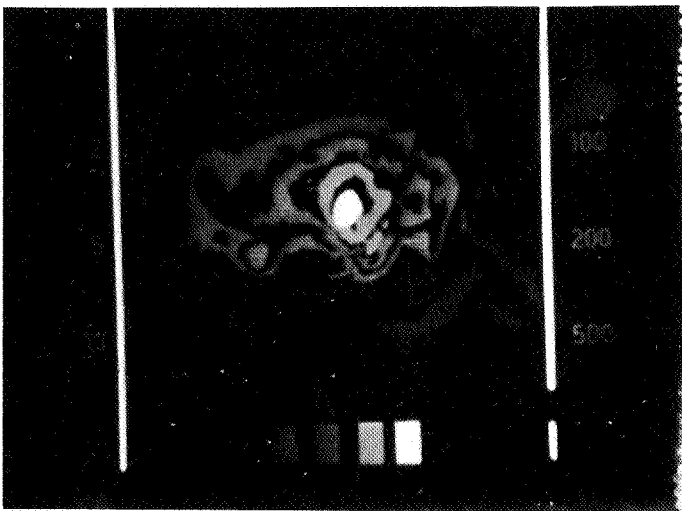
Figure 5. Infra-red thermograph of Case A No. 2 hot spot. Maximum temperature indicated is 760 to 780°F.

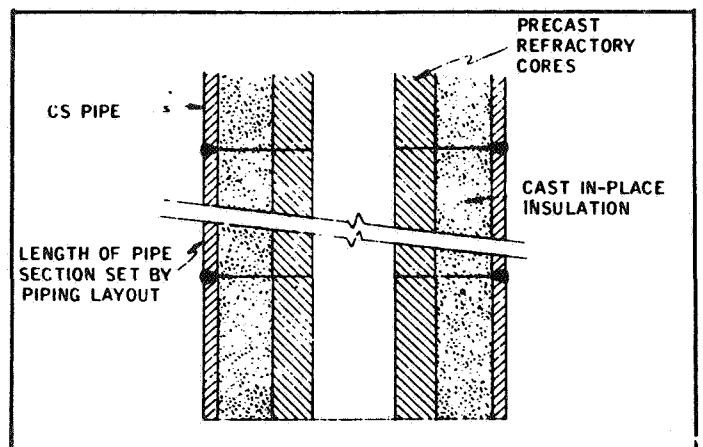
Figure 6. Prelined pipe assembly.

The repair lining technique specified utilized precast refractory cores. The cores were cast in a temporary shack facility at the site. The cores were then placed within the replacement pipe sections and castable insulation was poured into the annulus between the cores and the pipe. This permitted rapid assembly of the transfer line system since lining of the pipe and assembly of the pipe sections could be made in a "building-block" fashion. Figure 6 illustrates the lined pipe connection, and Figures 7 and 8 show a typical casting operation of cores and insulation, respectively.

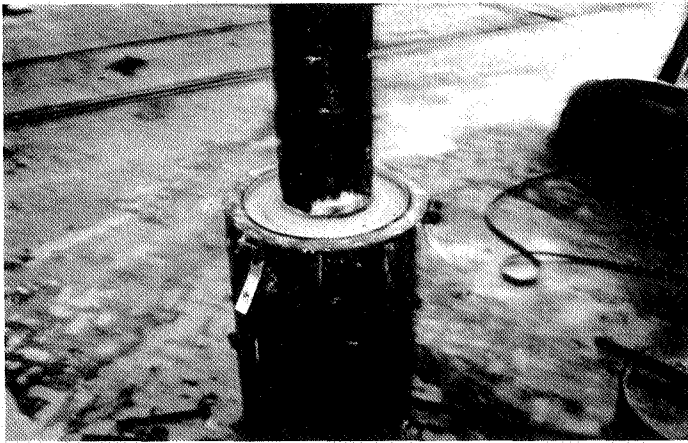
Figure 7. Refractory core casting method.

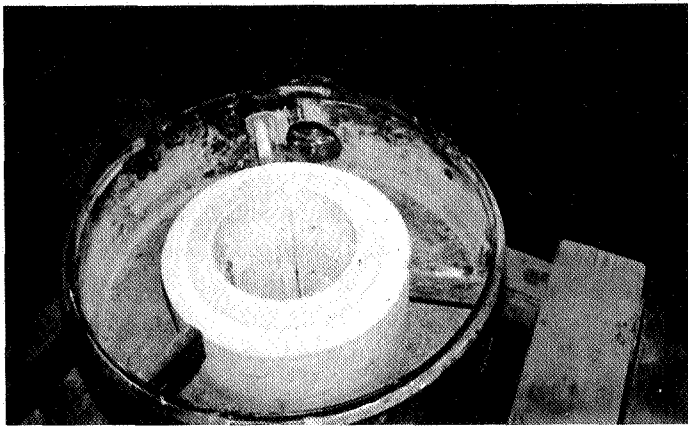
Figure 8. Header with core positioned for casting insulation layer.

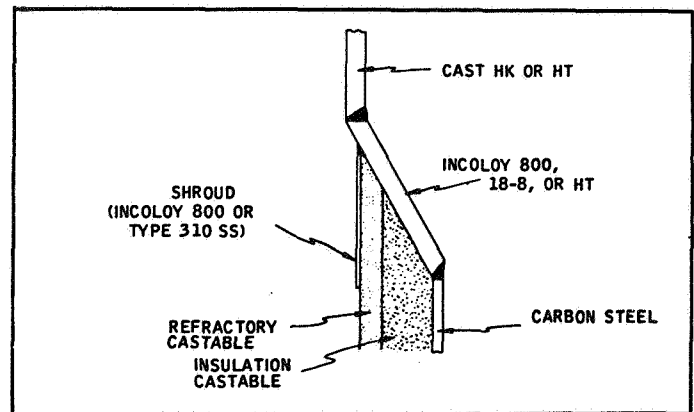
A typical transition section design is shown on Figure 9. One of our units (Case C) has four reformer header-to-outlet transfer-line transitions featuring HK-40 headers and wrought Type 316 stainless steel transition sections. The cracking history has been as follows:

1. Thermal stresses at the welds due to differential expansion between dissimilar metals.
2. Lack of ductility of the cast HK-40 component.
3. Piping movements caused by thermal expansion imposing additional bending stresses on the weakest component of the system.

Figure 9. Transition piece design.

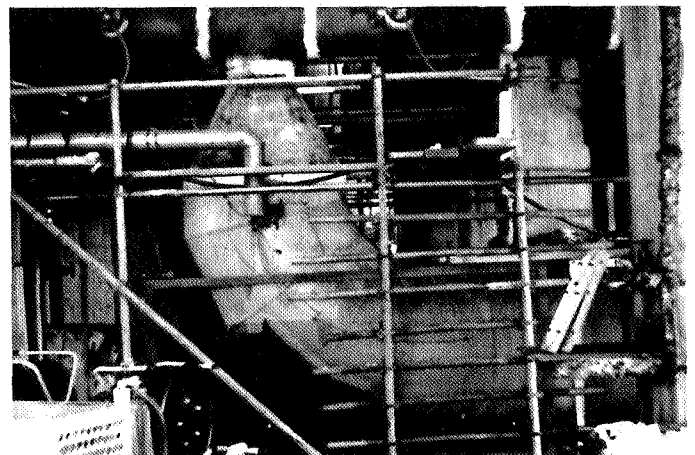
Similar cracking has been experienced at the hot end joint of the outlet header/transfer line transition cone in the plant in Holland (see Figure 10), although these have not been serious enough to cause a shutdown. The header and cone at this location are HT (Modified) alloy.

Figure 10. Transition cone—Case A.

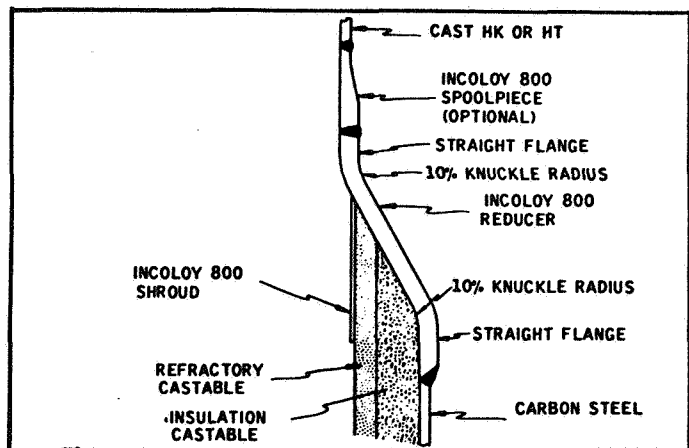
Figure 11. Improved transition piece design.

We favor a design of transition sections that would employ wrought alloy throughout the critical zone for more ductility, and the use of generous knuckle radii for the transition ends in order to avoid or minimize stress and temperature gradients at the points most susceptible to failure. This preferred design, also considered by others (2), is shown on Figure 11. It utilizes an Incoloy 800 concentric reducer. The Incoloy 800 alloy provides improved ductility to withstand cyclic stresses. The use of knuckles locates the welds away from the conical transition into the straight pipe section to avoid the stress intensification due to change in geometry at the weld. Careful thermal flexibility

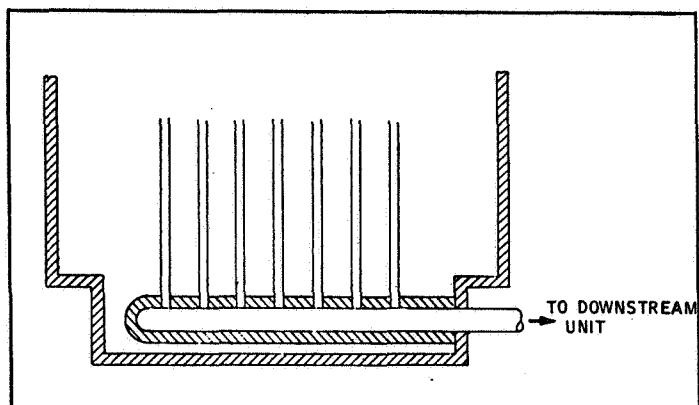
Figure 12. Internal hot-alloy header configuration—Case D and E.

The next two cases describe similar failures with HK-40 reformer furnace outlet headers, and two different approaches taken for solution of the problem. In these plants, the headers were located in a trough below the main floor in the furnace (Figure 12). Both failures were precipitated by thermal shock from water impingement from the onsite steam generators; also inherent design weaknesses were thought to be a contributing factor. Other authors have described similar problems with weld cracking in this type of design.

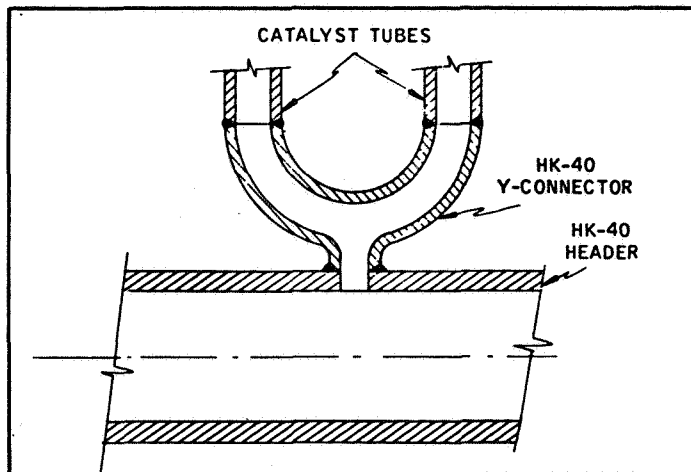
In Case D—a small, two-train hydrogen unit having 24 tubes in each furnace—the HK-40 header was supported by sliding support shoes welded to the bottom of the header. The tubes were connected to the header through an HK-40 Y-piece shown in Figure 13. The No. 1 train of the unit experienced header failures on two occasions. In one, a tube failure in the downstream process gas boiler led to water backup and failure of the header from thermal shock. The second failure, three months later, was caused by water carryover from the onsite steam drum. Water may possibly have penetrated to the header which, in any case, exhibited severe cracking. Many of the Y-pieces were found

Figure 13. Y-connection, catalyst tube-to-header—Case D.

cracked, and a crack was found in the header originating from the support shoe weld.

Repairs were made to the header, and a number of replacement Y's were installed. The repairs were time-consuming because it was necessary to solution anneal the exposed HK-40 components prior to welding. To improve the reliability of the design, and to facilitate future repairs should these be required, it was decided to revise the system by utilizing a more ductile material for the header, specifically Incoloy 800. In addition, the troublesome HK-40 Y-connectors were eliminated, and an improved header support system was provided.

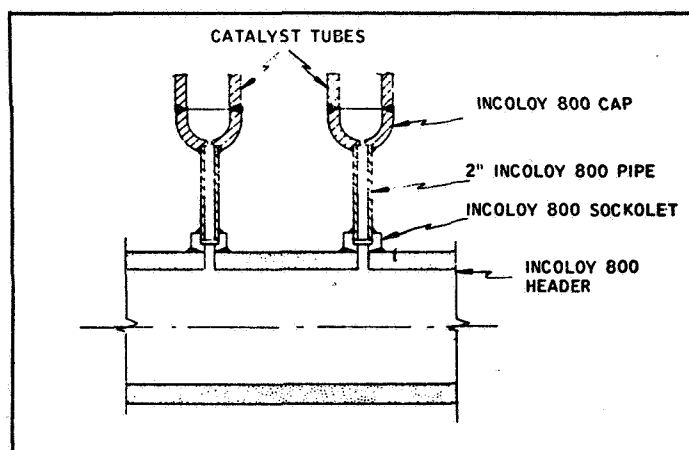
Figure 14. Revised Incoloy 800 connection, catalyst tube-to-header—Case D.

The revised tube-to-header design is shown in Figure 14. Full size tube-to-header connections were not feasible due to close tube spacing in the furnace. Therefore, short, 2-in. Incoloy 800 straight-run connectors were used. That also provided flexibility for the small differential thermal movement between header and tubes. The header remained in the furnace trough to protect it from direct heat input. An external header and external tube outlet pigtailed were considered to permit onstream tube isolation by clamping. However, the increased complexity of the design and the fact that two furnace trains were available reduced the incentive for "on the run" tube isolation. The new header support, shown in Figure 15, avoids welding on the header.

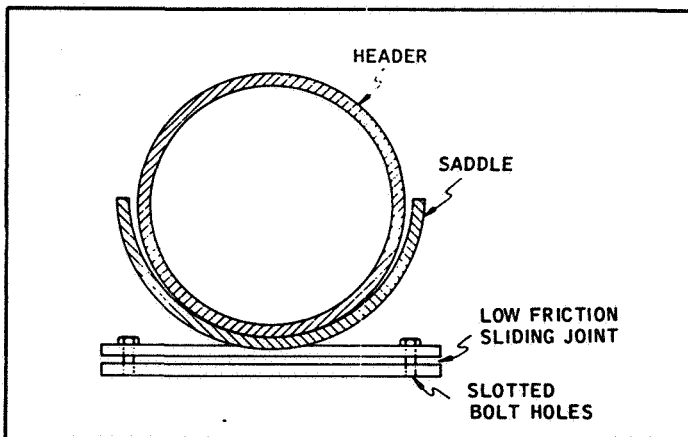
Figure 15. Revised header support guide—Case D.

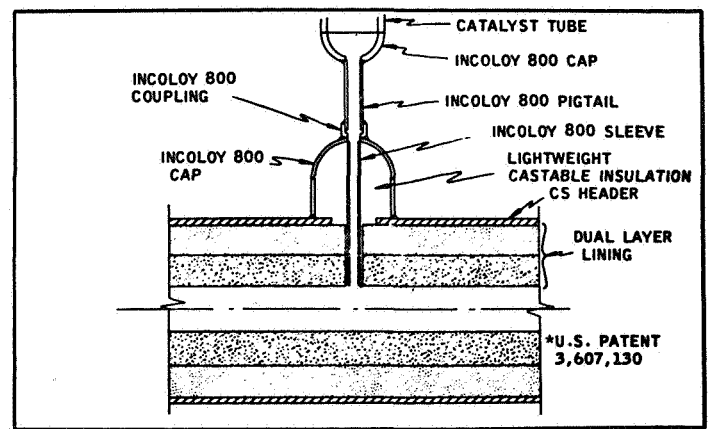
Figure 16. Replacement internally-lined header connection—Case E (U.S. Patent 3,607,130).

A design providing maximum reliability, in our opinion, could be achieved using the Esso Research and Engineering Co. patented (1) internally-lined header system. The internally-lined header design, shown in Figure 16, is our preferred header design, developed originally for use in hydrogen plants. It consists of a dual-layer, internally-lined header (without shroud). A refractory core method is employed, similar to that described in the Case B repair. An Incoloy 800 cap is used at the base of the catalyst tubes, while an insulation-filled Incoloy 800 cap is used against the header. The vertical pigtailed tubes are of Incoloy 800, and are of sufficient length to permit onstream pigtail clamping. The vertical orientation keeps all thermal movement in one plane and simplifies the mechanical design. The HK-40 tubes in the Case E revised design are extended below the main floor of the furnace and require removal of the original header box and installation of a new floor/tube seal.
