# New Tubes Solve Reformer Heat Problem

Supertherm alloy replacements for original tubing in radiant section provide satisfactory performance in California ammonia plant.

C.P. Level  
Collier Carbon and Chemical Corp.  
Brea, Calif.

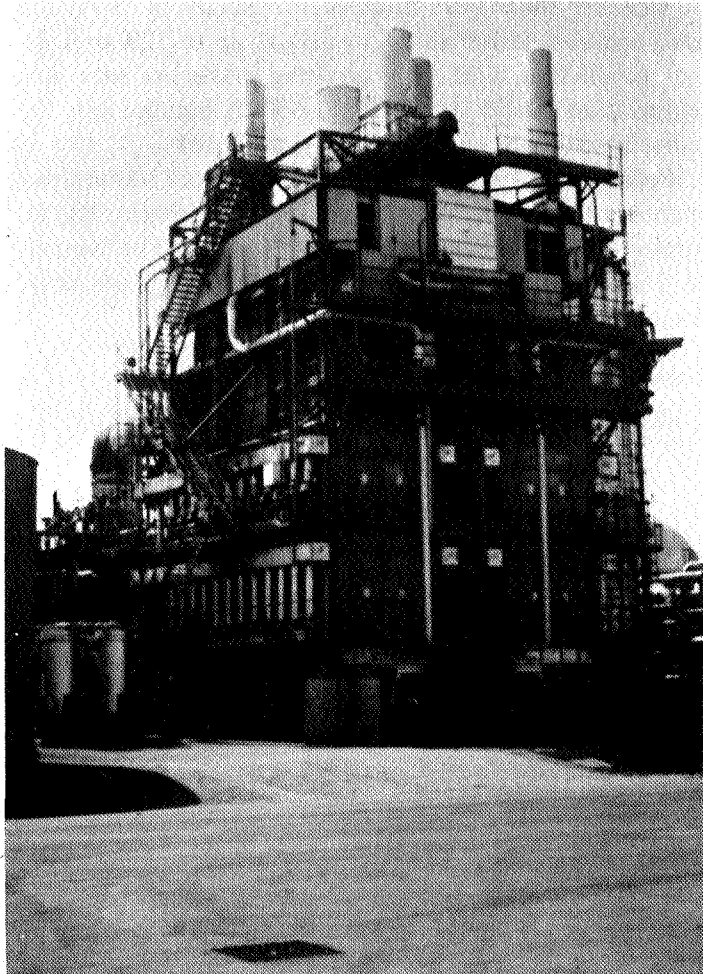
Figure 1. Primary reformer at Brea, Calif.

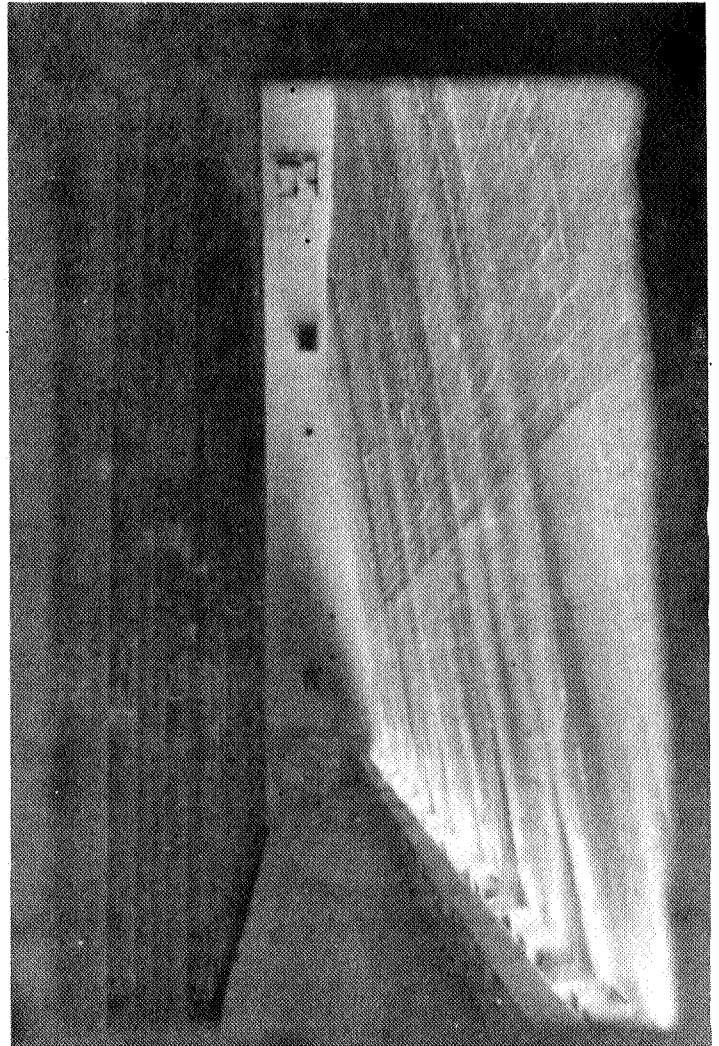
Figure 2. Radiant tubes, showing bottom burner terrace.

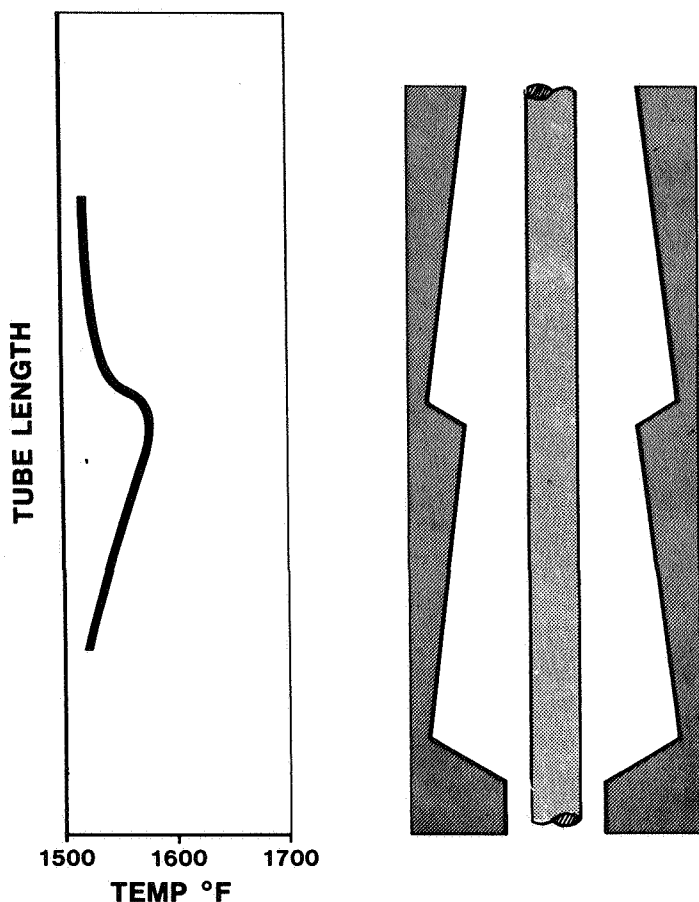
Figure 3. Typical tube temperature profile.

Before switching to Supertherm, the furnace radiant tubes were HK-40 with a 0.75-in. wall thickness. The tube internal diameter was 5 in. The reformer has always exhibited a rather unusual radiant tube skin temperature profile, shown in Figure 3. This profile is only approximate. Accurate measurement of tube skin temperatures is considered very difficult, although Collier has extensive experience with both optical and infra-red pyrometers. In this case, there is considerable evidence to indicate that the hot spot is opposite the upper burner terrace, the most convincing indication being that this is where all the tube failures have occurred. Much work has been done trying to smooth this profile by adjusting the firing split between the upper and lower burners, and also the proportioning of the air between the two levels.
