Ammonia Plant Heat Exchanger Problems

Useful data and recommendations for avoiding future failures result from a detailed investigation of five problems encountered in a Dutch processing facility.

R.M. Osman
Exxon Chemical Co.
Florham Park, N.J.

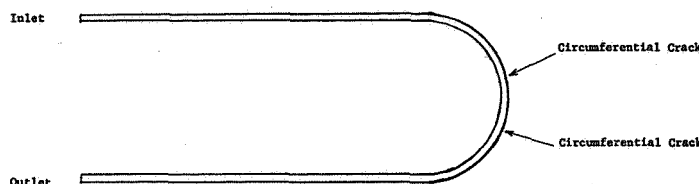
One complete U-tube was sent out to a metallurgical testing laboratory for analysis. Visual inspection of the outside of the tube showed two circumferential fissures, approximately 1/2-in. in length, in the outer radius of the U-bend. Figure 1 shows the location of the fissures. Dye penetrant inspection of the entire bend and adjoining straight tube sections showed no other defects.

Figure 1. Location of visible fissures in leaking tube taken from Catacarb reboiler.

bore. The two U-bend cracks seen from the outside of the tube were also visible on the inside, as they had penetrated the full wall thickness. No other defects were perceptible with the naked eye, but dye penetrant inspection of the bore revealed several minute circumferential fissures, 1/4 to 1/2-in. in length. As with the two larger cracks found previously, these small cracks were located in the outer radius of the U-bend; i.e., the portion in tension. Neither visual examination nor dye penetrant check indicated any defects in the straight portions of the tube.

Based on the microstructural examination results, it was concluded that the failures were due to improper heat treatment of the U-bends. Unstabilized austenitic stainless steels,

- Do not stress relieve Type 304 stainless steel U-bends, or those of any other unstabilized austenitic grade (e.g., Type 316).

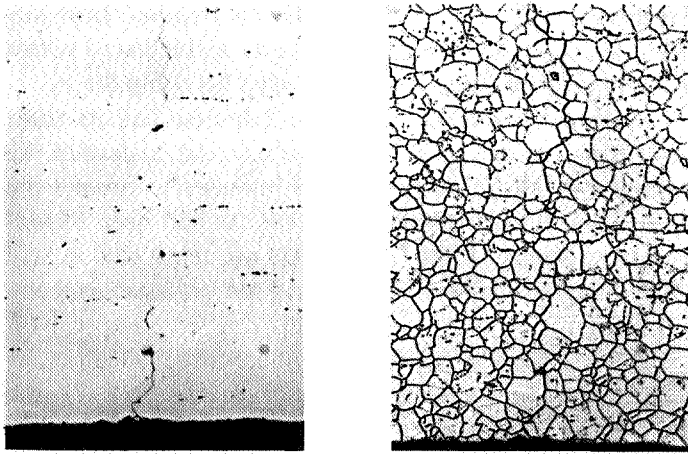
Numerous micro-cracks, undetected during dye-penetrant inspection, were found near the two cracks which extended through the entire wall thickness. These micro-cracks originated at the surface of the bore, and followed intercrystalline paths. Figure 2 shows one such crack, and also depicts the carbide precipitations at the grain boundaries.

Figure 2. Photographs of microcracks originating at the bore of Catacarb reboiler tube U-bend (X200). Left, unetched; and right, 10% oxalic acid (note carbide precipitations).

such as Type 304, have a strong tendency to precipitate carbides when heated into the 800-1500°F range. These precipitations were found only in the bent portions of the tube, indicating local heating at an unfavorable temperature range either during bending or during installation of the tubes. Most probably, the local heating represented an attempt to stress-relieve the U-bend area, although no such heat treatment was specified in the exchanger mechanical design.

The actual cracking mechanism apparently was triggered by the slight corrosion noted at the carbide-precipitated grain boundaries on the bore of the tube. This hypothesis is confirmed by the fact that the observed intercrystalline cracking originated at the surface of the bore. It is unclear exactly what caused the observed grain boundary corrosion. Wet CO₂ is not generally believed to initiate such cracking. Possibly the agent was polythionic acid, formed during the startup phase when the sulfur-containing high temperature shift catalyst was reduced.

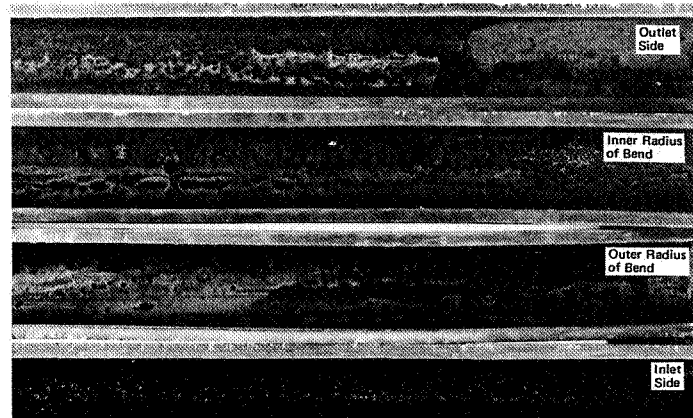
To pin down the root cause of these frequent waste heat boiler tube failures, various failed tube samples have been sent out for metallurgical testing laboratory analysis. The results have consistently indicated significant fouling and corrosion on the bore of the U-bends attributable to impurities in the boiler feedwater. Even in the case of the first failure, where a gas temperature excursion actually precipitated the tube ruptures, subsequent investigation found deposits and corrosion in and adjacent to the U-bend areas. Figure 5 shows the deposits found in a tube taken from the bundle (No. 1) removed from service in May, 1973. Tube samples taken from earlier bundles showed even more evidence of fouling. Figure 6 shows serious pitting corrosion found on a tube taken from the No. 2 bundle pulled in February, 1972.

Because waterside deposits act to insulate the tube metal from the necessary cooling effects of the boiling water, the tube metal temperature will be considerably elevated if fouling occurs. The estimated U-bend metal temperature with design inside and outside fouling factors is 743°F, but if there is significant deposition of boiler water solids, the inside fouling factor will exceed design, and the metal temperature may rise well above this level.

Figure 5. Deposits on bore of tube taken from No. 1-bundle after May, 1973, removal.

- Employed frequent waterside chemical cleanings, initially with citric acid, later with sulfamic acid, and most recently with hydrochloric acid (HCl cannot be used with the No. 2 bundle because of austenitic stainless steel tube/tubesheet welds on the 5 Cr-½ Mo tubes).

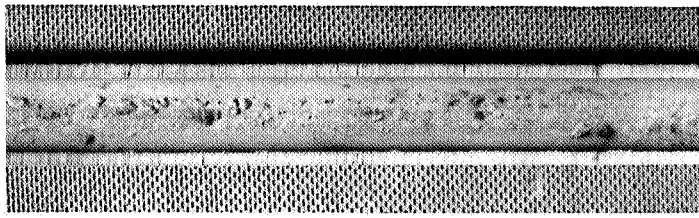
Figure 6. Pitting corrosion found on tube taken from No. 2 bundle after February, 1972, removal.

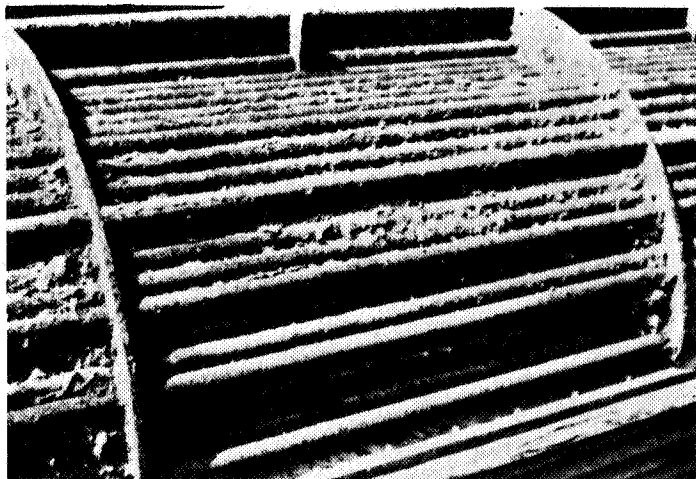
Figure 7. Photo of syn gas intercooler bundle pulled in February, 1973.

Thus, after less than six years of operation, the syn gas compressor intercooler bundles have each required replacement twice, and the newest set of bundles have already started to leak. Over the same time period, one syn loop water cooler has been replaced, another has been completely plugged off, and the remaining two original bundles are leaking. Figures 7 and 8 are photographs showing the conditions of a syn gas intercooler bundle pulled in February, 1973, and of a syn loop cooler bundle pulled in May, 1973.

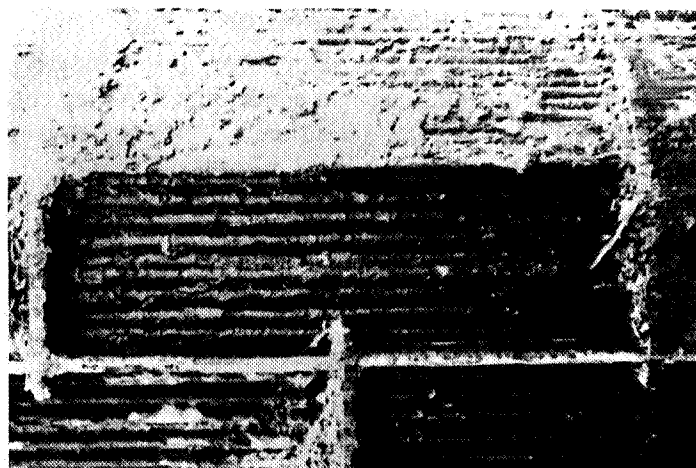
Figure 8. Photo of syn loop water cooler bundle pulled in May, 1973.

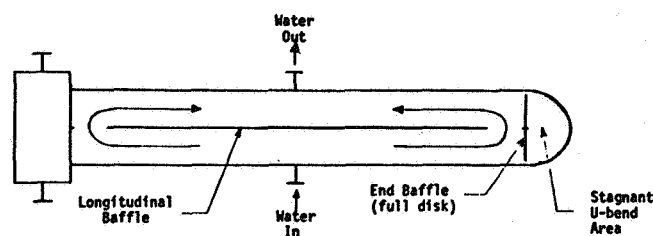
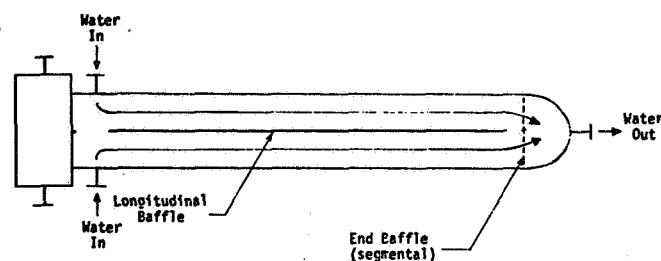
The syn loop cooler bundles, as shown schematically in Figure 9 at A, have a "G" shell design, with a horizontal longitudinal baffle. The strength of this baffle, and the strength of its longitudinal sealing strips, limit the shellside pressure drop, and hence limit the cooling water velocity. Moreover, there are several local low velocity areas in the design. During the May, 1973, plant turnaround, inspection of the areas where the transverse baffles cross the longitudinal baffle revealed very heavy fouling deposits. Also, the design flow pattern bypasses the U-bend area (full disk end baffle), leaving it stagnant and subject to highwater temperatures.

Figure 9. Modifications to converter effluent cooler. Original "G" shell design is shown at A, and modified "Split E" shell design is shown at B.

To eliminate the localized “dead” areas, and to permit an increase in cooling water flowrate and velocity (limited by allowable pressure drop across the longitudinal baffle seals in the original design), the following design improvements have been incorporated in replacement bundles now in stock or on order:

Omitting the inner row of U-bends will eliminate the “dead spots” at transverse/longitudinal baffle crossings where heavy deposits had been found, by allowing water to flow through the vacant tube holes in the transverse baffles. It was realized that this extra “bypassing” introduced into the flow pattern will hurt the effective temperature driving force somewhat, but it was estimated that the reduction in fouling level would more than make up for this factor. Also, since there will be improved access to the center of the bundle, turnaround cleaning (with a high pressure water jet) will be simpler and more effective.

1. It eliminates the stagnant area around the U-bends.
2. It removes any limitation on the shellside pressure drop because pressure levels above and below the longitudinal baffle are essentially the same. This permits use of maximum available cooling water header pressure drop to maintain high water velocity.
3. It eliminates any concern over the quality of sealing between the longitudinal baffle and the shell, because there is little driving force for leakage, and almost no effect on heat transfer if leakage should occur.

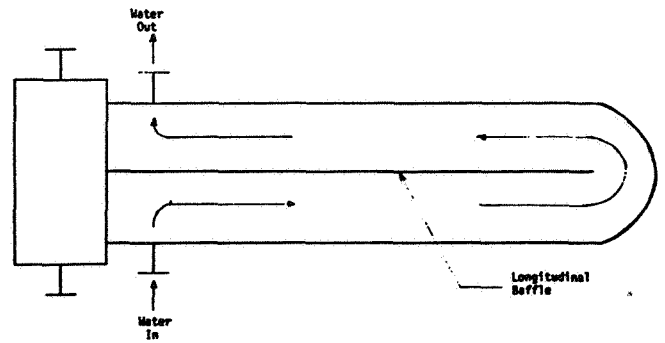
The syn gas compressor intercooler, as shown schematically in Figure 10, are “F” shells (two shellside passes), again having longitudinal baffles. As designed, cooling water velocities were less than 3 ft./sec., and the water flow could not be increased, because the longitudinal baffle strength limited allowable shellside pressure drop to only 7-8 lb./sq.in. To eliminate this restriction the following bundle design changes—details shown in Table 5—were made, to allow the full pressure drop available in the cooling water headers (40 lb./sq.in.) to be taken across the longitudinal baffle:

Figure 10. Cooling water flow pattern through “F” shell syn gas compressor intercoolers.

- The longitudinal baffle thicknesses were increased.
- The number of sealing strips was increased.
- The baffle spans were reduced by increasing the number of transverse baffles.
- The longitudinal baffle to shell clearance was reduced on one bundle.

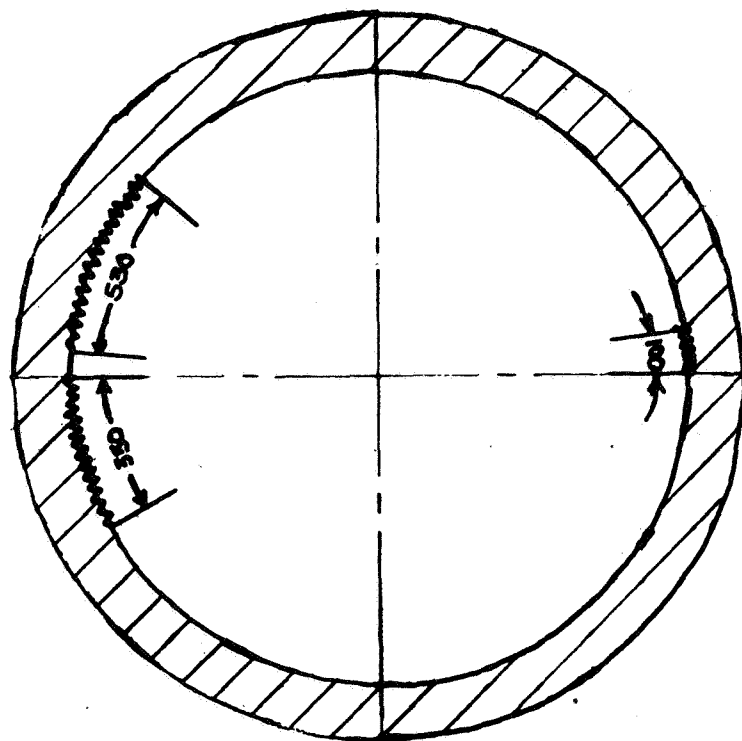
In May, 1973, after 4-1/2 yr. in service, an inspection of this exchanger revealed three circumferential cracks at the junction of the stainless steel shell section and the C-½ Mo tubesheet. No gas leakage had been noted, however. Cracks were in the vicinity of the weld. Crack lengths were 21, 13 and 4 in. Figure 12 shows the orientation of the cracks.

An investigation of the failure revealed that the cause was excessive *radial* differential thermal expansion at the joint between the C-½ Mo tubesheet and the stainless steel shell section. Note that the codes normally used for exchanger mechanical design do not cover such radial thermal expansion stresses. Detailed theoretical calculations, based

Figure 12. Orientation of cracks found at north shell/tube-sheet junction of feedgas preheat exchanger (dimensions are in mm.).

on ASME Section VIII Division 2 (more sophisticated analysis than Division 1) code criteria, showed that the maximum stress intensity at the outer surface of the joint is 105,000 lb./sq.in. vs. a maximum code allowable of only 54,300 lb./sq.in. This, of course, explains the observed cracking. A contributing factor may have been the poor type of shell to tubesheet joint shown in Figure 11, which in fact is no longer permitted under the Dutch pressure vessel code.

The cracks were ground out as far as practicable, but appeared to penetrate deep into the shell wall. The ground-out crack area was welded with Inconel 182 filler wire, and final dye penetrant checks revealed no indications of new cracks. The shellside was successfully hydrotested, and the exchanger returned to service. Visual inspection in August, 1973, and March, 1974, indicated that the new weld is still in good condition.

A complete new replacement exchanger is currently on order. The new design, in Figure 13, eliminates the need for a stainless steel shell section by going to a much thicker tubesheet, and to C-½ Mo for the shell material. C-½ Mo is

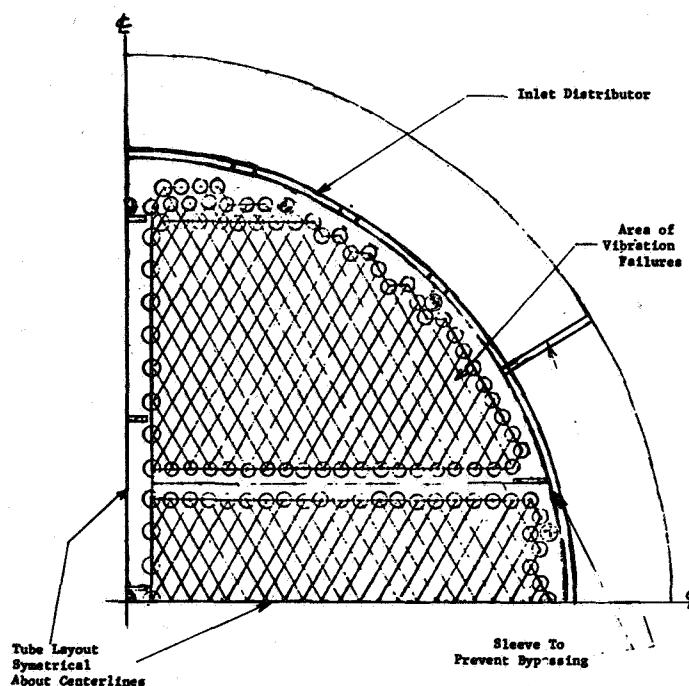
Shutdown inspection revealed that several tubes had failed by cutting at the baffles. The location of the failed tubes is shown in Figure 16. Note that the failures were directly underneath the section of distributor which had extra holes added adjacent to the inlet nozzle projection. Tube pulling in the area surrounding the failed tubes revealed evidence of baffle cutting in the top three rows of tubes, but none below that.

Figure 16. Location of tube vibration failures in low-temperature shift feed cooler.

From the appearance and location of the failures, a tube vibration problem was indicated. To confirm this, theoretical calculations were made to check for flow induced tube vibration. Calculations were based on a method outlined in a paper by J. S. Fitz-Hugh of Oxford University. (1) The critical flow velocities which cause flow-induced tube vibration are given by:

A comparison of the actual velocity range with the tabulated critical vibration velocities indicates that the exchanger inlet velocity is quite close to the second mode vibration critical. Considering that the tube failures were located under a section of the distributor which had a higher than average hole density, the local inlet velocity must have been somewhat higher than 14.2 ft./sec., and would therefore be right in the range calculated to produce tube vibration. Moreover, Fitz-Hugh (1) suggests a safety margin of at least ±20% around the calculated critical velocity to avoid vibration problems.

Once the mechanism for the tube vibration failures had been theoretically confirmed, the question of course became "What do we do about it?" For a short-term fix, two rows of tubes surrounding the failures were plugged off, and the extra distributor holes adjacent to the inlet nozzle projection were eliminated. To raise the critical vibration velocity safely above the actual inlet velocity, the unsupported span length (appears squared in the denominator of the V_c equation) was reduced by creating temporary extra "baffles" in the top portion of the bundle. These "baffles" were created by forcing 0.079 in. thick stainless steel strips in between every other tube row, as shown in Figure 17. Since the tube-to-tube clearance is normally only 0.065 in., the force fit strips created a rigid assembly that effectively clamped the tubes in place. The long-term fix will employ a complete new bundle which will have nine tube support baffles vs. the original four, but which will continue to use an improved inlet distributor to provide a good heat transfer coefficient.

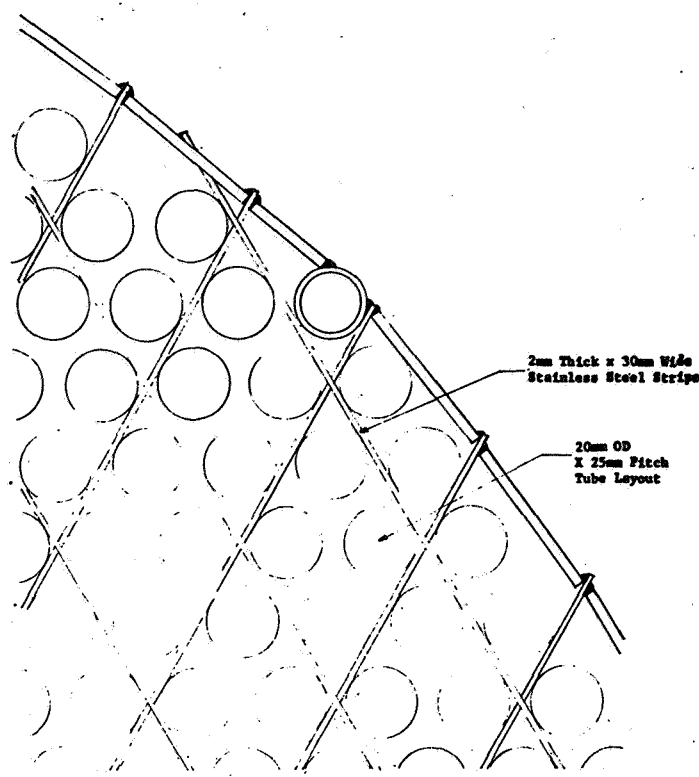
Figure 17. Detail showing field fabrication of temporary "baffles" for low-temperature shift feed cooler.
