Failure in Start-up Heater Tube

Detailed study of incident involving tube rupture at English ammonia plant shows temperature imbalance to be a contributing factor.

J. Mitcalf
Shellstar Ltd.
Ince, England

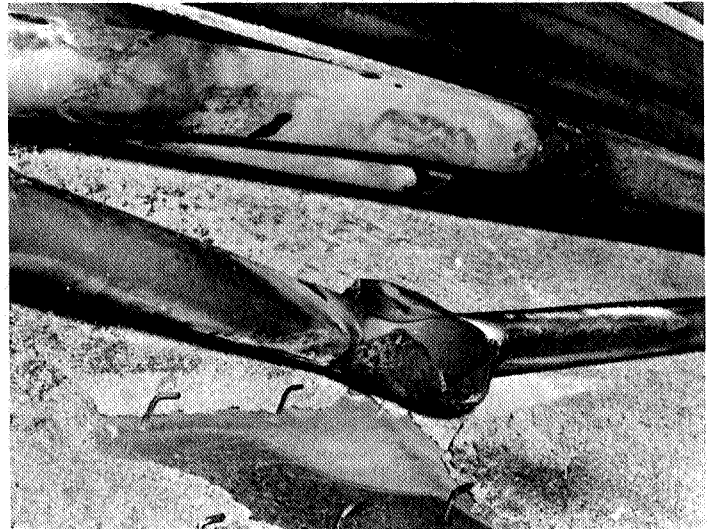
Preliminary inspection showed that the outlet tube of the south coil had ruptured longitudinally, about 10 ft. from the furnace floor, i.e. about 30% up the vertical tube. The length of the rupture was 11 in. It is shown in Figure 1. As can be seen in Figure 2, extensive damage was done to

Figure 1. Ruptured tube, showing scouring of the refractory from the furnace wall.

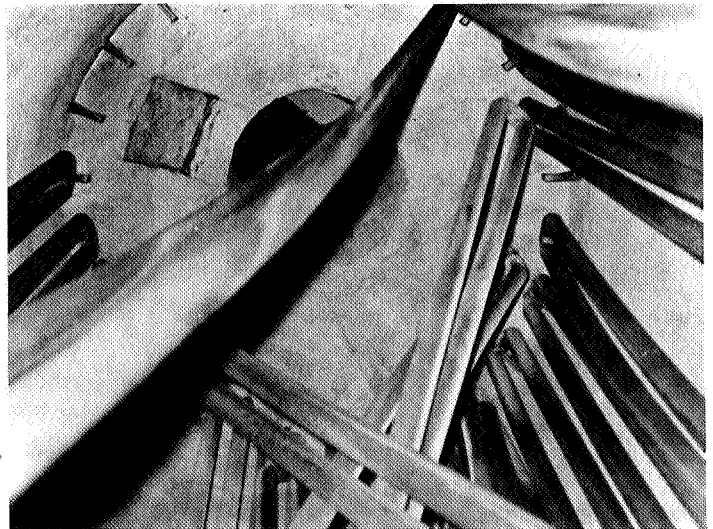
Figure 2. General internal view of the heater, showing piping dislodged from its hangers.

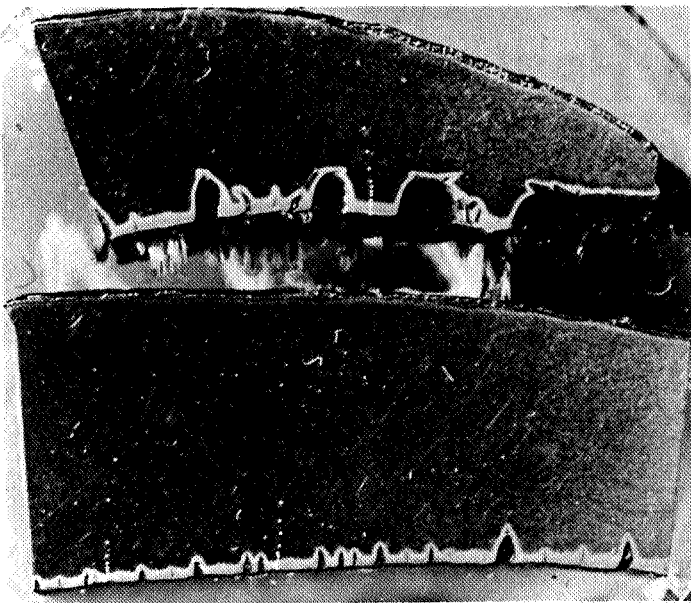
Examination of the failed tube, i.e. the south outlet, showed that in the region of the rupture there were fissures in the tube bore up to 1.7 mm. in depth; the inner surface of the tube was nitrified to a depth of 0.8 mm. on the flame side and 0.38 mm. on the shadow side. Figure 3 shows some of the damage. It was also noted that the fissures themselves were nitrified to a depth of 0.2 mm.

At a location 20 cm. from the rupture, 5% creep was

Figure 3. Cross section of rupture on a location halfway its length, south inlet tube.

present, and at this point the tube wall had thinned from 11 mm. to 9 mm., although the tube bore remained circular.
