Explosion of Ammonia Liquor Tank

New operating procedures code was developed following a detailed investigation of the incident at an agricultural chemicals plant in England.

D. Henderson
Imperial Chemical Industries Ltd.
Billingham, England

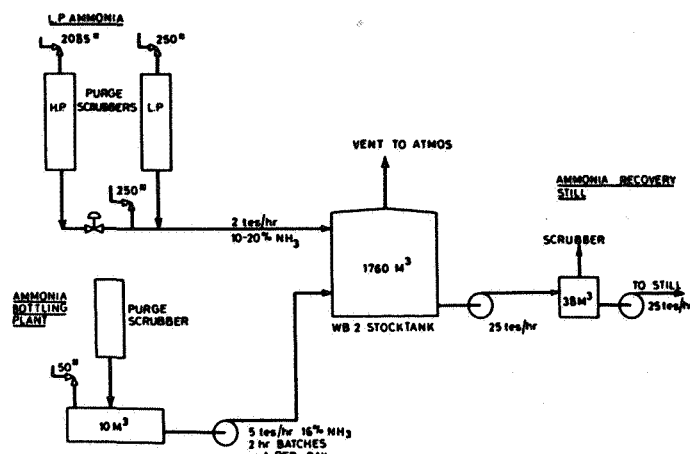
Figure 2. Diagram of the liquor system.

Liquor was supplied to the tank from the high-pressure water scrubber associated with ICI's Kellogg low-pressure ammonia (LPA) plants, and from a small ammonia bottling plant. The only consumer of the liquor was an ammonia recovery still. Normal flow rates to the tank were 50 ton/day from the LPA plants and 10 ton/day from the bottling plant. Strength of the liquor varied from 10 to 20% ammonia at ambient temperatures. The still consumption was

At the beginning of the incident, the tank was filling up, after the still had been run 13 days previously. Figure 2 is a line diagram of the system.

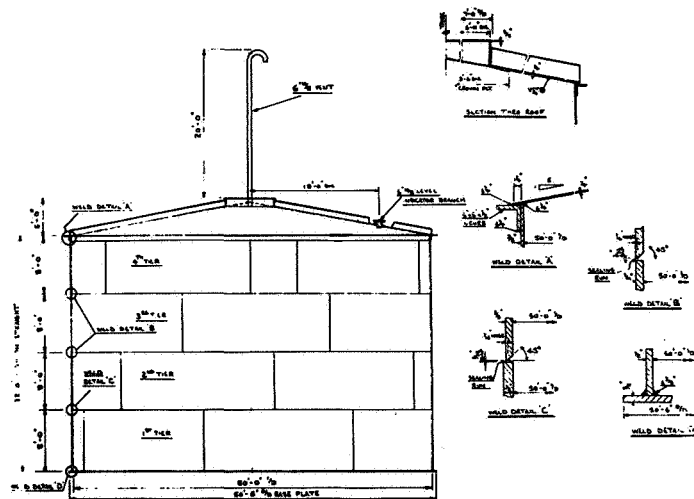
Figure 1. Detailed design and method of construction of the tank.

Mild steel was the material of construction of the 1,750-cu. meter tank, which was 50 ft. in diameter and 32 ft. in height. Detailed design and construction method is illustrated in Figure 1. The tank vented to atmosphere through a 6-in. I.D. vent pipe, 20 ft. long, mounted vertically at the apex of the tank roof: no relief valve or vacuum release valve was therefore fitted.

2. The roof-to-wall joint should be weaker than the wall-to-floor joint so that in the event of over-pressuring, the roof fails: this was *not* the case in the incident described.

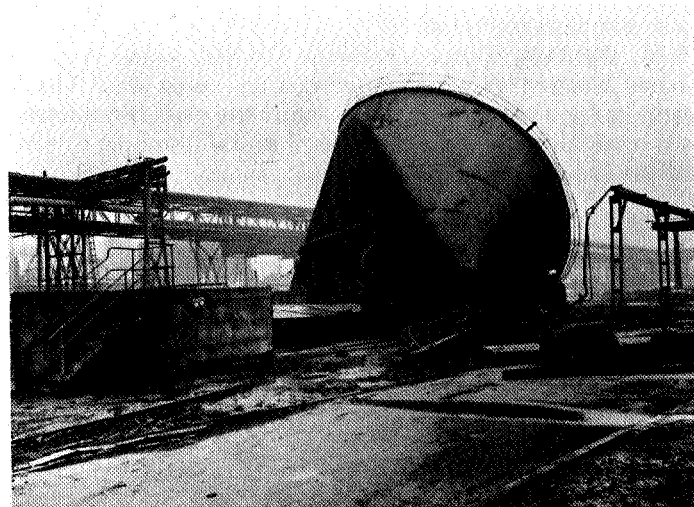
Figure 3. View of failed tank from west of bund, looking southeast, showing demolished sections of the bund wall.

The resultant position and appearance of the tank is shown in the photographs in Figures 3, 4 and 5. The evidence indicated a rupture of the side wall of the tank from its base, a movement of the tank in a southerly direction, collapse of the tank on the south bund wall section, and the removal of a section of the bund wall from the west side. The latter is thought to have been caused by either weight of ammonia liquor or—more likely—by the concrete steps attached to the tank stairway colliding with the wall and knocking a section out.

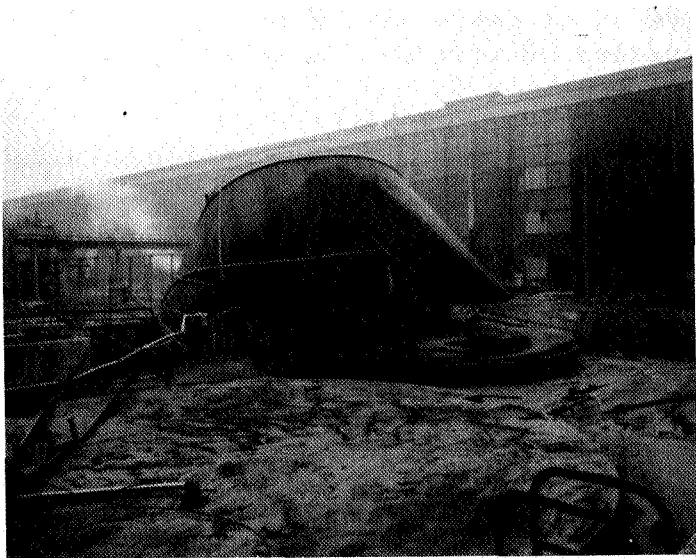
Figure 4. General view across banded area, looking southwest.

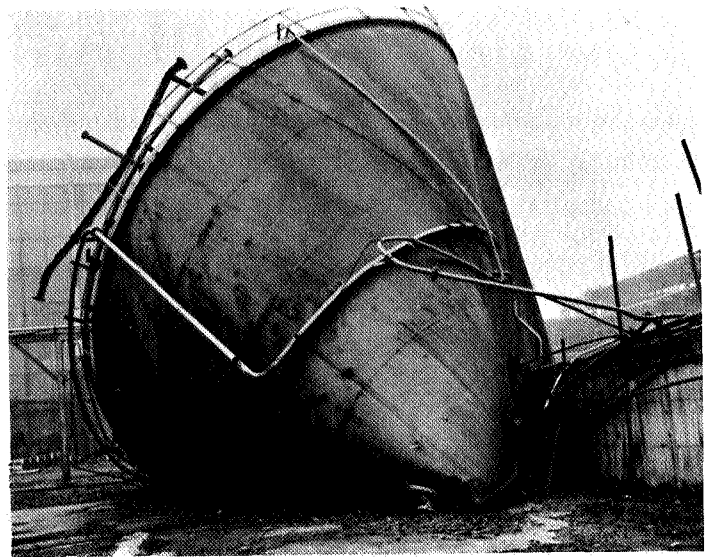
Figure 5. Close-up of failed tank from the east side. The probable sequence of events during the failure was as follows. The initial failure of the base-to-wall seam occurred on the north side of the tank and ran around to the south side in both directions. This caused the north side of the tank to lift most, and the effect of the pressure in the tank was to eject the liquor through the split seam, and to push the tank in the opposite direction. Therefore, the tank virtually pivoted about its south side base seam (the final separation of the split seams was only about two feet) and fell onto the bund wall. The weight of the unsupported north side of the tank wall then caused it to collapse inwards, resulting in the final appearance shown in the photographs here.

Internal over-pressuring was virtually certain to have been the cause of failure. The dished appearance of the tank base indicated that on initial over-pressuring the tank began to “inflate,” or attempt to attain a spherical shape, and then failed along the weakest point—the base-to-wall joint in this tank. A pressure of 30 lb./sq.in. gauge would probably have been required to bring about failure.
