Failure in Secondary Reformer Vessel

Thorough investigation of ruptured shell of reformer in ammonia plant during repairs aimed at preventing future recurrences of the same problem.

M.B. Sterling and A.J. Moon
Amoco Oil Co.
Texas City, Tex.

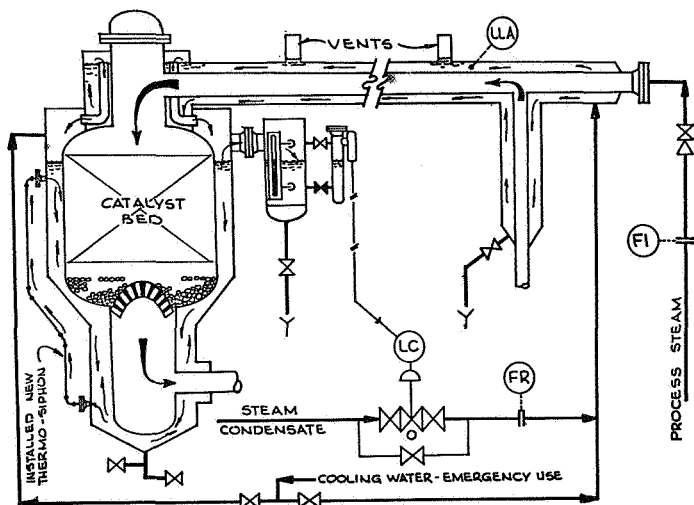
Figure 1. Reformer water jacket cooling system.

After consultations with M.W. Kellogg, Amoco installed thermal siphons on the water jacket. These consist of four 3-in. diameter pipes spaced 90° apart, each connected to the top and bottom of the jacket. Their purpose is to increase the cooling and water circulation in the jacket.

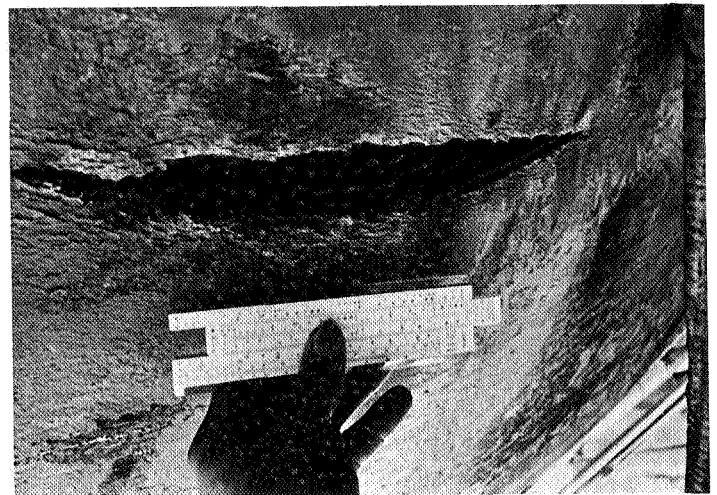
Figure 2. Secondary reformer — rupture in vessel wall.

At 6:00 pm, October 27, 1973, the shell ruptured, and the plant was promptly shut down with no other damage. Fortunately no equipment was in the path of the escaping hot gases. A section of the shell wall about 6 ft. high and 18 ft. in circumference was severely bulged, and the final rupture, shown in Figure 2, measured 18 in. in length and 1-3/4-in. in width. The internal refractory was relatively undamaged and had not deformed with the tower wall, as illustrated in Figure 3. The rupture was about one ft. above the catalyst bed opposite a crack in the internal refractory lining, as shown in Figure 4.

Repairs to the vessel shell were made by replacing the bulged area with an ASTM A-515, Grade 70, fire-box quality, carbon steel plate approximately 6 ft. 10 in. high by 18 ft. 10 in. in circumference. The new plate was double beveled and butt welded in place with E-7018 electrodes, the root pass being made with E-6010 electrodes. A magnetic particle inspection was made at the root pass, at the back chipped surface, on both sides of the weld halfway out and on the completed weld. Preheat and postheat were completed by using electrical resistance coils. Thermocouples and a strip chart temperature recorder were used in main-

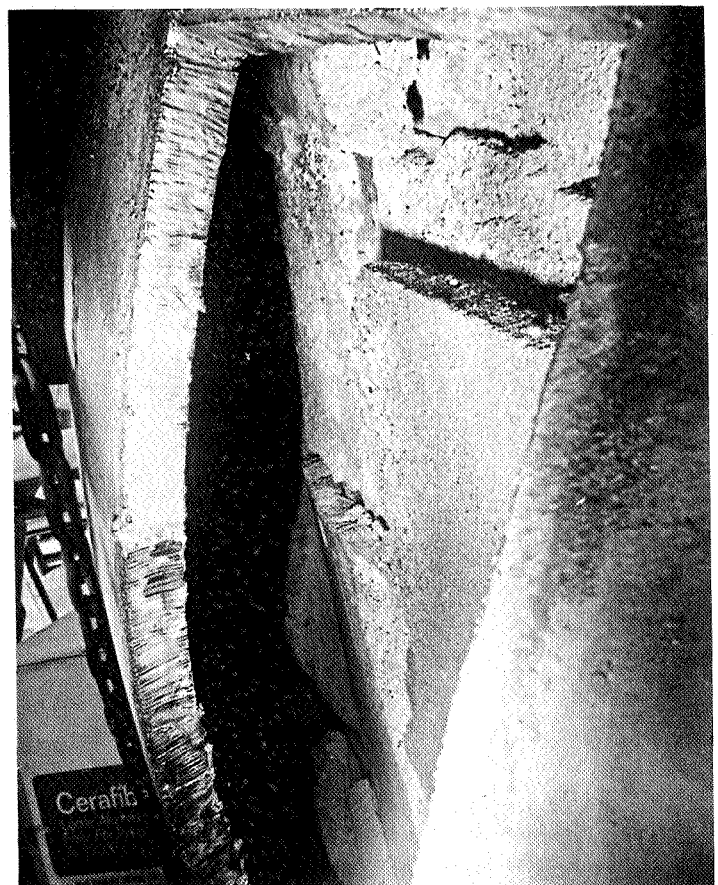
Figure 3. Secondary reformer — refractory inside the bulged section of shell.

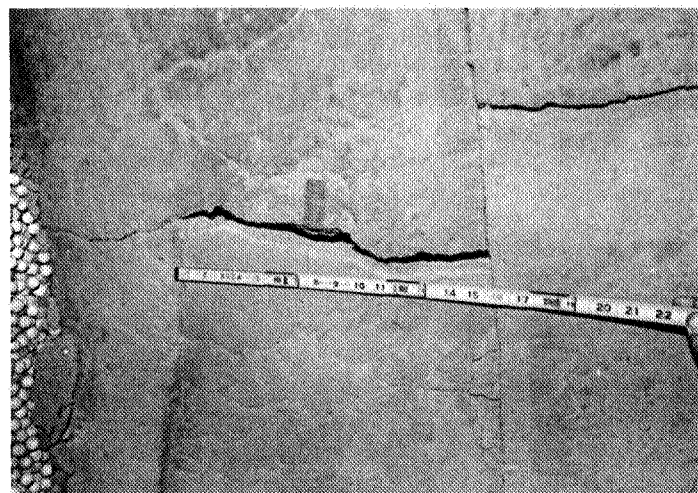
The shell failure occurred when heat radiated to the shell through the crack in the refractory lining. An initial thermal crack in the refractory may have been enlarged gradually by successive thermal cycles, and the collection of debris in the opening, until the wall became overheated and the failure finally happened. Because of the fine grain structure of the metal in the area of the rupture, we believe the shell was exposed to hot gas for a short time, probably only a few minutes. The water then was boiled from this area in the external water jacket, allowing the vessel shell temperature to rise to 1,500-1,600°F. The transfer line water jacket level was observed to be normal about an hour before the failure. We have therefore concluded that the failure resulted from short-time high-temperature stress rupture. There was no evidence of hydrogen attack in the metal samples.

Figure 4. Secondary reformer — crack in refractory at location of shell failure.

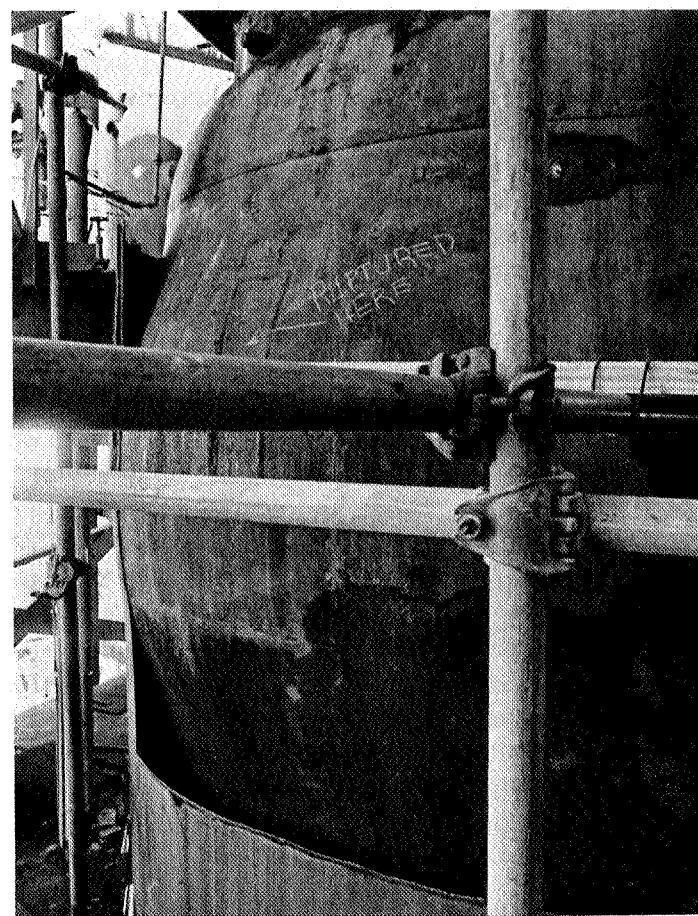
An overall view of the shell, including a temporary patch installed to oxidize the catalyst, is shown in Figure 5. It will be seen how the vessel wall had bulged, thus contacting the water jacket.

Figure 5. Secondary reformer — bulged shell at location of rupture.

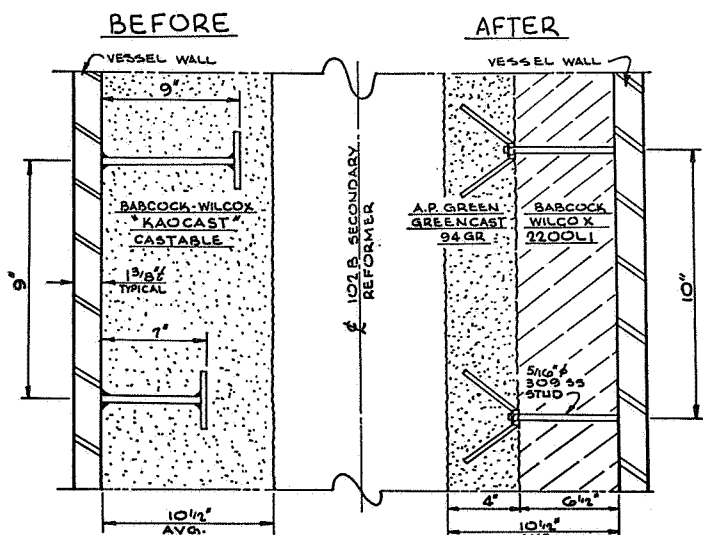
Figure 6. Comparison of old and new refractory systems in ammonia plant at Amoco's Texas City facilities.

The monolithic refractory lining was replaced with a two-phase system. This will reduce the amount of heat transferred to the metal wall and will also reduce the probability of refractory cracks propagating to the vessel shell. Refractory lining and studs were removed and the old stud wells were ground smooth. The interior of the vessel was sandblasted. Approximately 1,000, 5/16-in. diameter, No.

309 stainless steel studs with 3-in. "V" anchors were installed in rows 10 in. apart, staggered on 10-in. centers. The two-phase refractory system consists of 6-1/2-in. of an insulating refractory applied to the shell, followed by 4 in. of an alumina castable refractory. Both materials were gunned in place. A comparison of the old and new refractory systems is shown in Figure 6.
