# Ammonia Reformer Freeze-up

A disastrous failure of tubes in a primary reformer at a pressure of 14,000 lb. per square inch was the first such incident in 22 years of operation.

E. R. Johnson  
Union Texas Petroleum Division  
Allied Chemical Corp.  
Hopewell, Va.

A catastrophic failure of an ammonia reformer operating on natural gas feed in Allied Chemical's Nebraska plant resulted in an intensive investigation to determine the causes. The failure and subsequent study is the subject of this article.

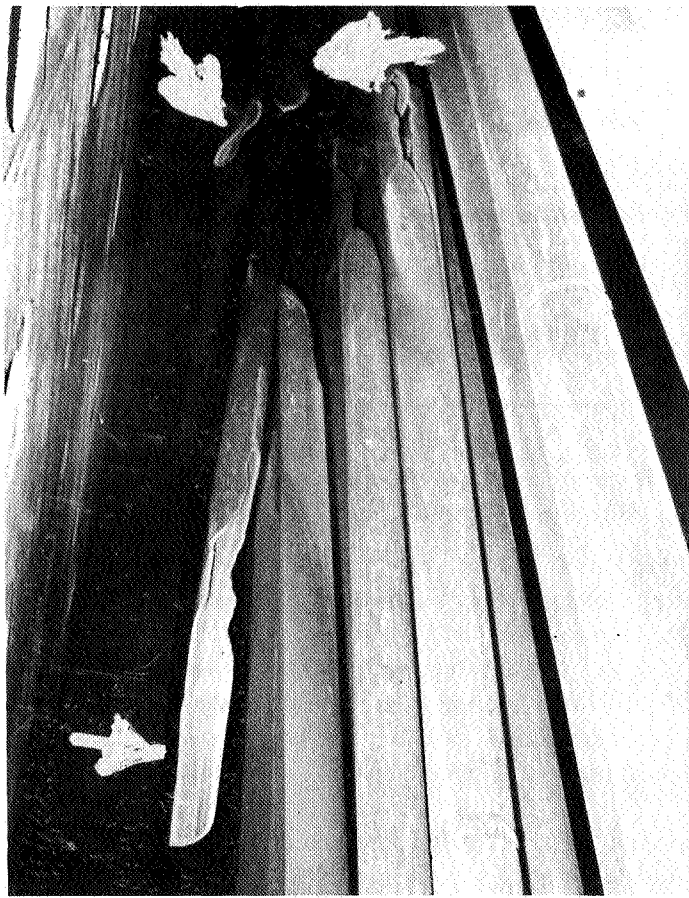
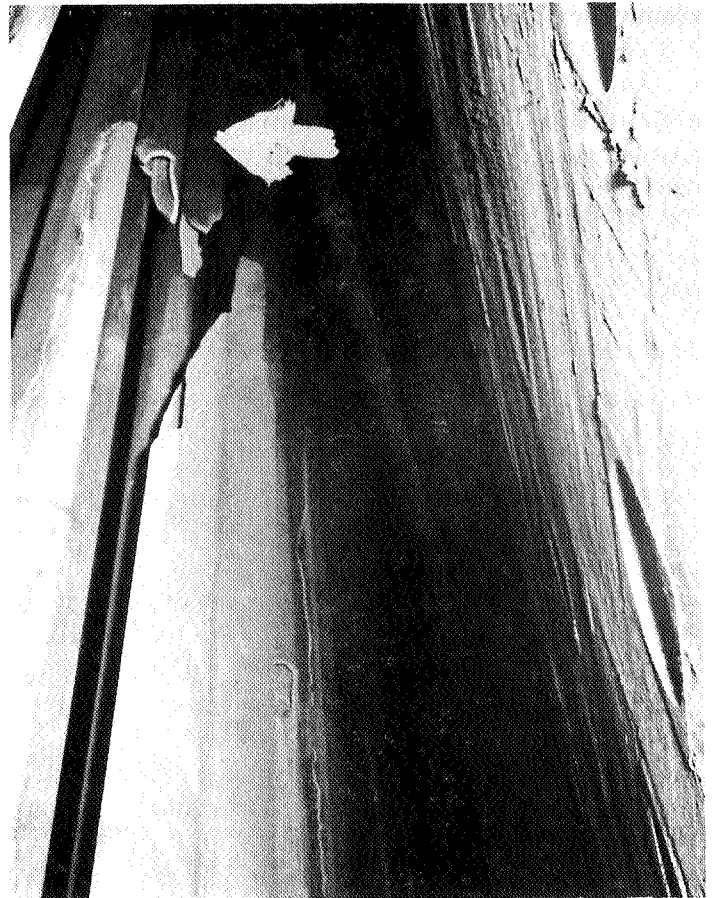
Later investigation showed that at shutdown there were leaking tubes in the secondary reformer waste heat boiler. As soon as heat was taken off the train, these leaks, instead of generating steam on the process side, leaked boiler feed water into the process side of the waste heat boiler. The water flowed by gravity back into the bottom of the secondary reformer where, due to the vast heat sink in the secondary catalyst, it was vaporized sending steam back through the transfer header into the primary reformer. In the primary reformer the catalyst tubes acted as condensers converting the steam to liquid water in the catalyst tubes.

At shutdown the weather was cold, but during the shutdown the temperature dropped to minus 29°F, extremely cold even for Nebraska. An operator inspecting the primary reformer a few days later found that 72 of the 142 tubes in the furnace were destroyed. A plant engineer took the Polaroid pictures shown in Figures 2-4.

Figure 1 and 2. Two views of the hanging remains of severed tubes, with the fractured ends indicated by the arrows.

1. In the past we have tried to avoid cold weather shutdowns, but in the future we will try even further to minimize the possibility of a shutdown during sub-freezing weather.

reformer with an inert gas, such as nitrogen or CO<sub>2</sub>.

3. Keep the reformer warm, either with a few burners on lazy flame or, if maintenance is required on the reformer, close it in around the bottom and maintain an auxiliary source of heat inside, even if it means building wood fires on the floor.

4. Provide double-block-and-bleed on the reformer at any point where water or steam could be admitted to the unit.

5. Provide auxiliary heat on the bleed between each double block. This showed up as a serious factor in our case because even where double blocks with bleed between were installed, the bleed would have soon frozen and sealed itself off in the temperatures encountered during our incident.

6. Give special attention to draining any tube bundle carrying liquid which could be turned loose in the system in event of a leak.

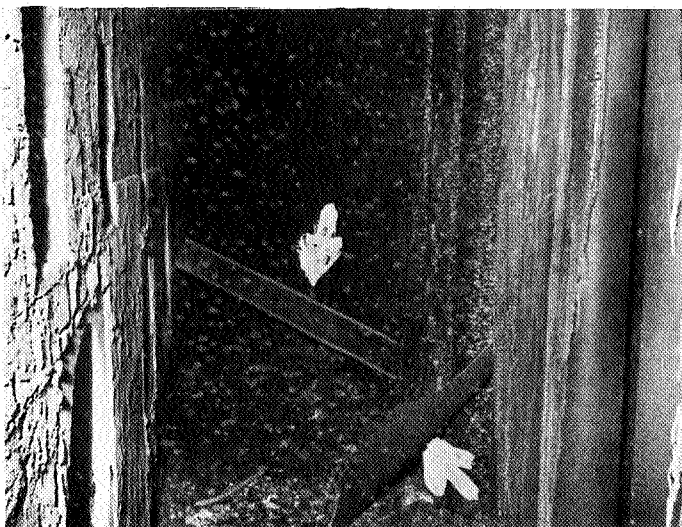
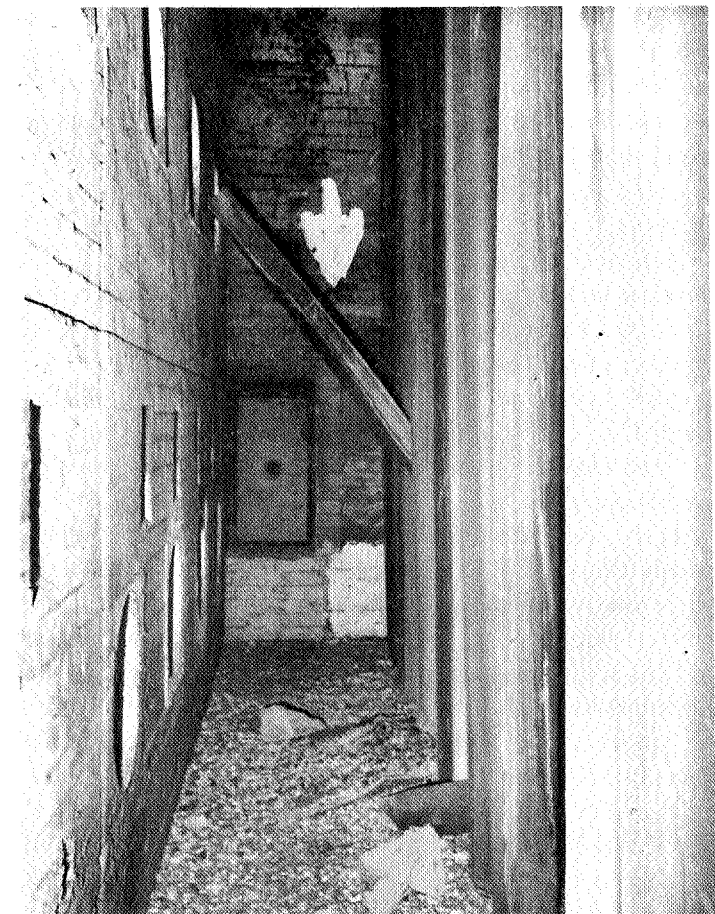
Figure 3 and 4. Two views of fallen pieces of shattered HK-40 tubes lying in catalyst and rubble on the floor of the reformer.

In reviewing the overall incident we attempted to assay the temperature and pressure at which the tubes had failed. Pressure determination was simple. From the strength data for aged, HK-40 alloy tubes at low temperature we readily calculated that the 4-in. tubes would have ruptured at 14,300 lb./sq.in. However, from the strength of ice data (1) we could calculate that it would be impossible to fracture our tubes.

The equilibrium temperatures and pressures for water and ice I have been plotted more precisely in Figure 6. It can be seen that at -9°C the freezing pressure of water was in equilibrium with the strength of our tubes. Therefore, at -9°C and 14,300 lb./sq.in., our tubes with sound wall ruptured. In an attempt to explain the extreme destruction of our tubes, rather than mere splitting, we calculated delta V for tube and ice at the failure point. The calculations show that while the tubes could increase internal volume by only 8% at the rupture pressure, the water freezing at -9°C would expand by 12% in going from liquid to ice I.

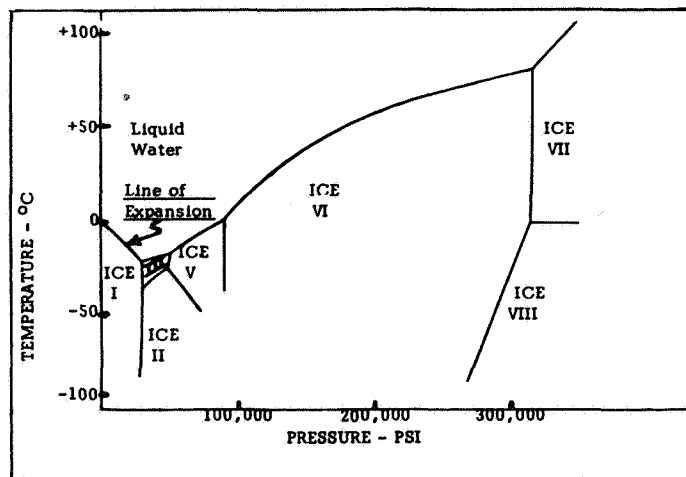
Based on data in the International Critical Tables, mainly that of P.W. Bridgman (4), the following solid-liquid phase diagram, Figure 5 has been constructed showing the pressure-temperature equilibrium points for liquid water and the seven known forms of stable ice which could exist at temperatures involved in our specific incident.

The metastable ice IV which can exist in the area of ice V, and ice IX which is fully stable only below -100°C (5), are not shown. Although the data show ice forms stable at 100°C and 350,000 lb./sq.in., the ice form of importance in freezing damage is ice I. This displays the anomalous behavior of expanding when going from liquid water to ice I, unlike the contraction that takes place upon formation of all the other forms of ice, and, in fact almost all other known chemical compounds and elements. The locus of

Figure 5. Phase diagram for water and the ices.

temperatures and pressures which could have burst our tubes is therefore the boundary of water and ice I, marked "line of expansion" on Figure 5.

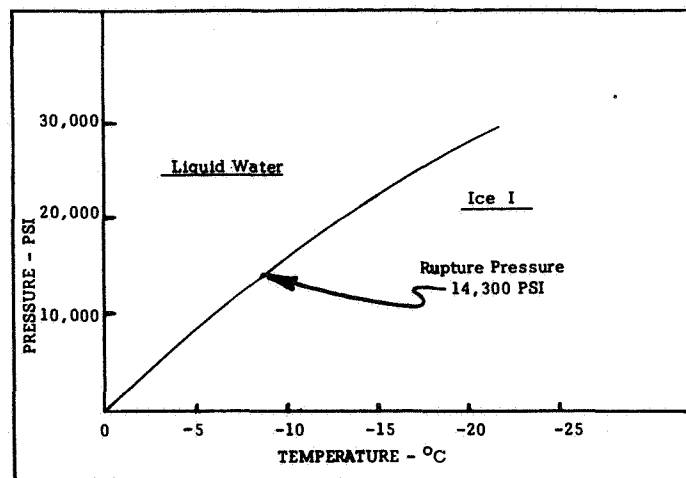
As a matter of interest we plotted the strength of a used HK-40 tube of 0.61-in. wall (a modern high-pressure reformer tube). (6) Applying the same method as above, it appears that the 0.61-in. wall tube should rupture at about -18°C and 26,000 lb./sq.in. Since the maximum pressure at which ice I can exist is about 30,100 lb./sq.in., a tube which could stand such a pressure without exceeding the elastic limit could not be damaged by freezing water.

Figure 6. Freezing pressure of water.
