# Additional Incidents from a Survey of the Industry

*The following brief items were developed under the guidance of J.D. Stafford, Occidental International Engineering Co., London, England. As part of his efforts in this undertaking, he read papers where the author was unable to be present at the actual symposium.*

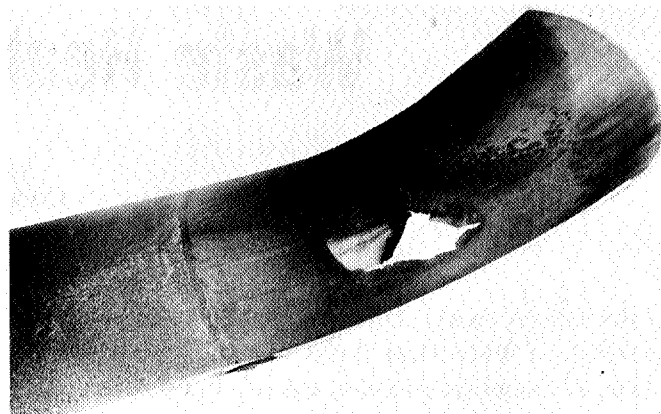
On the shell side, process gas is cooled whereby condensate is formed which is drawn off by a separate 6-in. pipe. After bursting of one of the bends in this pipe there was a heavy leakage of synthesis gas. Immediately the block valves down- and upstream of the damaged pipe were shut and a vent was opened. But gas streaming out in the meantime caused an explosion, followed by a fire. This fire lasted about 10 minutes until the gas pressure had dropped. Nobody was hurt. Material damage involved cable lines, electromotors, instrumentation as well as the windows and the cement asbestos wall of the compressor hall. The inspection of the cracked pipe bend—made of carbon steel—showed a strong erosion of the wall, Figure 1.

The velocity of the condensate flow through the bend is about 5 ft./sec. The condensate is saturated with gas, especially with CO<sub>2</sub>, and the flow pattern, therefore, will be bubble flow.

Usually there is only a low corrosion rate of carbon steel by CO<sub>2</sub>-saturated water, but in this case of a gas-liquid two-phase flow the corrosion is accompanied by strong

Figure 1. Condensate pipe burst by erosion-corrosion.

erosion. The new pipe was made of austenitic stainless steel. Moreover, the wall thickness is measured from time to time.

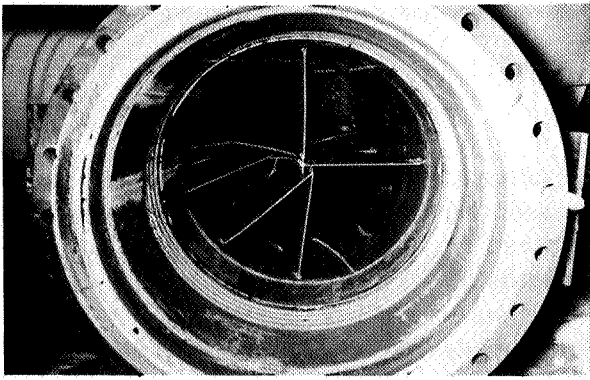
By the pressure drop there is a two-phase flow with a growing gas content within the pipe. This two-phase flow is pulsating and therefore it causes a strong vibration of the pipe. There were lots of cracks and leakages, and there was

Figure 2. MDEA-pipe with damaged sheets.

At first we made an installation of four sheets (1.2-in. thick, stainless steel) cross-shaped and so we had four cross sections. After a running-time of roughly one year it was destroyed by vibration corrosion, Figure 2. Then three inserted tubes of diameter of 9-in. and a wall thickness of 1.3-in., Figure 3, were installed within the pipe.

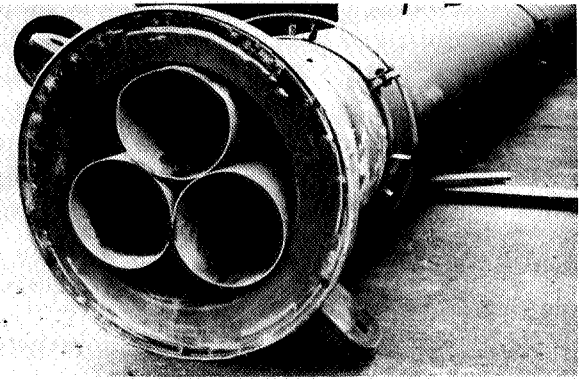
Figure 3. MDEA-pipe with three inserted tubes.

By the final step the flow velocity is unchanged and the pressure drop within the seven cross sections is only a little larger because the wall friction area has grown. The parting of the cross-section of the pipe reduces the separation of the gas-liquid flow and gives also a more uniform flow. Since that time—nearly six months—no more vibrations were observed. #

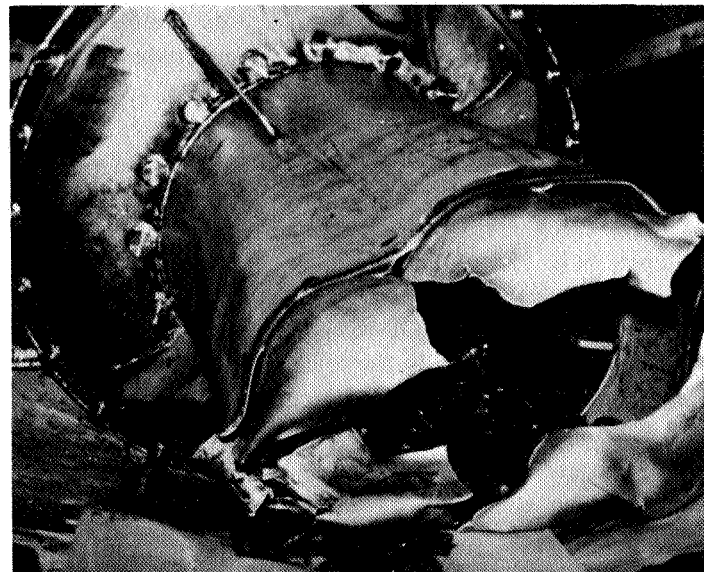
The internals had been damaged as can be seen in Figure 1.

A second explosion took place in the same plant in April 1974. The damages to the internals of the high pressure scrubber were basically similar to the damages caused by the first explosion.

Figure 1. Damaged internals.

Stamicarbon decided to change the operating conditions in the high pressure scrubber in such a way that the scrubber off-gas would not be within the explosive limits. This resulted in an off-gas containing ammonia and carbon dioxide. Further reduction of the ammonia and carbon dioxide content of this off-gas will be carried out in an absorption system operated at a pressure of only some atmospheres.
