Failure and Repair of Ammonia Converter Basket

How Shahpur Chemical's fertilizer manufacturing complex in southern Iran solved a major defect problem caused by chloride stress corrosion cracking

A. Kusha and D. Lloyd,
Shahpur Chemical Co.,
Tehran, Iran

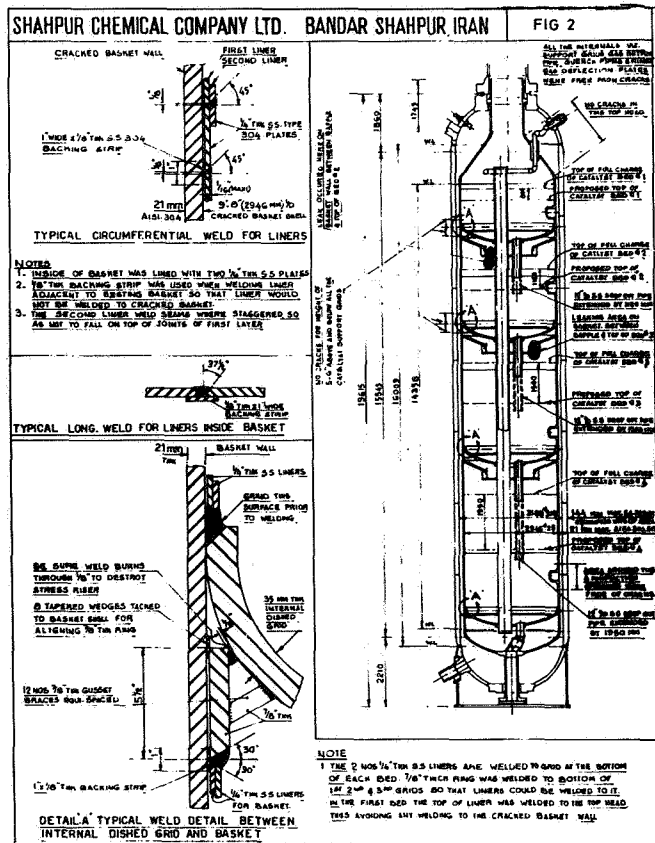
Figure 2. Details of the internal basket, showing cracks and welds.

Referring to Figure 2, visual examination of the basket showed cracks in the basket wall on each of the four beds, 360° round. Most of the cracks were vertical. The two hot spots on the pressure shell at beds two and three were caused by large vertical cracks. Ultrasonic examination of the basket showed extensive cracking in the basket wall between the catalyst support grids. Many cracks were not visible from the inside basket wall. A band of cracks mostly in the horizontal direction was found in the second bed extending around the circumference of the basket. The cracking is illustrated in Figures 3, 4 and 5.

Again referring to Figure 2, a "window" cutout was made in the basket wall at the hot spots in the second and third beds. An air arc was used to cut out the basket wall and the insulation and shroud behind it. Examination of these windows confirmed that the cracks had started on

the outside, and had propagated inward.

Examination of the external pressure shell at these two locations (dye penetrant, ultrasonic and hardness) detected no damage to the external vessel. However, the inside of the pressure shell had a thin coating of catalyst dust and insulation. The two windows were repaired by replacing the shroud and insulation and welding a 7/8-in. thick rolled stainless steel plate in position.

The repair of the basket wall was accomplished by lining the inside with two layers of 1/4-in. thick plate. Three 1/4-in. plates were installed at the second bed to give additional strength to the basket wall in the region of the horizontal band of cracks.

A liner was welded to the grid at the bottom of each bed. A 7/8-in. thick ring was welded to the bottom of the first, second and third grids so that the liner could be welded to it. In the first bed the top of the liner was welded to the undamaged top head.

The liner had to be installed in narrow strips (18 in.) about 5 ft. long so as to fit through the 20-in. manways. Backing strips 1/8-in. thick were used to avoid welding the liner to any part of the cracked basket. The second liner weld seams were staggered with the joints of the first layer.

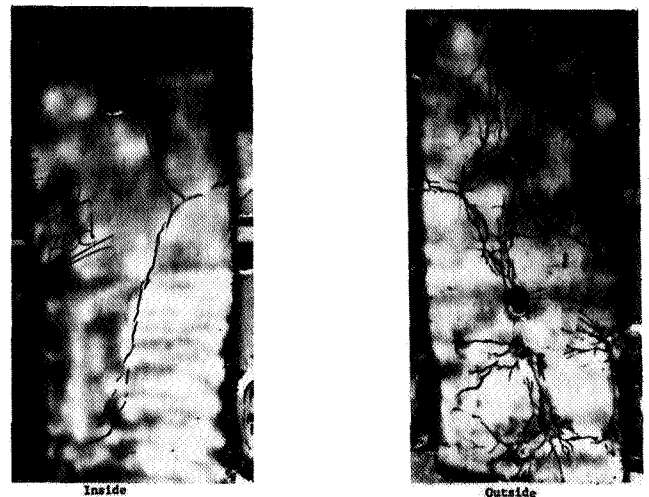
Figure 3. Photographs of the gross sample from the basket shell in bed 2. Dye penetrant applied to reveal smaller cracks. Left is inside and right is outside surface.

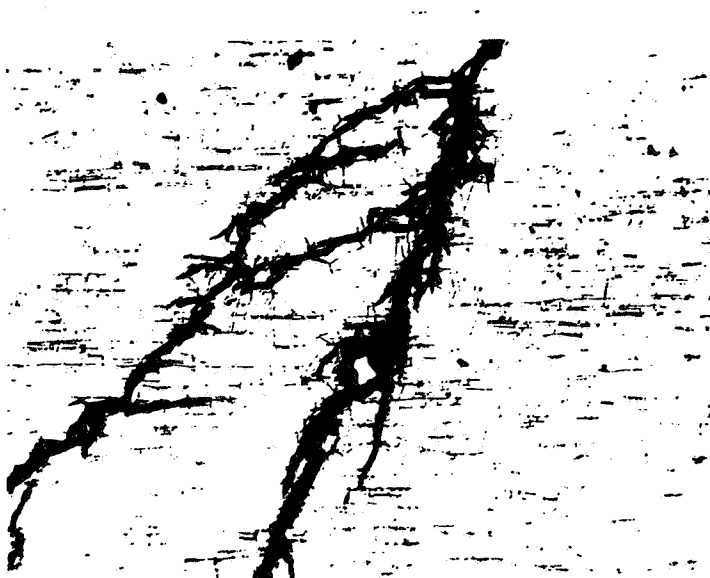
Figure 5. Photomicrograph of a section from bed 2 sample, illustrating nitrided branching transgranular cracks. Oxalic acid electrolytic etch. Total magnification 200x (exposed at 100x, enlarged 2x).

The residual plate-rolling stresses in the basket material, and later the pressure stress occurring during catalyst reduction, contributed to the stress factor. As nitriding of the crack surfaces had developed to the same degree, cracking had obviously occurred prior to, or very soon after, commissioning.
