Lessons Learned from Radiant Tube Cracking

A case history review of problems in high pressure reforming furnaces in four different ammonia plants, and the steps taken to solve them

J. Jansen,
Unie van Kunstmestfabrieken,
B. V., Pernis,
Netherlands

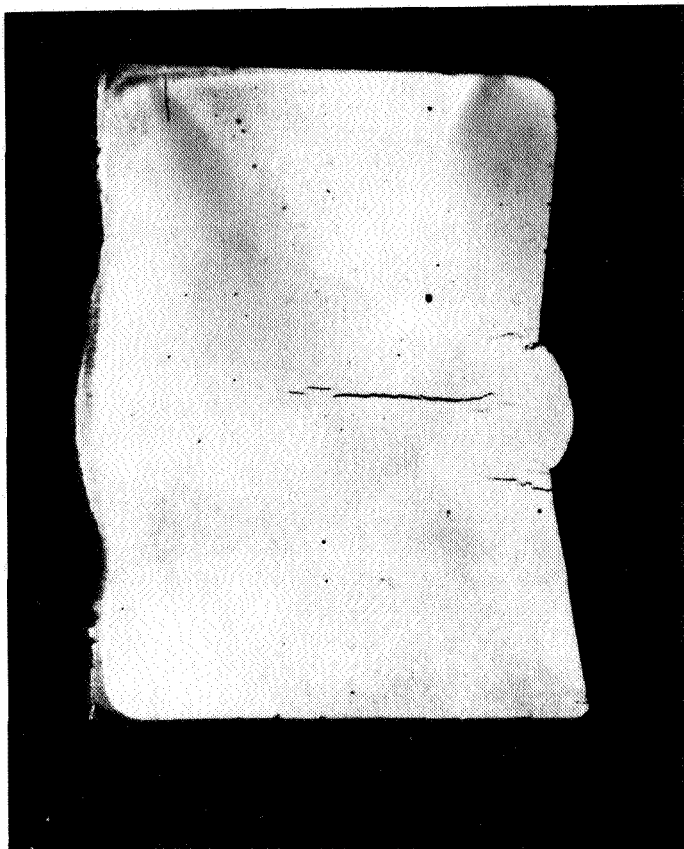
sults were such that we did a complete X-ray check of all tube welds exposed to flame radiation. Of the 336 catalyst tubes, 85 had cracks in the upper welds and two had cracks in the lower welds.

Figure 1 shows a typical crack. It originates in the root pass and penetrates the filler passes. It was not possible to obtain an indication of the depth of the cracks from the X-ray pictures. Lengths varied from a few up to 340 mm., all around the weld circumference.

In Holland, the steam reformer is subject to the boiler code. Consequently, the X-rays had to be examined by government inspectors. It was mutually agreed that 62 of the 87 defective welds were not acceptable and had to be repaired. The remaining 25 showed only very short cracks, which were considered acceptable.

Figure 1. A typical weld crack.

Repairs were carried out as follows: 18 tubes were replaced by new tubes, which were available in stock; 12 were removed from the furnace and repaired in our own workshop; 17 were removed and repaired in a vendor's workshop; and 15 were repaired in the furnace itself.

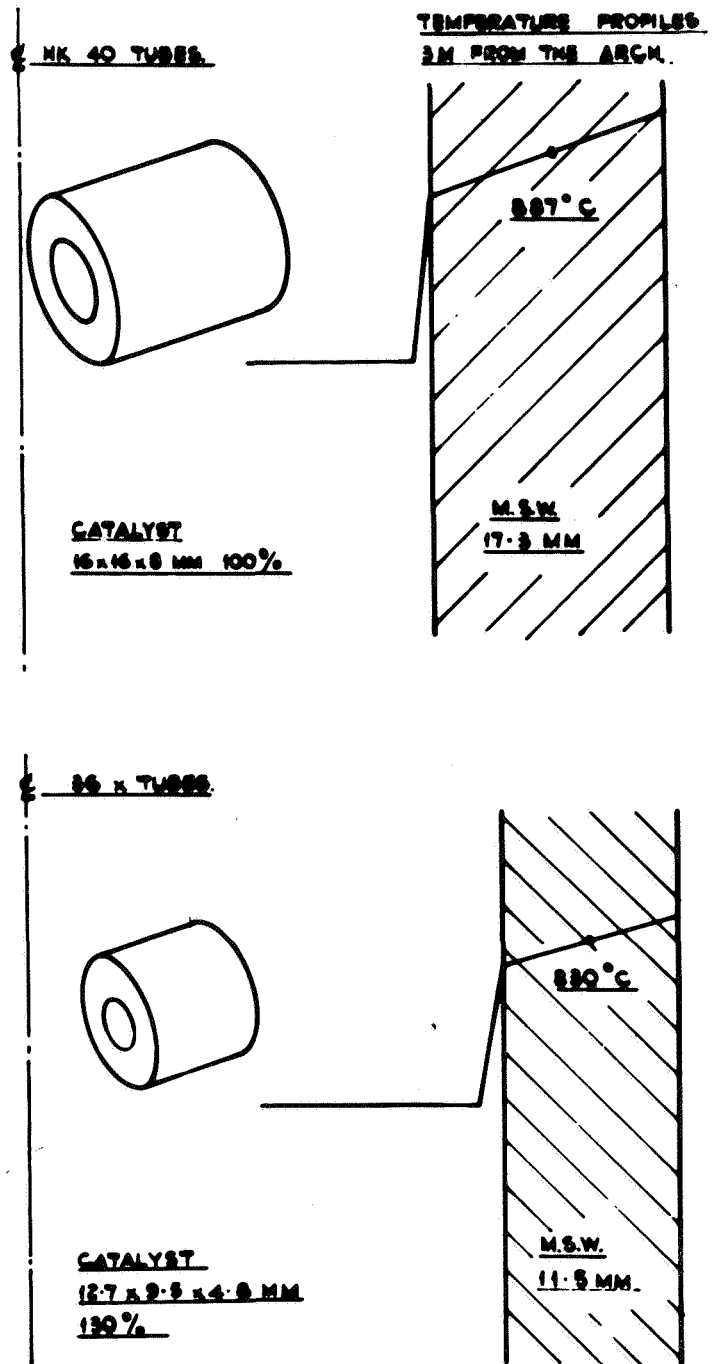
Lower thermal gradient across tube wall, inducing less stress. With more catalyst per tube, plus a smaller catalyst pellet, a 50-55°C lower midwall metal temperature could be expected about 3 m. from the arch. Calculations to this effect were made by the contractor. At that time, the smaller wall thickness did offset the higher cost of the 36X material. And 30% more catalyst was considered to reduce the risk of hot banding.

The calculated metal temperatures for both the 36X and the HK-40 tube are shown in Figure 2. At the top is the old situation; thick walled HK-40 tubes and larger catalyst rings. The lower sketch shows the thinner walled 36X tubes together with the smaller catalyst rings. The mid-wall metal temperatures shown are those at a distance of 3 m. from the arch: 887°C for HK-40 tubes and 830°C for 36X.

Figure 2. Calculated metal temperatures for HK40 and 36X tubes.

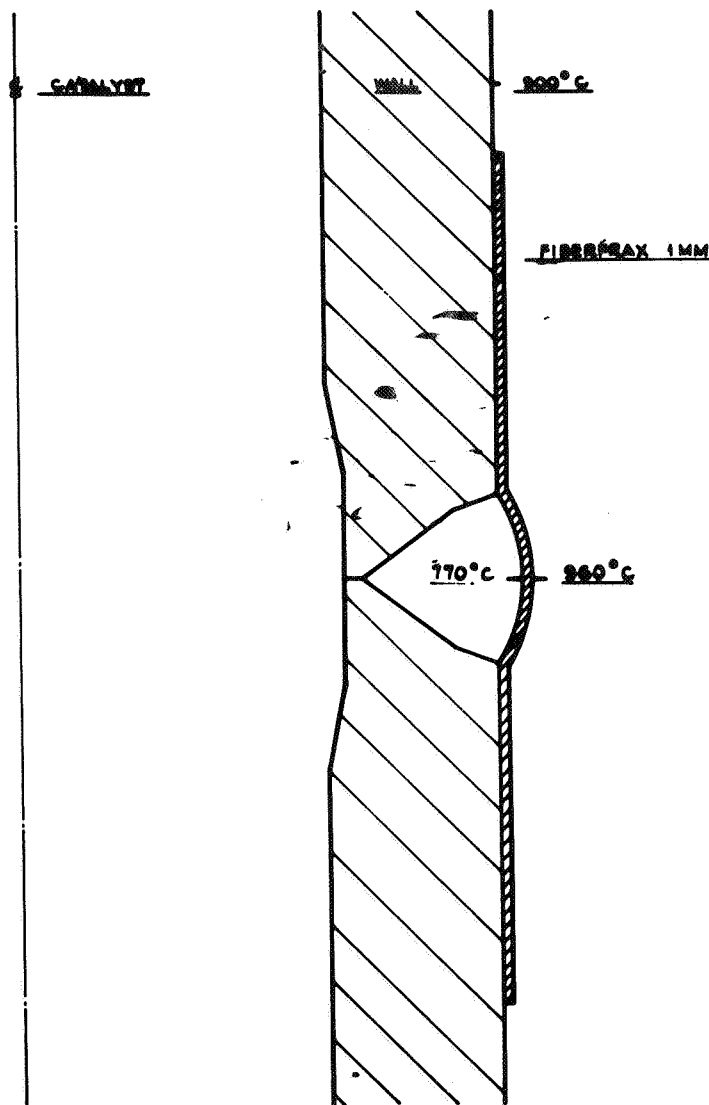
Based on the measured temperatures of tube and insulation, the decrease in temperature caused by the insulation is calculated to be about 100°C, shown in Figure 4.

Figure 4. Effect of insulation on tube wall temperature.

2. All welds were insulated. After experimenting with different materials, all welds were insulated with 1-mm. thick, 100-mm. wide "FiberFrax" wrapped around the welds after dipping in "Rigidizer W," and secured during drying by means of "Kanthal" wire. Details are given in Table 1.

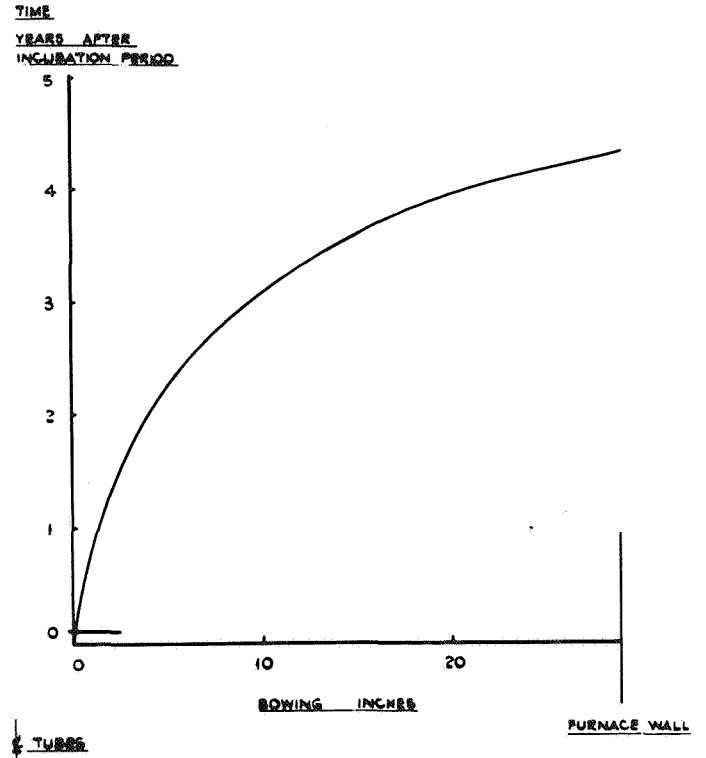
ture of the typical bowing rate of a tube, which is shown in the graph in Figure 6. We found that the tubes remained straight during an incubation period varying in length but that once a tube started bowing it followed approximately this typical curve.

This graph shows that the amount of bowing is quite acceptable during the early years of operation. For example, two years after a tube has started bowing it has, typically, a deflection of about 4 in., or less than one diameter. However, during the next three years it can be expected to reach the furnace wall, a deflection of 30 in.

Some theoretical calculations into the bowing problem led us to believe there are two causes:

1. There is a temperature difference between the two sides of the tubes in a furnace of this configuration. Once bowing has set in, this temperature difference increases and so does the bowing rate.

2. The tubes are bottom-supported only and the thermal effects are added to by creep caused by the weight of the tube itself plus catalyst.

Figure 6. Increase in bowing over four years of operation.

1. Improve the burners. The present burners are a flat-flame radiant-wall design, but adjustment is difficult and there is often flame impingement on some of the tubes. These burner problems clearly aggravate the inherent circumferential temperature difference.

2. Top-support the tubes by counterweights or spring hangers. We are now carrying out trials with counterweights to top-support a number of tubes and check the theory. If these trials are successful, we will consider top-supporting all the reformer tubes.

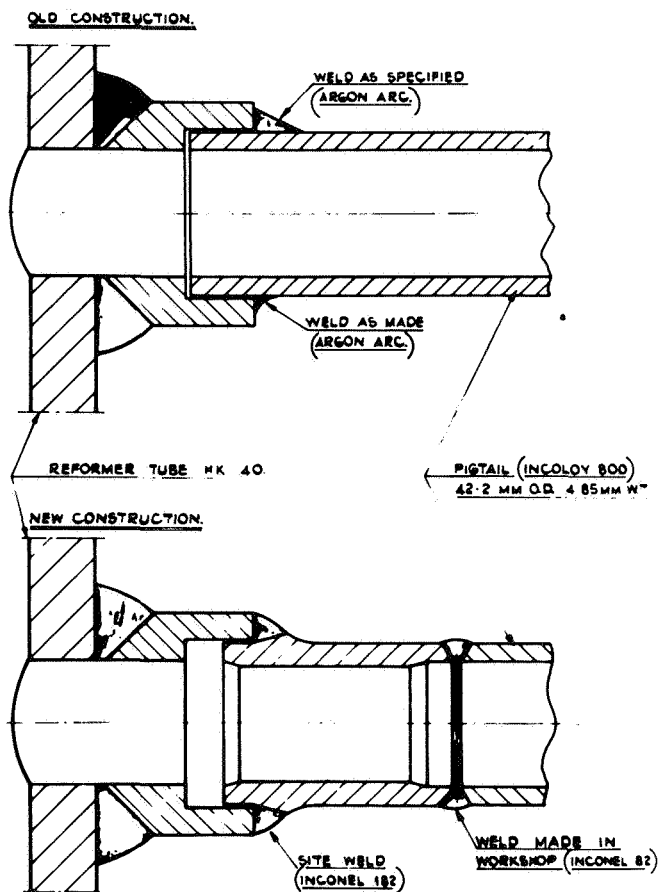
Problems were encountered with cracking of the pigtail-socket weld at the bottom outlet of the tubes. In May, 1973, a cracked weld caused a fire at the bottom of the reformer, damaging four tubes. An examination by dye-checking resulted in rewelding 8 of the 196 tube pigtail connections. Three months later, another shutdown of the plant was necessary as a result of a cracked weld. This time, 89 weld failures were found. After repair of the cracks, the decision was made to change the construction. The modifications were made in a shutdown of three weeks in April, 1974. Details of the old and new construction are given in Figure 7. Design pigtail temperature is 830°C.

A study of the possible causes of the cracks led to a conclusion that bowing of the catalyst tubes and bad welding caused the failures. In a furnace with staggered tubes bowing cannot be avoided. The staggered pattern gives a shadow-effect on the tube surfaces, resulting in a temperature difference and an unequal elongation. An

Figure 7. Old and new construction in furnace at Geleen.

angle of rotation of approximately 1.7° and a maximum stress of about 1.2 kg./sq. mm. in the pigtail were calculated; this stress is very close to the allowable value.

The bad welding and the incorrect weld profile caused a high stress concentration of the already heavily loaded pigtail. Because of this it was possible to get fractures by low-cycle fatigue after a very small number of cycles. During the period before May, 1973, the reformer had been cycled 27 times.

To solve the problem a transition piece was used between the pigtail and the socket. The connection was made by electric-welding using Inconel 182 electrodes. #
