Corrosion in a Naphtha Reformer

A satisfactory solution reported in this case history of an approach to some unusual failures in an ammonia plant in India, now returned to operation

N. B. Tendolkar, V. Sitaraman, and A. Ponnuswamy,
Madras Fertilizers Ltd.,
Manali, Madras, India

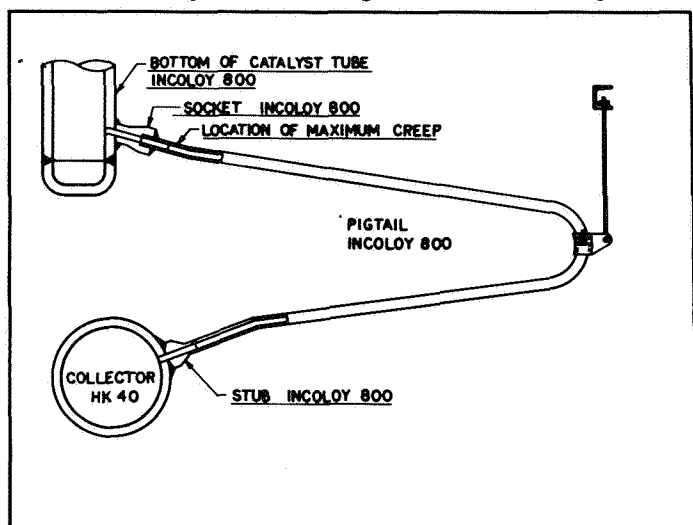
Figure 3. Outlet pigtail.

The Incoloy 800 outlet pigtails are welded to the socket at the bottom of the reformer tube and to the Incoloy stub on the collector at the other side, as seen in Figure 3. Design conditions are 465 lb./sq. in. gauge and 816°C. The pigtails are supported by a "J" clamp at the "U" bend.

Slight sagging of pigtails was noticed within one year of operation, but the amount of sag was not considered abnormal for horizontal pigtails. Sagging became pronounced in early 1974. During a shutdown in July, 1974,

creep and sag measurements were taken on one sample pigtail. This tube had a creep of 7% close to the weld with the catalyst tube. Ultrasonic examination at this region showed higher attenuation than the rest of the tube. The problem of such an abnormally high creep in three years of operation was referred to Haldor Topsoe and Amoco International Oil Co. (AIOC) for their comments.

When the plant was shut down for a turnaround in August, 1974, for catalyst change, all the pigtails were inspected for creep. The summary report of the inspection showed: tubes with creep above 8%, 9; tubes with creep between 6 and 8%, 37; and below 6%, 194.

The high creep could not be accounted for by operating temperatures, which had always been conservative and well below design. Individual hot catalyst tubes could not account for the general widespread increase in creep of the outlet pigtails.

Samples from high-creep locations were metallographically examined. The grain size of the tubes was found to be ASTM 6 to 7 corresponding to mill annealed material (1,800°F). The original specification required the tubes to be "solution annealed" (2,100°F) with a grain size of 6 or larger.

The test certificates mentioned the tubes "as annealed" with a grain size of 6 to 7. This slight, but significant, variation in heat treatment condition had unfortunately been overlooked by the fabricator and the surveyors. Mill annealed Incoloy 800 has only about 25% of the creep rupture life of the "solution annealed" material at design conditions.

The sagging and excessive creep of the outlet pigtails are the result of using mill annealed Incoloy 800 material instead of solution annealed material.

A complete set of Incoloy 800, solution annealed replacement pigtails was ordered immediately, with delivery promised in 12 months. Meanwhile, pigtails with high creep were replaced selectively from the 26 spares available. The spares were solution annealed in India and the grain size checked metallographically before use.

Nine pigtails with over 8% creep were replaced completely. The top legs of 37 pigtails with 6 to 8% creep were replaced. Additional sling supports were provided on the top legs of pigtails with excessive sag.

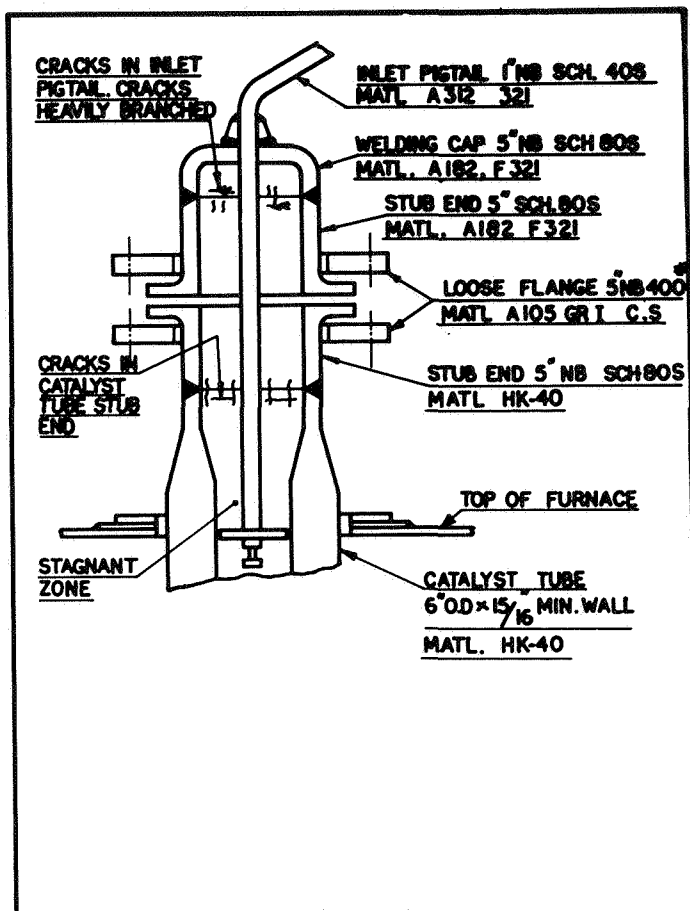
Figure 4. Catalyst tube and inlet pigtail.

The catalyst tubes are made of centrifugally-cast HK-40, 6-in. OD × 15/16-in. thickness. The top of the tube terminates in a 5-in., Sch. 80, HK-40 stub-end with a carbon steel loose flange, seen in Figure 4.

When the catalyst tubes were being air-blown after new charge of catalyst loading in August, 1974, leaks were found in 57 tubes by soap test at the weld between the tube and the stub-end. Dye-check from inside at this location on all the tubes showed cracks in 232 out of 240 tubes. The cracks were both circumferential and transverse in the heat-affected zone (HAZ) of the butt weld. Transverse cracks had propagated up to 1½ in. on either side of the root of the weld.

reached in these independent investigations. The cracks were found to be predominantly transgranular in the weld metal and the HAZ, while they were intergranular in the parent metal. This is typical of chloride-induced stress corrosion cracking. Metallographic structure of the tube was found normal and in agreement with the low operating temperature. Attempts to locate the contaminant by electron microprobe analysis were unsuccessful. Elaborate swab tests by MFL on the stub-end and the inlet pigtail yielded negligible chlorides.

We investigated the possibility of steam condensing at the uninsulated portion of the catalyst tube. During operation, about 18 in. of the bare catalyst tube is exposed to atmosphere outside the furnace ceiling due to expansion. Thermocouples were welded to measure the tube skin temperatures of the pigtail cap and tube stub-end.

The measured temperatures were below the dew point of the process feeds, even during normal operation. Continuous condensation and reevaporation of steam at these portions are strong possibilities. The exposed portion on one tube was insulated, and the skin temperature measured indicated an increase of 270°F.

Subsequent to finding cracks in the catalyst tube stub-ends, all 240 inlet pigtails were dye-checked. Cracks were found in 181 out of 240 pigtails at the weld between the weld-cap and the stub-end. All the inlet pigtail materials are type 321 stainless steel. The cracks were again both circumferential and transverse in the HAZ of the weld. The cracks were heavily branched, the first strong visual evidence of stress corrosion cracking.

Repair work of the cracked reformer tubes was probably unprecedented in its magnitude. All 240 tubes were physically removed from the furnace to the maintenance workshop. The tubes were air-tested at 100 lb./sq. in. gauge in a demineralized water tub. No cracks except those at the stub-end weld were found. All tube butt welds were dye-checked and found satisfactory. Many welds and specifically known hot areas on the tubes were sample radiographed. No cracks were detected. The stub-ends were cut off and the tube ends machined down to remove all cracks and dye-checked.

A world-wide search for replacement stub-ends was made. Only Incoloy 600 material was readily available for fabrication of stub-ends at five weeks delivery. HK-40 stub-ends were quoted at 10 to 12 weeks delivery. In view of the high resistance to chloride stress corrosion cracking of Incoloy 600 stub-ends and its favorable delivery, purchase was immediately approved in favor of Incoloy-600 from the U.S.A.

Madras Fertilizers, therefore, decided to insulate all the exposed portion of the catalyst tube system except the carbon steel loose flanges, at the next available opportunity. Though the inlet system has axial entry, the extension

Of the various proposals examined for relieving the stagnant condition in this zone, the most promising one appears to be the drilling of a few small holes in the inlet pigtail near the flange which would provide enough flow to maintain the inside wall above the condensation temperature.

Repairs to the cracked inlet pigtails consisted of machining off the cracked area and re-welding. The welds were sample radiographed, dye-checked, and hydrotested.

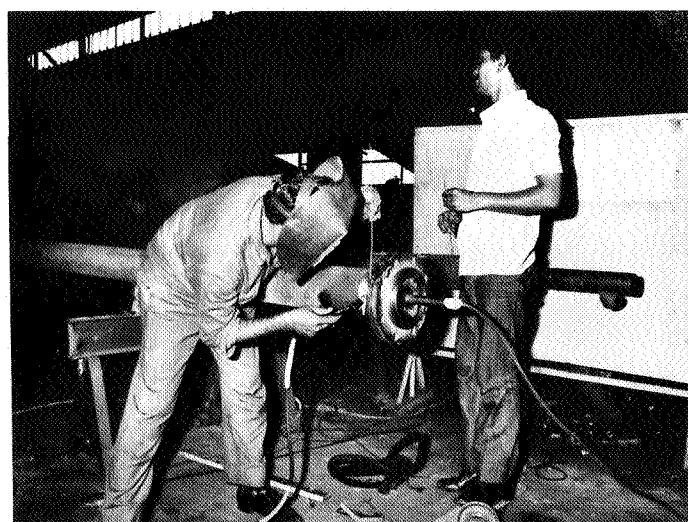
Figure 5. Welding Inconel-600 stub ends to the HK-40 catalyst tubes. Root run is being welded by the “tig” process with argon purge.

The new stub-ends were welded to the catalyst tube using TIG root run with Inconel 82 filler wire and MMA filler runs with Inconel 182 electrodes. All the root welds were dye-checked and the finished welds were 100% radiographed and dye-checked. No post-weld heat treatment was used. Completed tubes were hydrotested to 1,100 lb./sq. in. gauge using demineralized water. Welding is shown in Figure 5.

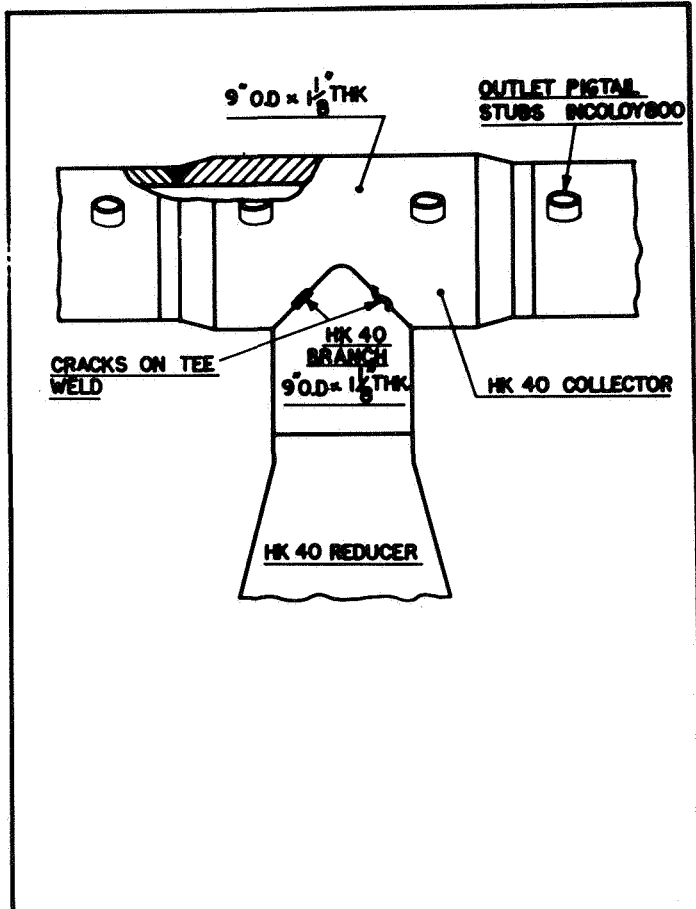
Figure 6. Outlet collector cracks.

refractory lined transfer manifold through a HK-40 reducer, seen in Figure 6. Dye-check of the collector tee welds showed two cracks in collector No. 1.

The weld cracks on HK-40 outlet collector Tee-weld and HK-40 reducer to carbon steel header weld are isolated instances. We believe that these are due to propagation of weld defects left during initial fabrication. #

Field repair welding of used HK-40 material is considered to have a chance of success. The collector tee was therefore solution annealed at 2,100°F for 5 hr. Solution annealing was successful only in the third attempt; the first two attempts had to be abandoned when the heating elements failed on reaching 2,100°F.

After solution annealing, the cracks were ground to a depth of $\frac{3}{4}$ in. As the cracks tended to propagate with the heat from large grinding wheels, material had to be removed with small cutters. The cracks were not chased to the root, for fear of further propagation during material removal and welding. The grooves were welded with Inconel 182 electrodes. A few surface cracks which developed during welding could be ground out and welded. No post-weld heat-treatment was employed.

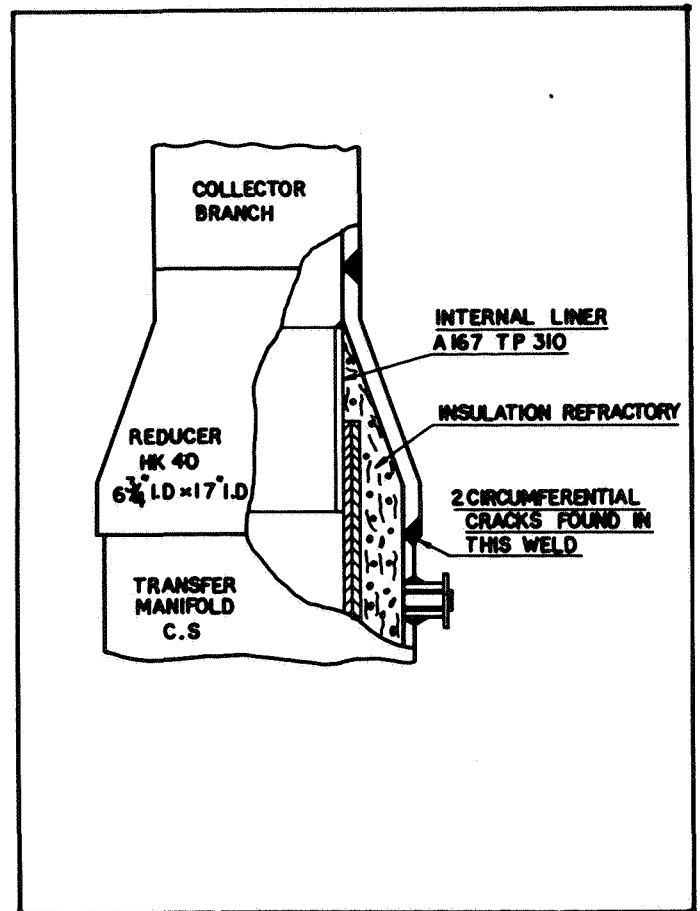
Figure 7. Reducer weld cracks.

The large end of the HK-40 reducer is welded to the carbon steel transfer header which is internally lined with refractory, as shown in Figure 7. Making and inspecting this weld presented quite a few problems during project construction. The completed welds had to be ultrasonically examined as internal refractory made radiography impossible.

Because of the initial problems, the welds are ultrasonically examined on every shut down. During the air test of the reformer in August, 1974, one weld was found to have a leak about 2 in. long. Subsequent ultrasonic examination showed another crack, about 180° from the

first, which had propagated ½ in. from the root.

The cracks were ground out up to the root and welded by MMA with Inconel 182 electrodes. This welding presented no problem, as the HK-40 material had not been subjected to the high operating temperatures. The completed repair weld was ultrasonically examined.
