Hydrodesulfurization Incidents Teach Lessons

Two types of failures in ammonia plant hydrodesulfurization vessels provide guidance to help preventing recurrence

W. D. Clark,
Imperial Chemical Industries, Ltd.,
Billingham, England

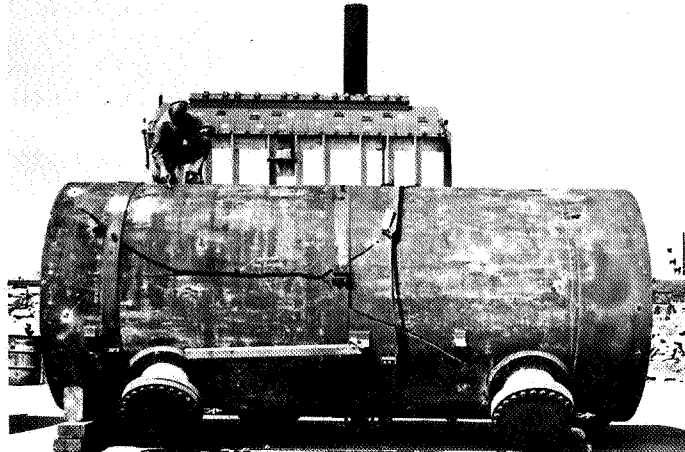
Failure on hydrostatic test after modification. In 1970, carbon deposits had choked the top of the top catalyst bed and it was decided to burn these off. Unfortunately control was inadequate and part of the top strake was grossly overheated. As a smaller catalyst volume was acceptable, the vessel was modified on site by cutting out a 5 ft. band and rewelding and applying local stress relief. The vessel was then pressure tested with water at 13°C, and split at 540 lb./sq. in. The crack was about 10 ft. long,

Figure 1. The result from the first incident (part of the vessel only), showing failure on a hydrostatic test.

basically vertical and had been initiated about 14 ft. below the repair weld. It is shown in Figure 1.

It had been initiated at an internal 1½-in. square section catalyst grid support ring. This had been installed in two pieces with two butt welds, and fillet welds above and below it. The butt welds were of the lowest quality and had cracked and caused a crack to grow through the fillet welds into the shell. Part of the crack was "old." This defect had initiated the failure. Similar defects were found at each of the two butt welds in each of two support rings in each vessel, as seen in Figure 2. The defects in the other vessel were locally repaired.

A variety of tests including some fracture mechanics work was done on the steel. The fractured plate had about 30 ft. lb. Charpy V at 13°C, other plates in the vessel were tougher—70 ft. lb. There was no clear evidence that ageing in service had reduced the toughness of the material: re-heat treatment gave very variable results.

We now insist that any butt welds in support rings have butt welds made to a high standard.

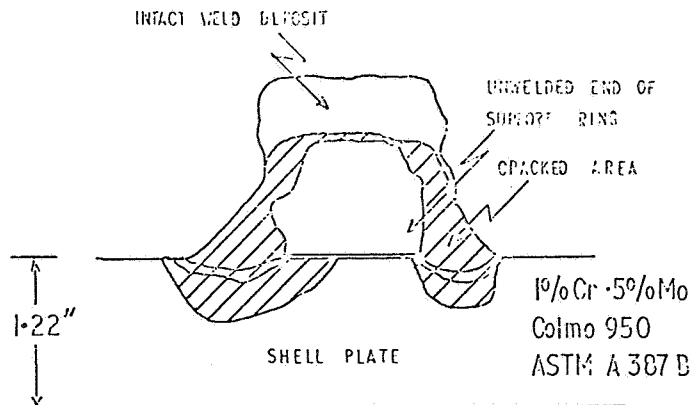
Figure 2. Profile of crack at support ring joint, 180° to failure.

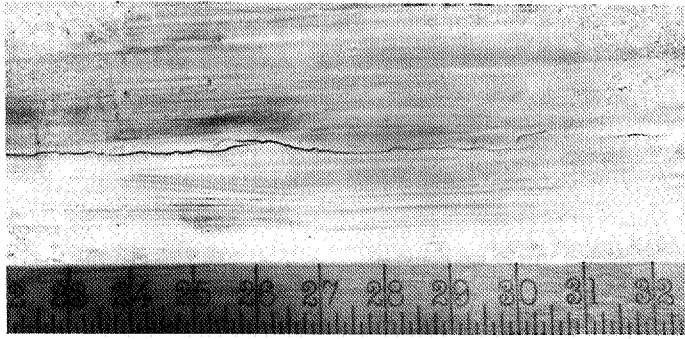
Stress corrosion. In 1974, the other vessel of the pair was observed to be leaking through its shell. A crack 28-in. long, seen in Figure 3, was found on the inside, which penetrated the wall for 5 in. It was in one of the double-V main seam welds made by the submerged arc process. No other crack was found except at a small fillet weld to a hand grip. A patch 36 x 12 in. was cut out and replaced *in situ*, stress-relieved, hydrotested, and the vessel is back in service.

Microexamination of the crack showed it to have a transgranular branching nature, and it is ascribed to stress corrosion by hydrogen sulfide, etc., derived from the

Figure 3. The second incident; a vertical crack inside the vessel.

scale when the vessel was wet. The hardness of weld and the heat-affected zone (HAZ) was in places up to 260 Hv, which implies susceptibility of H₂S cracking. The crack showed obvious tidemarks and had propagated in three stages, and the initial part was sulfided. It seems improb-

able from the nature of the crack that any part of it was caused during fabrication.

We now treat all vessels which have a sulfide scale and are of alloy steel as under suspicion, especially if the weld hardness may be above 240 Hv. Crack detection of all welds will be done as soon as possible, and start-up procedures avoid the pressure reaching more than 30% of the design pressure before the vessel is warm. #
