Fatal Accident in CO₂ Removal System

Remedial action after unusual incident in hot potassium carbonate service includes change to stainless from carbon steel for large elbow that had ruptured

T. R. Visvanathan,
Madras Fertilizers Ltd.,
Manali, Madras, India

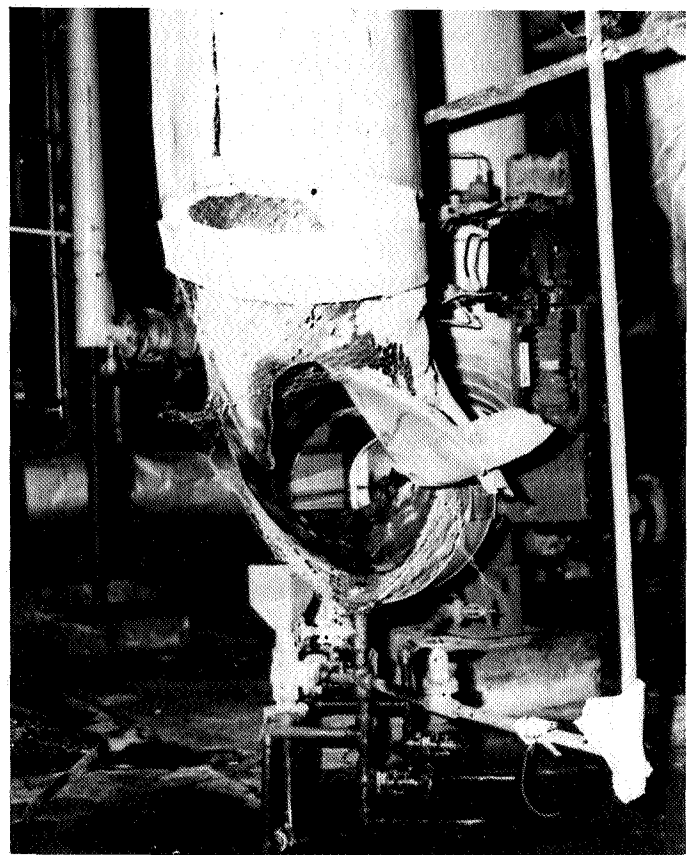
Figure 2. The failed elbow with the rupture.

A departmental inquiry committee, appointed by the management to go into the causes of the accident and suggest improvements in the piping system and control room, submitted its report on July 11, 1974. The accident was considered most unusual because the elbow had eroded over a large area, rather uniformly to about 2-3 mm. thickness, from the original 10 mm., during a period of about three years of operation, and it failed suddenly with a rupture of about 15 × 13 in. opening. Since the rupture faced the control room direction, the consequences were tragic.

Quality of materials used. It is believed from the nature of pattern of wear on the elbow material that erosion by the high velocity solution from the control valve orifice impinging on the elbow, with some possible cavitation by bubble collapse, is the major factor for the failure. The upstream carbon steel elbow and the main carbon steel pipeline have shown no corrosion/erosion during the same service period.

Metallurgical examination as well as the physical and chemical analysis of the failed and unaffected portion of the elbow have confirmed that the material used has not been defective and is within specification. Though it was known that high turbulence, and velocities considerably greater than 10 ft./sec., could result in erosive failure of carbon steel piping material, nobody foresaw that the control valve and its location near the carbon steel elbow would pose such a hazard to the safe operation of the plant.

The carbon steel elbow was substituted temporarily by a new one, lined with stainless steel weld overlay, and provided with some sentry holes to monitor possible erosion (so that the plant could be restarted early). This is to be replaced by a stainless steel elbow later after receipt of the imported piece.

As a long-term measure, stainless steel elbows have been ordered to replace all carbon steel elbows downstream of the control valves in the semi-lean, lean, and reflux lines.

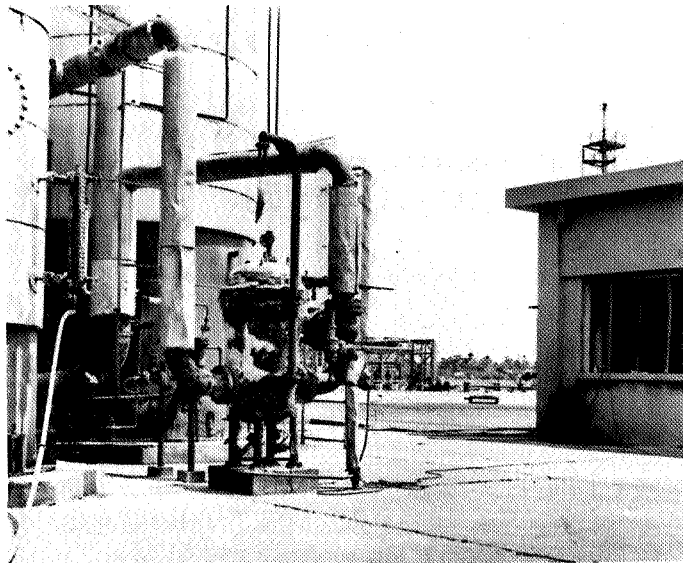
On the day of the accident, the ammonia plant was running smoothly at about 70% load. Around 7:30 pm, the 16-in. carbon steel pipeline carrying the semi-lean solution from the pump to the absorber ruptured suddenly, splashing the hot solution into the control room located directly opposite, after shattering the toughened glass panels. The nature of opening and the relative position and location of the failed elbow near the control room can be seen in Figures 2 and 3. The photograph taken from inside the damaged elbow on Figure 4 shows clearly the rupture facing the control room windows.

Figure 3. The relative position of the ammonia control room and the failed elbow (see arrow).

The glass panels in the control room were reduced considerably in size without sacrificing visibility and operating convenience.

For psychological reasons, strong steel shields were installed protecting the bends in the lean and semi-lean lines from the control room direction.

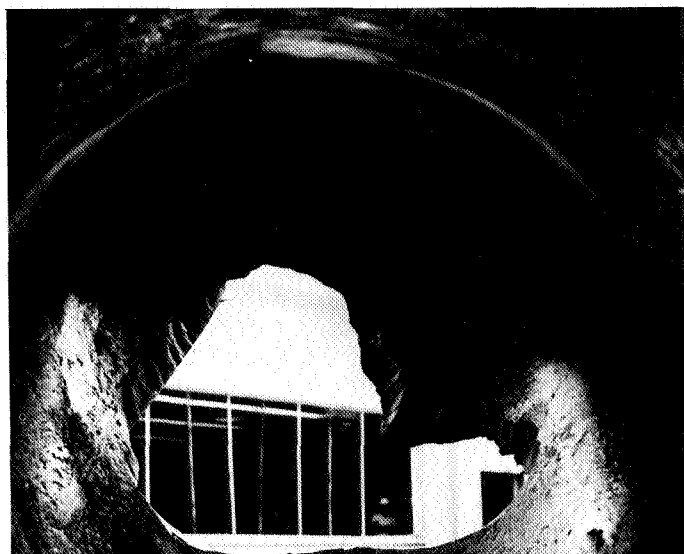
Figure 4. View of the control room windows from the inside of the ruptured elbow.

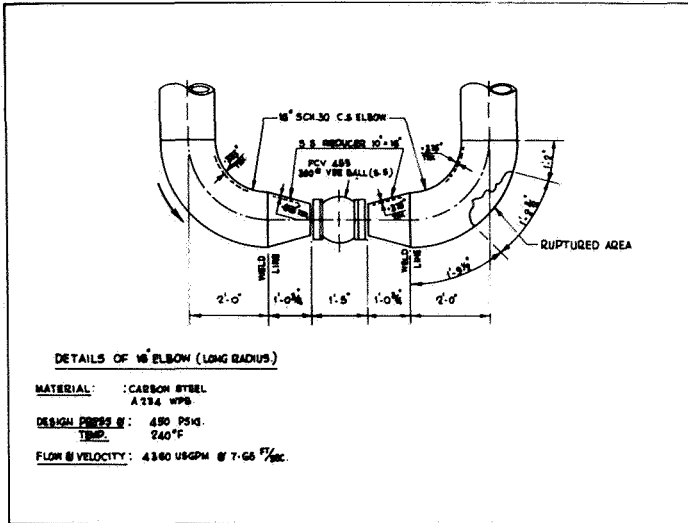
Piping design. The material selection of the piping and fittings was based on previous operating experience and knowledge available from similar plants using the carbon dioxide removal system. In many critical places stainless steel piping and fittings were used. Details of the elbow, control valve, and reducers in the affected semi-lean line are shown in Figure 5. The 16-in. pipeline is carbon steel seamless A 53 Gr. B. The elbows are ASTM A 234 Grade WPB, while the control valve with 10-in. opening and two 16 × 10-in. reducers are S. S. 304L.

While the upstream elbow was supported from the ground, the downstream elbow was not. It is difficult to say whether this arrangement contributed in any way to the erosion.

Average velocity of solution in the different lines in the carbon dioxide removal system is in the range of 5.3 to 8.4 ft./sec., which is well within the 10 ft./sec. considered safe by the designer for carbon steel lines as it ensures satisfactory protective film. For the higher velocities occurring in control valves, orifices and reducers, stain-

Figure 5. Details of the carbon steel elbow in the 16-in. semi-lean solution pipeline.

less steel is the recommended material.
