Repairing Titanium-Lined Urea Reactors

Experience in several British plants of ICI with corrosion in titanium-lined vessels led to the development of a number of useful repair methods.

W. D. Clark and O. J. Dunmore,
Imperial Chemical Industries Ltd.,
Billingham, England

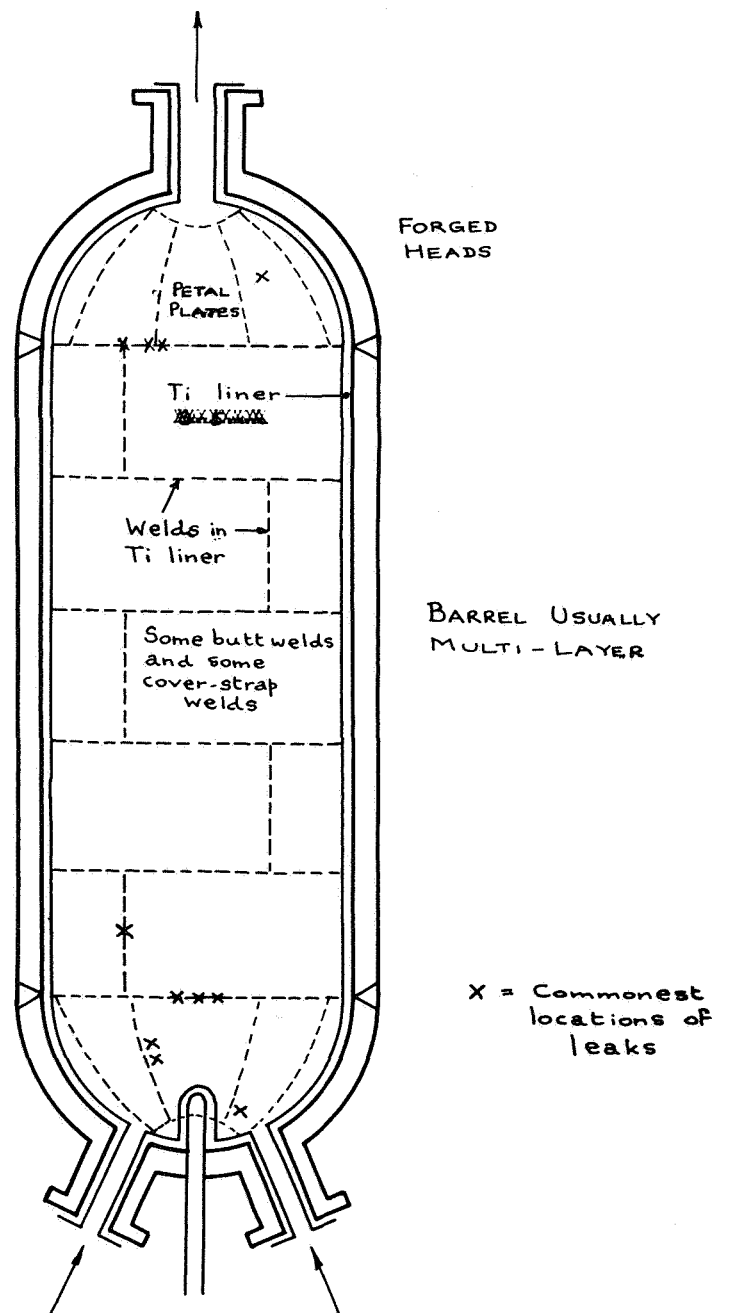
Figure 1. The general arrangement of a lined urea reactor.

Figure 1 shows the general arrangement of a lined urea reactor. The liner corrodes slowly but uniformly, the rate of loss being about 0.1 to 0.2 mm./yr. at the bottom, and 0.1 mm./yr. at the top. Inasmuch as the thickness is only about 5 mm., this loss rate will ultimately require replacing the entire lining; but that should not be necessary for more than 20 years, based on calculation. The first titanium-lined reactor is still in good condition after 11 years of service, and shows no immediate necessity to replace the liner within the next 10 years.

More severe corrosion, perhaps mainly erosion, is found at the inner end of the CO₂-inlet nozzle (which also carries the injected air) and in the exit nozzle. We have fitted an internal standpipe to the CO₂ inlet and sleeved the exit nozzle so that the erosion affects only an item which can readily be replaced.

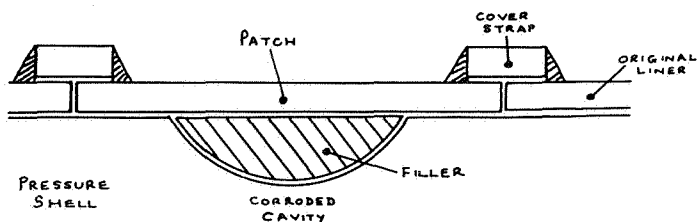
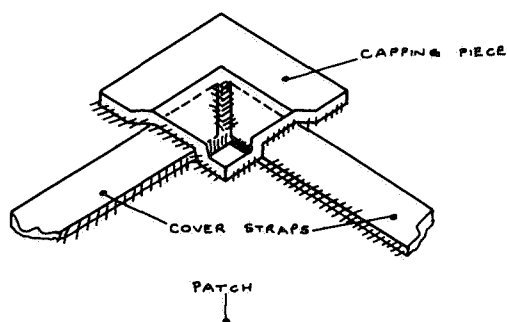
Figure 2. Two views of repair techniques.

In general, the damage to the liner is small—a crack an inch or two long in a fillet or a butt weld. If the leak has been allowed to persist for many days, there will also be attack on the steel of the shell, usually as a groove or cavity close to the leak, diminishing to negligible attack further away. It is not usual to find trouble near the exit weep hole. The extent of attack on the steel can be assessed by ultrasonic thickness measurements from the outside, except on the barrel of multilayer vessels.

One converter had lost about 2 in. of thickness of steel in the middle of a 20-in. diameter cavity. There is no doubt that a urea converter which is operated while leaking could cause a major accident.

The technique used, therefore, is to cut a window in the liner to expose the cavity, clean and wash out, and fill it up level with the steel. A titanium plate is then tailored to fit the window and lie flush with the adjacent liner. Cover straps of about the same thickness are then pressed down over the joints by suitable struts across the converter, and fillet-welded into position. The heat of the welding is not sufficient to affect the underlying steel. At the corners of the "window frame" a groove-weld is made between the straps. These corners are additionally reinforced by a separate capping piece, accurately shaped to fit closely over the straps and bed down on the liner, and this is fillet-welded to straps and liner.

Figure 2 indicates the technique. Because there is little air behind the various items it is found unnecessary to go to the considerable complication of argon purging behind the straps, long as the fillet welds are at least two runs thick.

For small cavities in the steel it may be simpler to use a single cover patch of titanium rather than a window frame of strip. If there is no cavity, it may be sufficient to do no more than fillet-weld a patch over the leak area. One point is essential: the fit of inserted patches, cover straps, etc., must be very good, otherwise the repair will not last.
