# Rupture in Ammonia Shift Conversion Unit

Investigation of incident showed direct cause was corrosion, itself a result mainly of poor water distribution and a lack of good pH control

G. B. Casey,  
Irish Nitrogen Ltd.,  
Arklow, Ireland

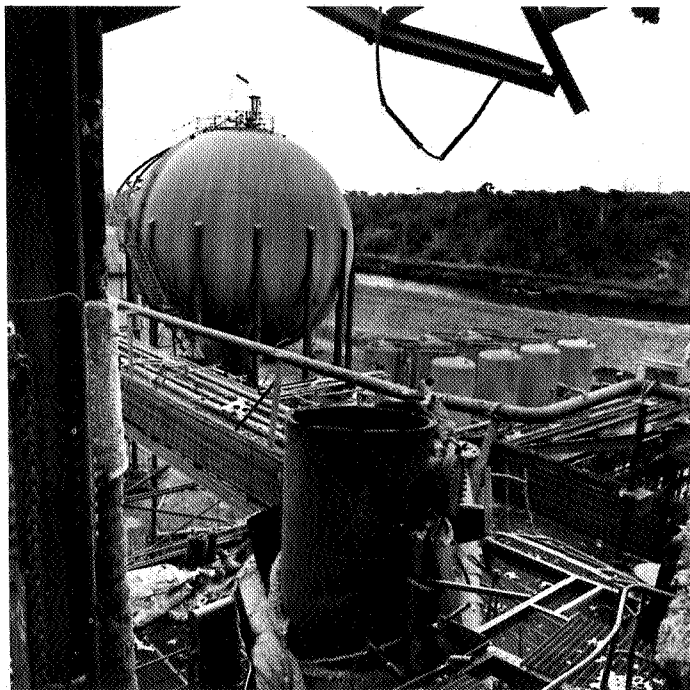
**Figure 2. View of the units and the sphere.**

Debris was scattered over a wide area. The top section of the injection cooler was thrown against one of the ammonia sphere stanchions. Damage was confined to the immediate vicinity of the unit. Figure 2 shows the general area with the damaged unit in the center and the ammonia sphere in the background. Figure 3 shows where the top section of the vessel ended up at the sphere.

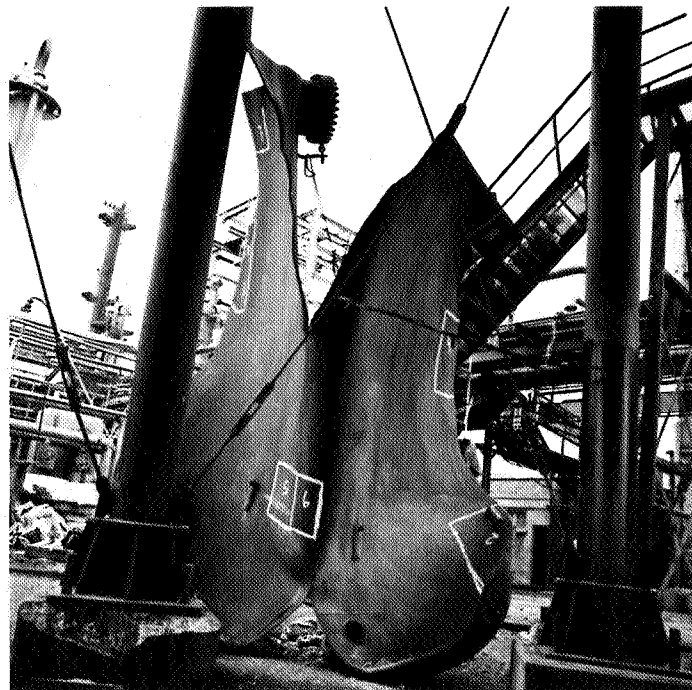
**Figure 3. View of the top section against the sphere.**

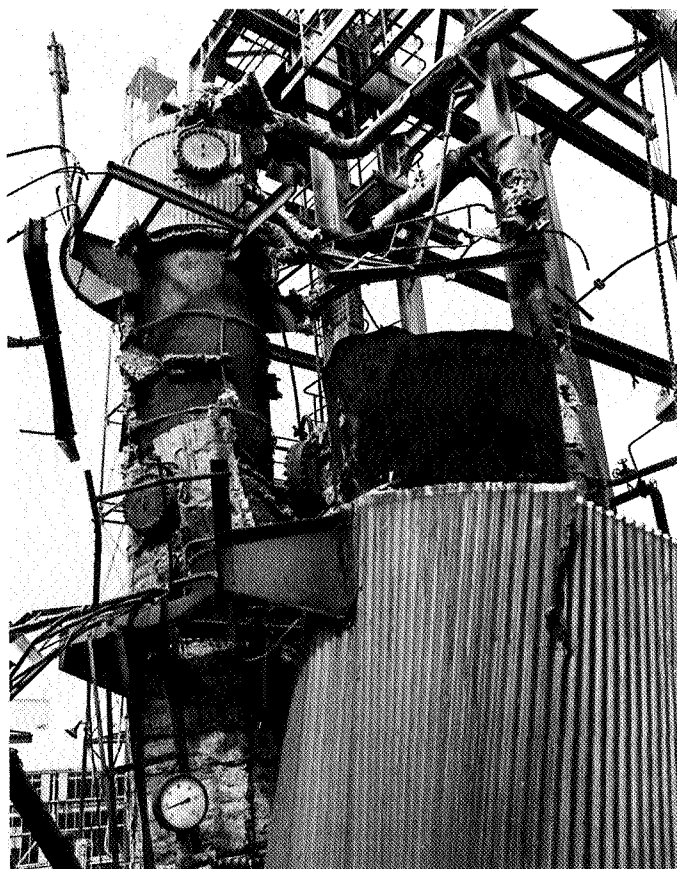
Figure 4 gives an idea of the damage done to the unit and what remained of the injection cooler. The saturator, a similar vessel, is the one beside the injection cooler.

**Figure 4. View of unit 600 after the explosion.**

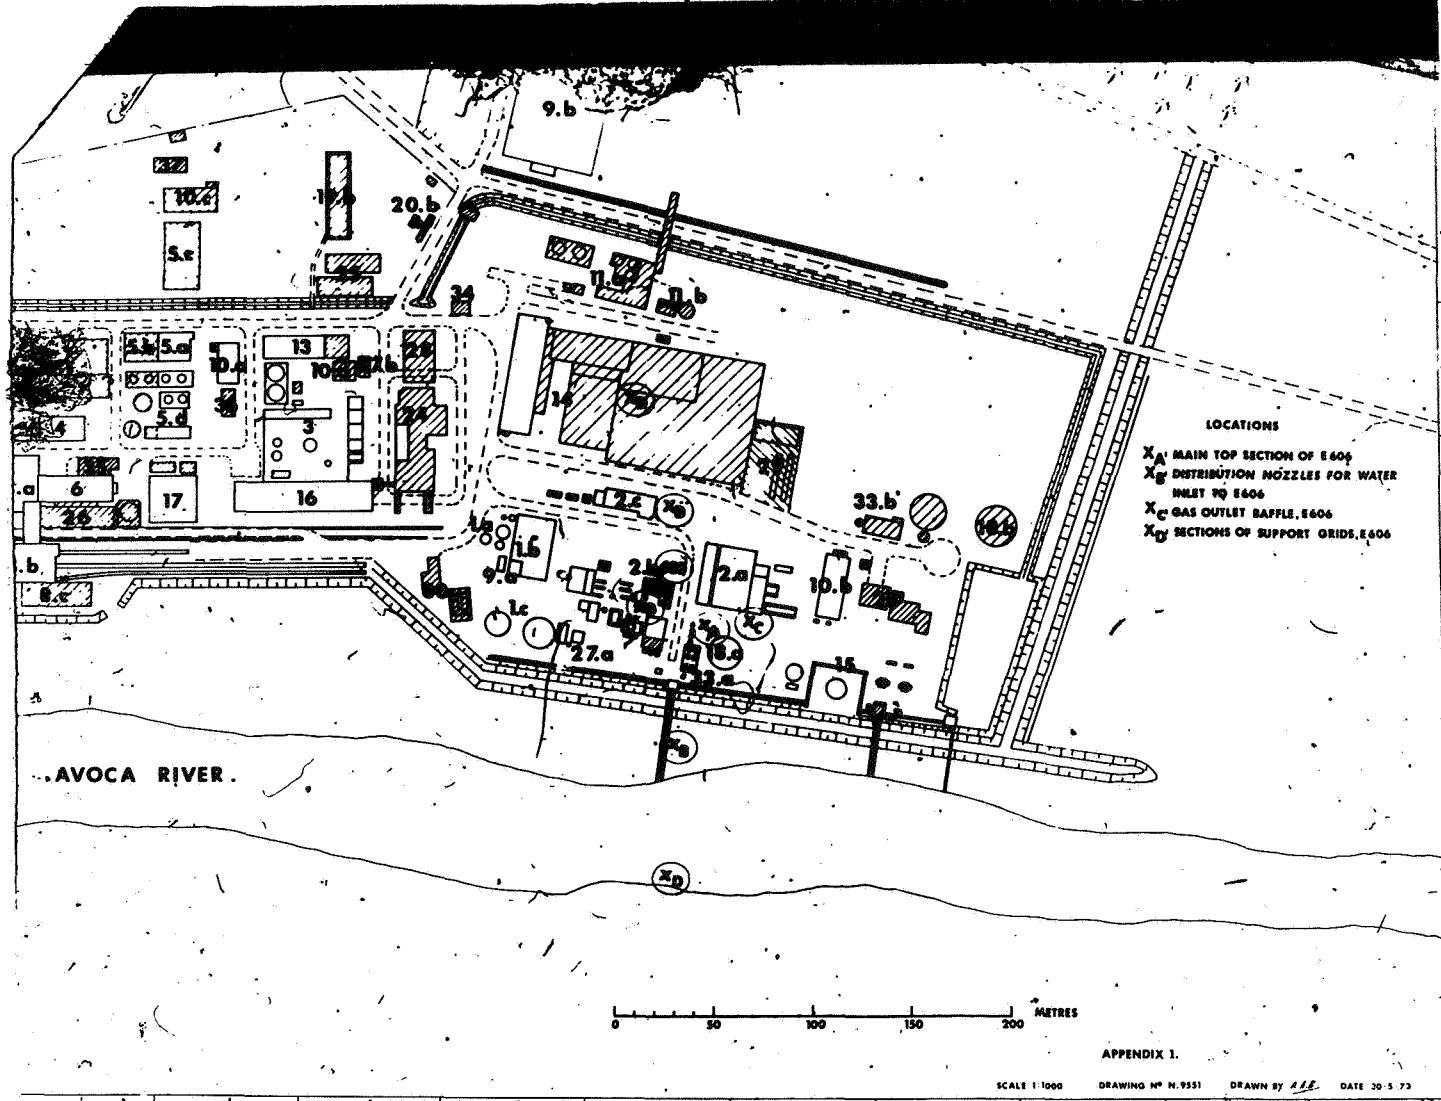
Figure 5 illustrates the distribution of fragments of the vessel after the explosion. XA is the top section of the vessel at the sphere; XB the distribution nozzle at the river bank; XC the gas outlet baffle of the vessel at the No. 2 compressor house; and XD sections of support grids scattered over a wide area of the plant.

**Figure 5. Plot showing distribution of fragments.**

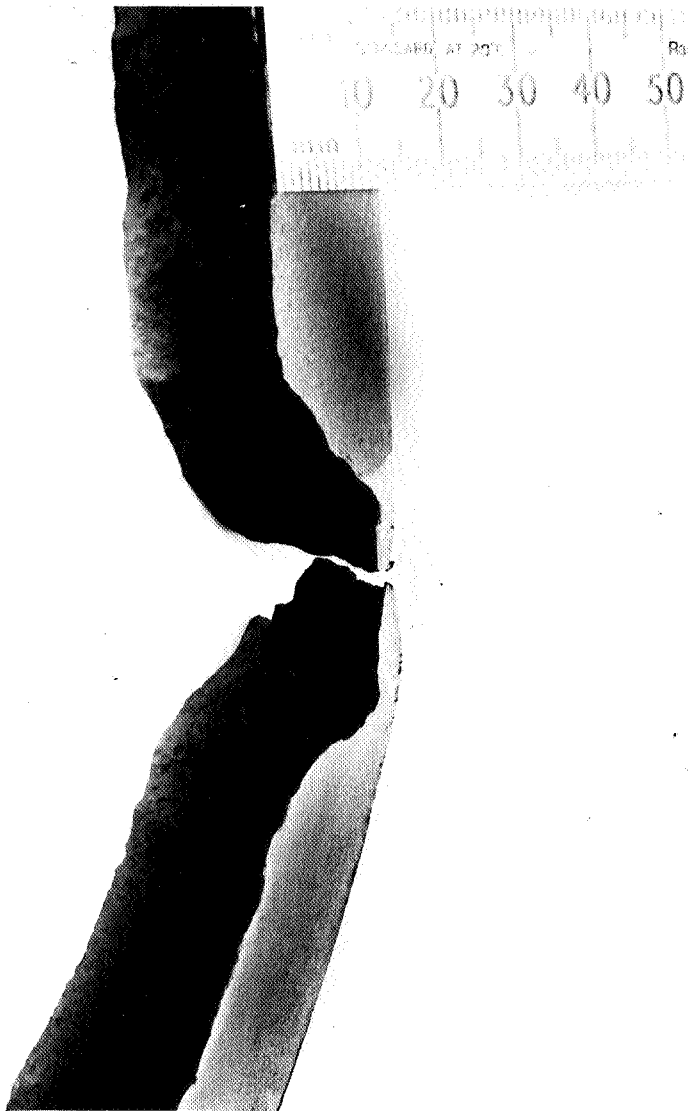
The metallurgist's examination found no evidence of a brittle fracture, the whole fracture area having a ductile appearance. Sections taken show the fracture passed through a weld which seemed to have preferentially cor-

roded. This can be seen in Figure 6, which shows a microsection through part of the fracture area. There was considerable thinning of the vessel wall in a fairly localized area.

The main conclusions were that a clear pattern of corrosive attack occurred on the inside surface of the vessel related to the distribution of water through the vessel. This thinned the walls of the vessel, eventually causing a ductile fracture. Although the fracture was through a vertical weld, it was considered that this was coincidental but that the weld corroded preferentially.

**Figure 6. Microsection through part of the fracture area.**

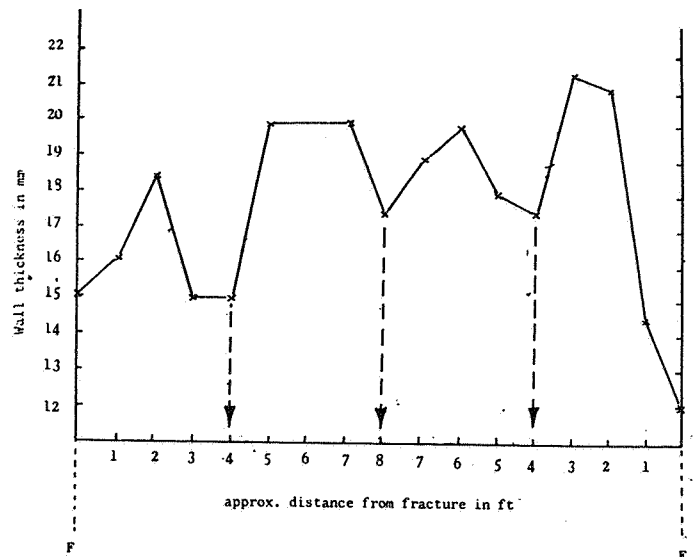
Figure 7 shows that when the circumferential variation of wall thickness in the top of the vessel was plotted, four areas of severe corrosion were found as can be seen. One of the troughs is predominant and here the fracture occurred.

**Figure 7. Variation of wall thickness in E-606.**

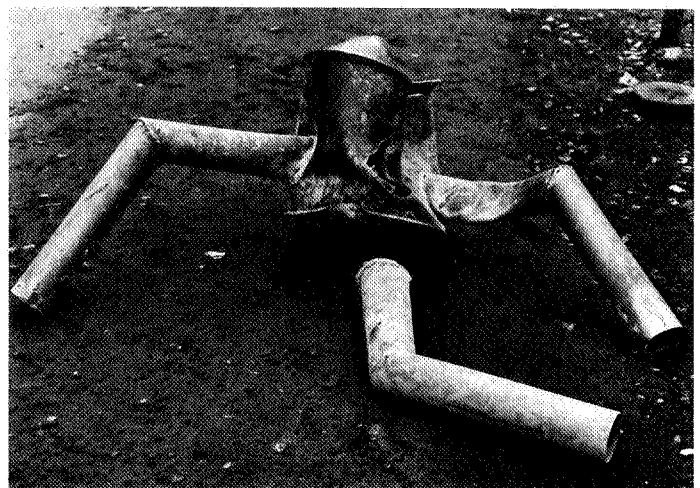
In Figure 8 the old water distributor is shown as recovered after the explosion. It consisted of four vertical legs, which can still be seen. Attempts to correlate the position of the four thinned areas of the vessel with the distributor legs met with some success.

**Figure 8. The old distributor (after the explosion).**

3. A distributor tray (weir trough type) was provided for the new injection cooler to improve the water distribution.

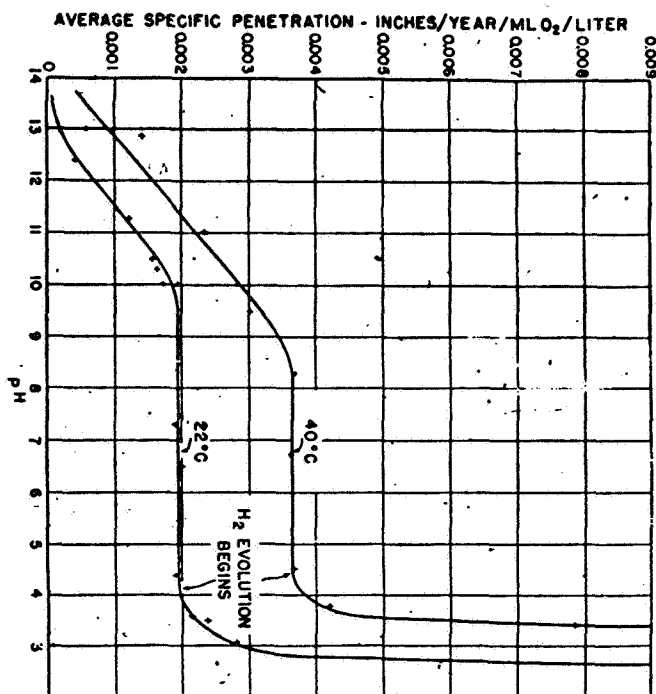
What happens when  $H_2$  evolution occurs can be seen in Figure 10, which shows corrosion rate vs. pH for the HCl system (the carbonic acid system is similar.) The corrosion rate increases very rapidly after hydrogen evolution starts. At increased temperature, the pH for hydrogen evolution also increases. Thus, for conditions in the injection cooler it could be as high as 6.0.

Figure 10. Critical nature of pH on mild steel corrosion.
