Solving Corrosion Problems in Steam Reforming

A case history is a BASF steam reforming methanol/ammonia plant, in which an improvement in the design of the waste heat boilers has eliminated plant breakdowns

M. Appl and K. Feind,
BASF AG, Ludwigshafen/Rhine,
West Germany

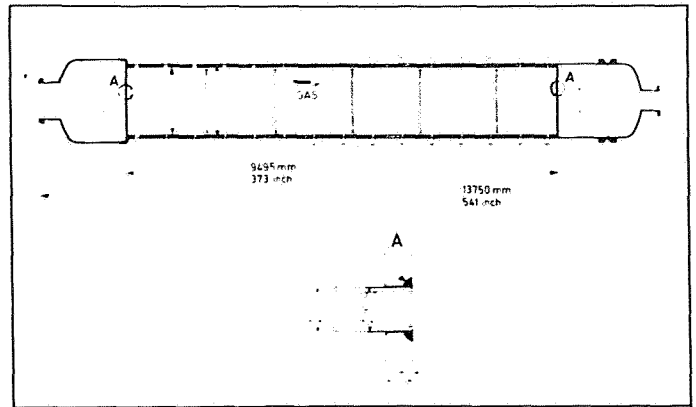
The main dimensions of the old cooler can be seen in Figure 2. The tube sheet on the gas inlet side and the inlet cover are fitted with a layer of insulating and refractory concrete and an Alloy-800 protection plate and with ferrules into the tubes.

Figure 2. Methanol plant waste-heat boiler (first design).

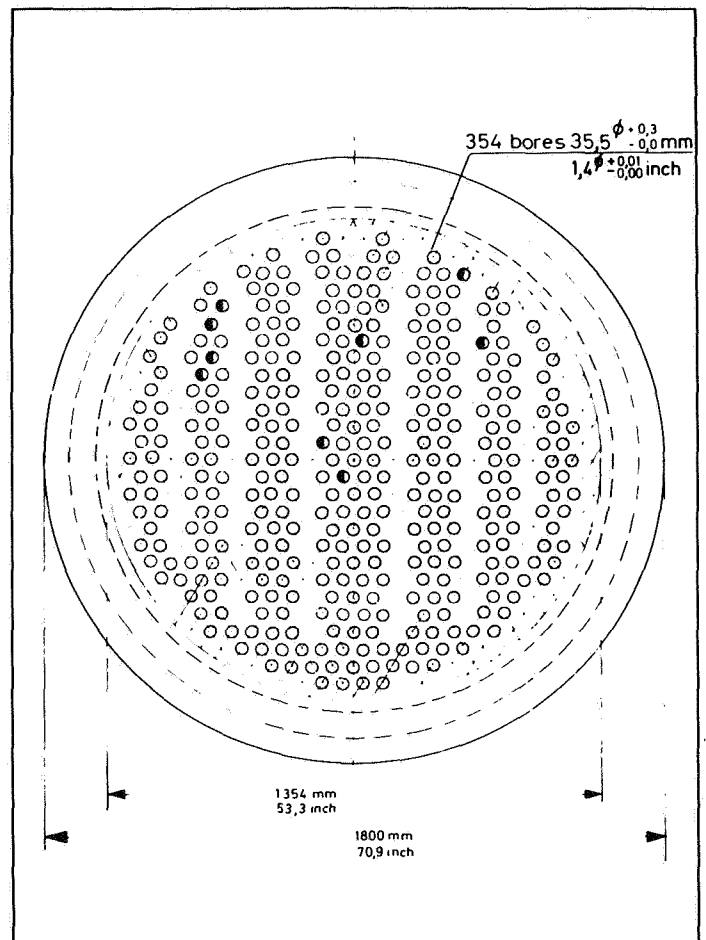
detected on the gas outlet side tube sheet when the cooler was inspected during a shutdown in September, 1970. They are shown in Figure 3. The damaged parts of the welds were reamed out and rewelded. After repair, the cooler was pressure tested with nitrogen at 100 bar. The test revealed another leaking tube, which was then repaired. In the subsequent pressure test, no further defects were detected.

Figure 3. Position of leaky tubes in the first gas outlet tube sheet in the methanol plant waste-heat boiler (first design) in Sept., 1970.

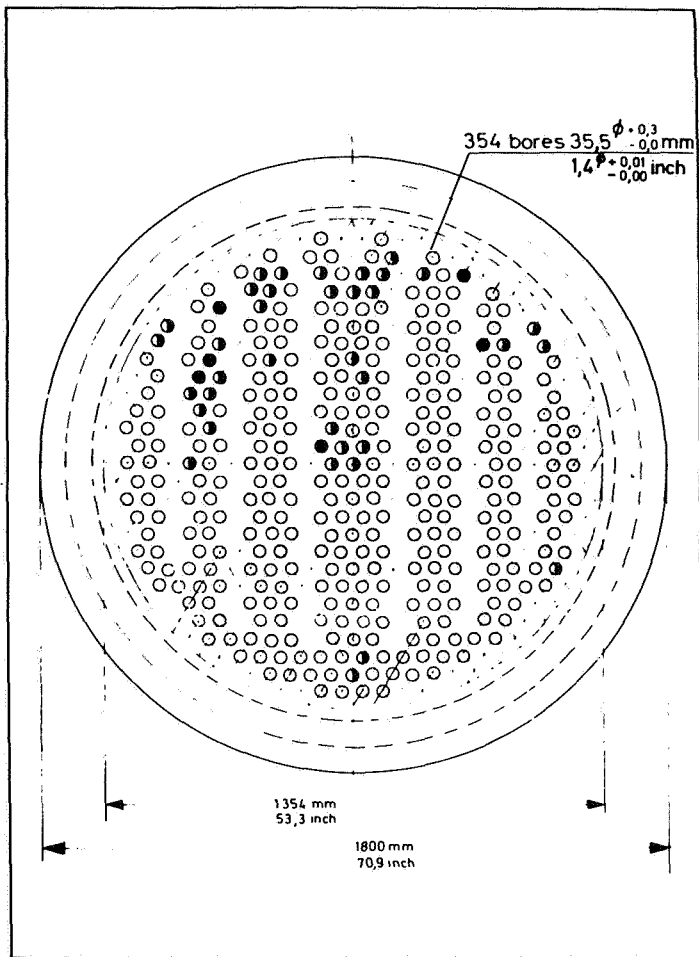
The plant then remained in operation until February 22, 1971, except for one brief shutdown. On February 22, 1971, nineteen defective welds were discovered, as shown in Figure 4. After reaming out and rewelding the 19 tubes, another 13 leaking tubes were detected during a pressure test with nitrogen at 4 bar. Still another 12 were found after repairing and testing at 20 bar.

Figure 4. Position of leaky tubes in the first gas outlet tube sheet in the methanol plant waste-heat boiler (first design) in Feb., 1971.

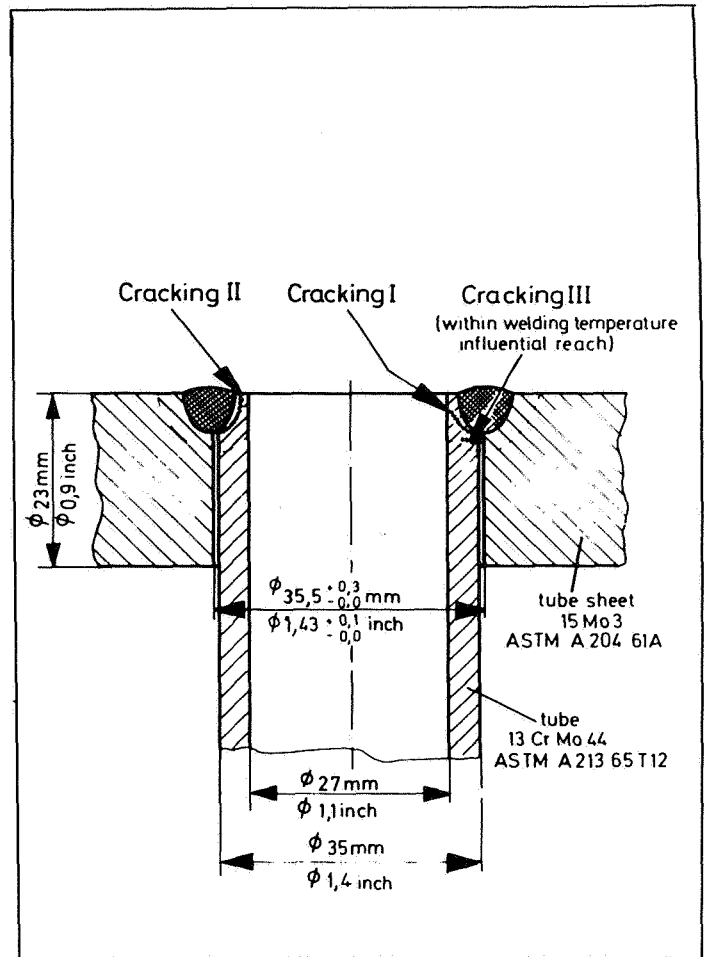
The examination revealed that all the cracks were circumferential. They commenced in the outer wall of the tube on the water side either at the root of the tube-to-plate weld or in the welding temperature influential reach. They were transcrystalline with lateral bifurcations, and some of them were filled with corroded material.

The weld and the cracks are shown in Figure 5. Even the specimen of weld from the tube that had not yet

leaked displayed a crack which had already penetrated through one-third of the tube wall. In the light of all the metallographic investigations, the BASF materials testing department ascribed the cracks to corrosion fatigue, i.e., "stress induced corrosion." The possibility of sudden failure as a result of a purely static overload could be excluded. The location of the leaks detected during the first and second repair jobs, seen in Figure 4, reveals that failure mainly occurred in the upper half of the tube sheet. The analysis of the investigations and the possible causes of failure are discussed below.

Figure 5. Schematic of tube welding on the methanol plant waste-heat boiler (first design).

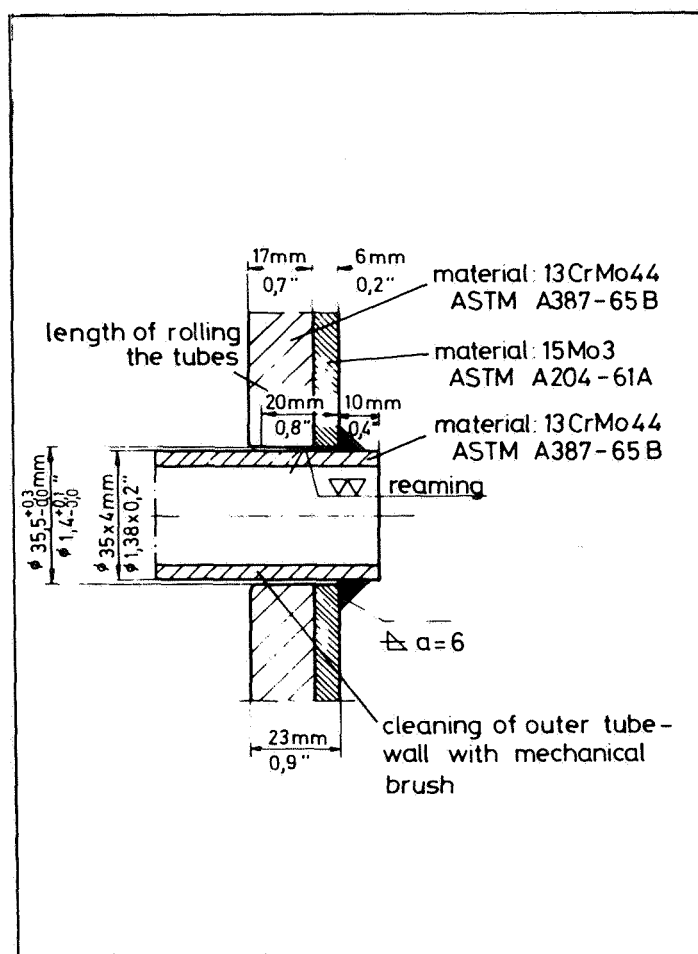
Figure 6. Tube welding in the second tube sheet on gas outlet side of the methanol plant waste-heat boiler (first design).

Thus, when the plant was shut down March-May, 1971, the cooler was cut open on the plant site. The bundle of tubes on the gas outlet side was shortened by 0.59 m., and a new tube sheet was welded in (material:

13CrMo44 for the tubes, but with a 6-mm. thick 15Mo3 weld overlay). Owing to this overlay, a filled weld between the tubes and the tube sheet was then projected, as shown in Figure 6. In other words, the weld differed from that in the original design seen in Figure 2.

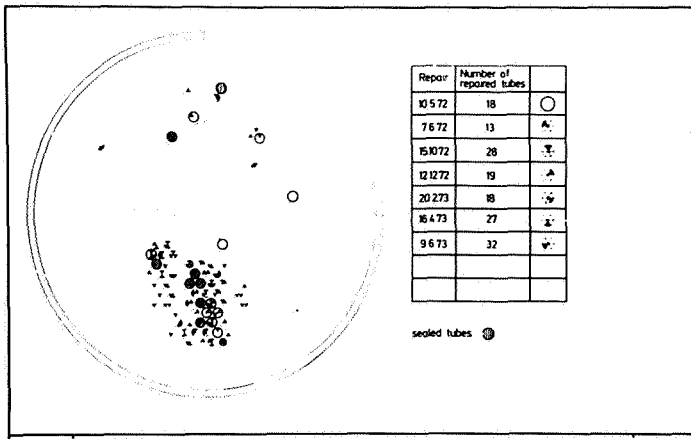
Thereupon, the plant was shut down. On May 9, nine leaking tubes were again found on the tube sheet at the gas outlet end. The nature of the damage indicated that cracks had first appeared in five of the tubes and that the high-pressure steam had damaged the other four. In addition, the escaping steam had eroded an area measuring 110×145 mm. from the wall of the dome cover.

Figure 7. Position of leaky tubes in the second gas outlet tube sheet of the methanol plant waste-heat boiler (first design).

15 mm. length at distances of 8 to 13 mm. from their ends. In some cases, the sides of the cracks were strongly eroded. It was safe to say that the cause of the damage was the same as that in the previous cases. The period of time that had elapsed before the damage commenced was also roughly the same as that that had elapsed before the first repair job.

After the nine tubes had been rewelded, the pressure was increased in stages to 90 bar. By this means, nine other leaking tubes were detected. The position of the points of failure in the tube sheet, the chronological course of the damage, and the number of leaking and not reparable tubes are shown in Figure 7.

Almost all the leaking tubes in the first repair job were in the upper part of the tube sheet. In contrast, the bulk of the damage in the new tube sheet was found in the lower part.

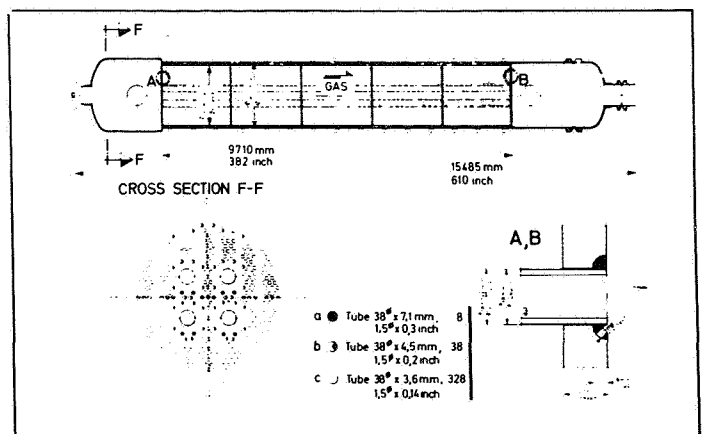
Figure 13. Ammonia plant waste-heat boiler (first design).

tube sheet and the tube-to-plate weld can be derived from Figure 13.

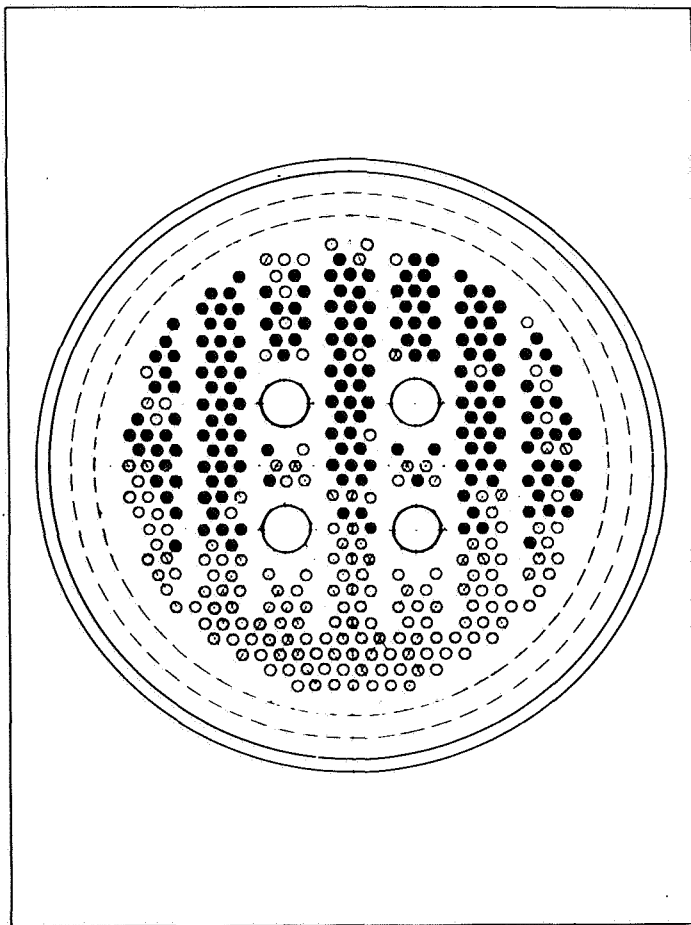
Figure 14. Position of leaky tubes in the gas outlet tube sheet of the ammonia plant waste-heat boiler (first design).

Damage to the tube sheet at the gas outlet end of the cooler first occurred on February 1, 1972, after the plant had been on stream 15 months. A total of 17 tubes had to be carried out at about two-month intervals until February, 1973.

After the seventh repair, the record showed that 189 of the 378 tubes in the cooler had to be rewelded. Of these, 31 tubes had to be rewelded for the third time; 46 for the second time; and 80 for the first time. A total of 32 had to be sealed. The positions on the tube-sheet of the tubes repaired is shown in Figure 14.

The nature of the damage and its analysis corresponded exactly to that previously determined in the cooler of the methanol plant. All damaged tubes were in the upper part of the tube sheet, as was the case in the first repair on the methanol plant gas cooler.
