Waste Heat Boilers: Problems & Solutions

P. Hinchley, Imperial Chemical Industries, Ltd., Billingham, Teesside, England

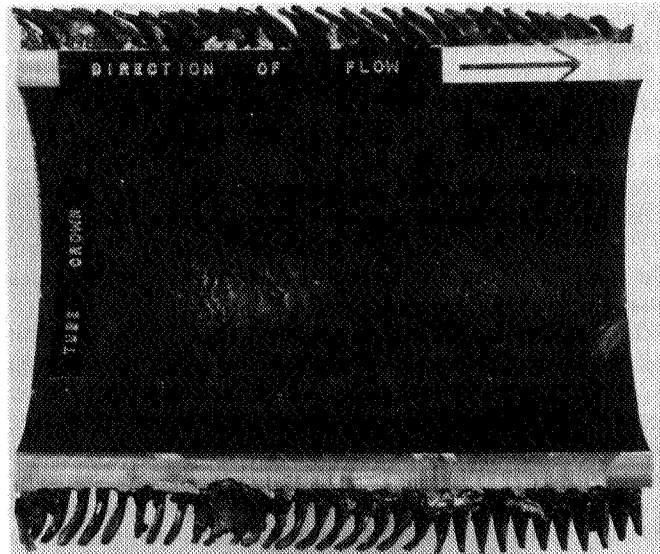
Failures have occurred on several boilers owing to a deep gouging corrosion at the 12 o'clock position, Figure 6. Experimental work has led to the conclusion that the problem has arisen because of the existence of a flow regime in part of tube where "dry-out" has occurred, i.e., where the wall is not continuously wetted. (2) In these "dry-out" zones any harmful chemicals can concentrate many thousand-fold and severe corrosion can occur if, say, there is free caustic in the boiler water. (3, 4)

1. At least three boilers have failed as a result of caustic concentration due to the presence of free caustic and the existence of a dry-out zone in the horizontal 4 in. NB tubing. The solution in one case was to change to congruent phosphate treatment and thus ensure the absence of free caustic. (5)

Figure 6. Tube of a horizontal flue gas boiler that failed as a result of severe corrosion in a region of dry-out.

In another case this was combined with a large increase in water rate and in a third case, where there was some doubt about the ability to avoid free caustic, 9% Cr 1% Mo tubes are to be used to replace the carbon steel tubes, some of which had only lasted three to five months.

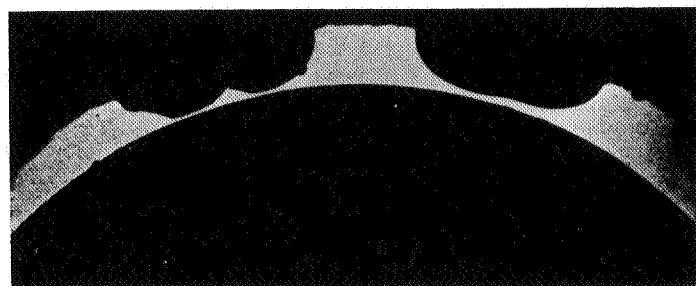
Figure 7. Water side corrosion of a fire tube boiler just beyond the end of the protective ferrule on the tube inlet.

1. At least three boilers have suffered severe corrosion on the water side of the tubes just beyond the end of the protective ferrules at the tube inlets, Figure 7. It has been caused by acidic or free caustic conditions in the boiler water. In two cases the aggressive corrosion had taken place below deposits that were themselves corrosion products originating from upstream equipment that suffered corrosion because of poor deaeration of the feedwater. Naturally, those boilers with the highest heat flux or poorest water distribution, or both, are most prone to failure should the boiler water quality deviate from the optimum.

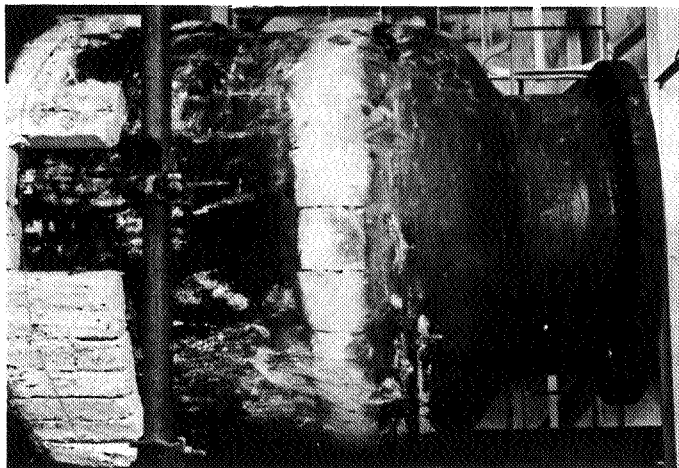
4. The gas channels of several boilers have swollen as a result of gross overheating when external insulation on the shell containing the water has been extended on to the refractory lined channel containing the gas, or when there has been a failure of the internal refractory lining, Figure 8.

▲Figure 8. Swollen inlet channel of a fire tube boiler caused by gross overheating when the external insulation of the shell was mistakenly extended over a channel containing hot gas, and which was lined internally with refractory material.

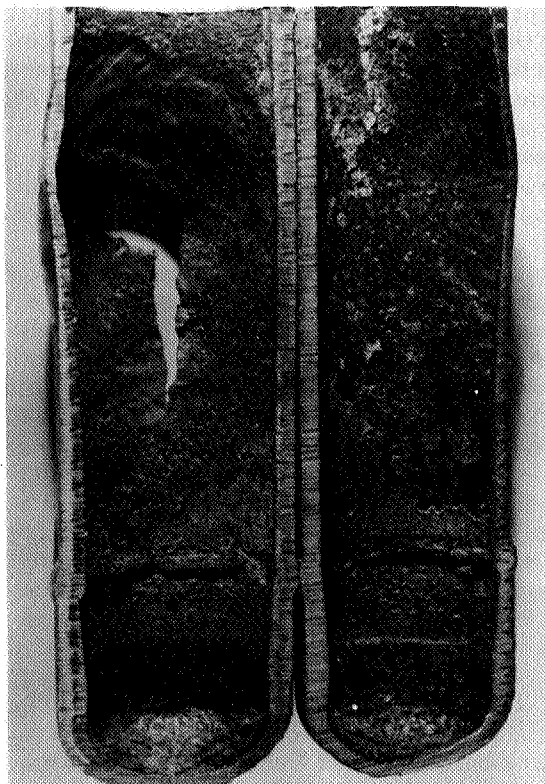
Figure 9. Section through the scabbard tube of a bayonet tube boiler that failed as a result of corrosion and overheating arising from water side problems.

3. Corrosion of tubes caused by the concentration of harmful chemicals in the boiler water, beneath deposits existing in the regions of the tubes subject to the highest heat flux. Frequent contributors to this problem have been contaminated return condensate and the breakthrough of acid or alkali with the feedwater, Figure 9.
