An Ammonia Shift Converter Failure

Brief case history of a metal failure in a high temperature shift converter resulting from hydrogen cracking, and what was done to solve it.

M. Appl, K. Feind, and W. Liebe,
 BASF A.G.,
 Ludwigshafen/Rhine, Germany

An extensive investigation into a failure in a high-temperature shift converter in an ammonia plant in Rotterdam-Pernis late in 1975 has led to several useful lessons and ultimately to process improvements for safer operation.

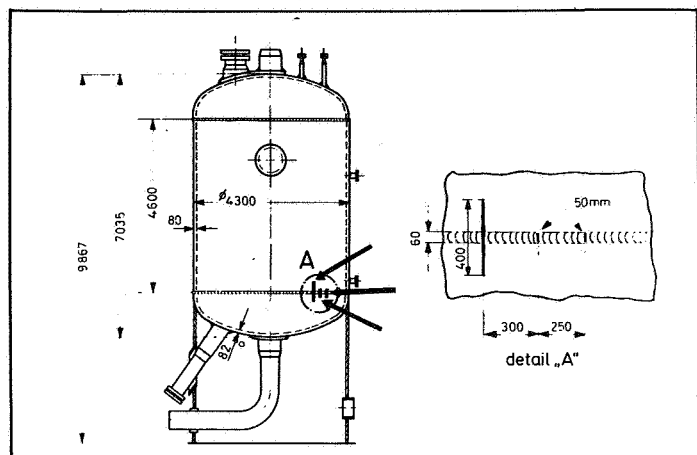
Magnetic and ultrasonic examinations of the converter's interior revealed one large crack and two adjacent small cracks in the wall, which has a thickness of 80 mm. They were located at the lower end of the cylindrical shell, perpendicular to the weld between the shell and the head. The position and dimensions of the cracks are shown in Figure 1. The large crack was 400 mm. long, with a maximum gap of 0.1 mm. All the cracks run from the inside to the outside. The small cracks are 50 mm. long and have not yet penetrated to the outer wall. None of the cracks starts from a welded part on the inner wall. In addition, a

Figure 1. Cracks in the HT shift converter.

number of smaller cracks were noticed where fittings were welded to the wall in the upper part of the converter.

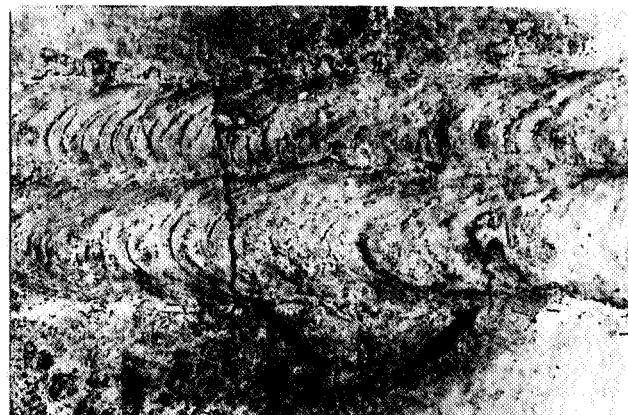
Figure 2 shows the weld between the shell and the head with two cracks on the inside of the converter. Ultrasonic examinations revealed several of these cracks in the weld metal. It was therefore an obvious assumption that the large crack also originated from an initially small crack within the weld.

Figure 2. Cracks in the weld.

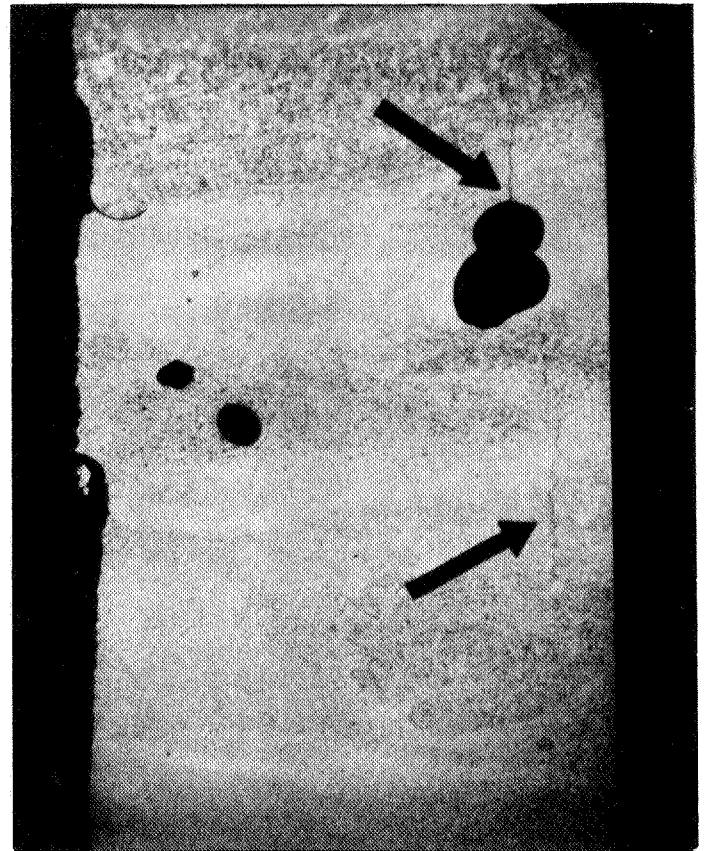
Figure 5. Porous weld.

intercrystalline and that their edges are lined with oxides (magnetite). All the cracks in the weld that connect with the inner wall of the converter display this layer of magnetite, whereas the other fine cracks do not.

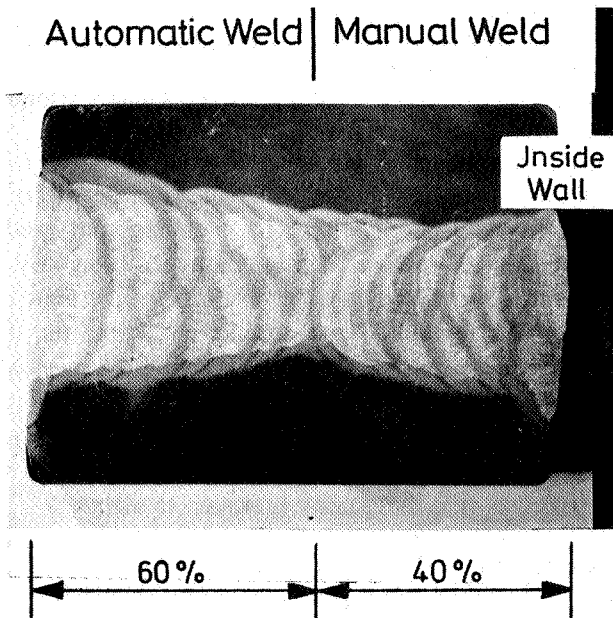
A cross-section at right angles to the weld can be seen in Figure 3. The weld was automatically welded from the outside and built up to about 60% of the wall thickness (submerged arc process, Ulme 3 rod, Arcosite Mo powder).

After the root had been machined, the inside of the converter was welded manually with a Philips coated kV2 electrode. The weld was stress relieved at 620 - 630°C, not in a furnace but by local induction heating. According to the manufacturer's report it must be assumed that the local stress relief operation was carried out correctly.

Hardness was measured on four lines drawn over the cross-section of the weld. Fairly high values, i.e., 240 - 270 Hv., were found for the weld metal, as opposed to 170 Hv for the parent metal. The figures for the strength of the weld metal were also close to the upper limit.

Figure 3. Cross section of the weld.

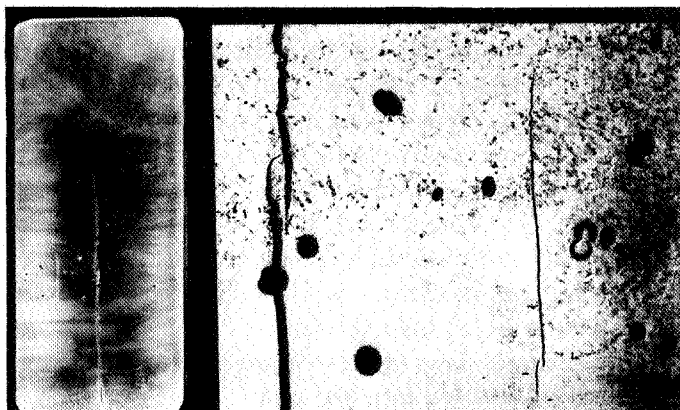
Several microscopic studies of the manual weld in the vicinity of the cracks revealed accumulations of pores and minute gas channels in the weld metal of the root passes. Figure 4 shows a horizontal cross-section through the weld. The pores and a crack issuing from one of them can be clearly recognized. A microsection perpendicular to the surface of another crack also revealed pores in the welding material, as seen in Figure 5. A crack running parallel to the edge of the fracture commences at a large pore. In Figure 6, the details are reproduced of a crack in the weld metal. It can be seen from the polished sections that the cracks are

The accumulation of pores in the manual weld indicates that the electrodes were moist. In such cases, hydrogen is formed during welding and diffuses into the welding material. The result is "hydrogen cracking." The initial cracks in the weld were probably formed immediately or within a few hours after welding.

Figure 4. Horizontal section through the weld.

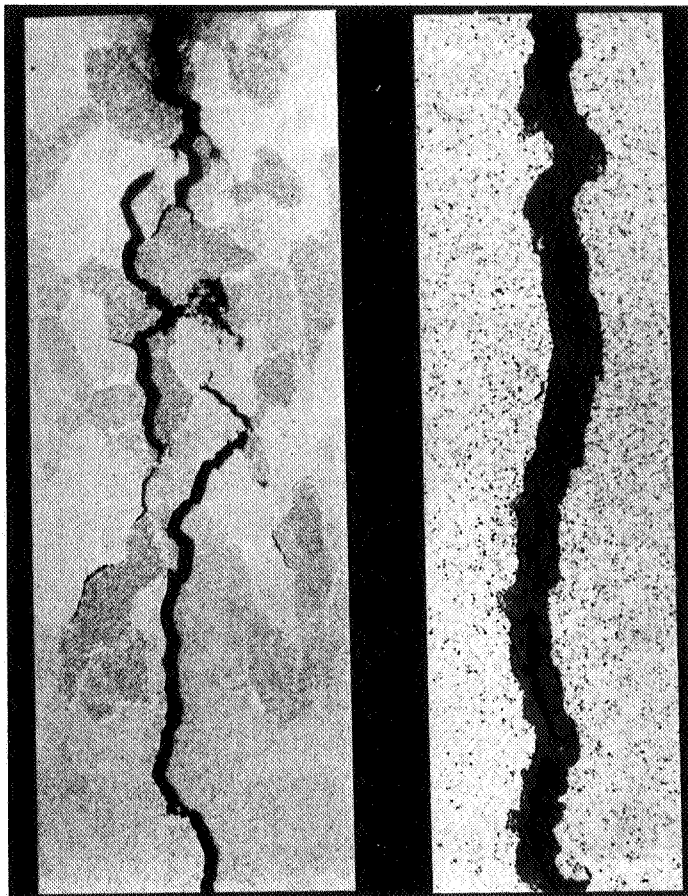
Figure 6. Details of a crack.

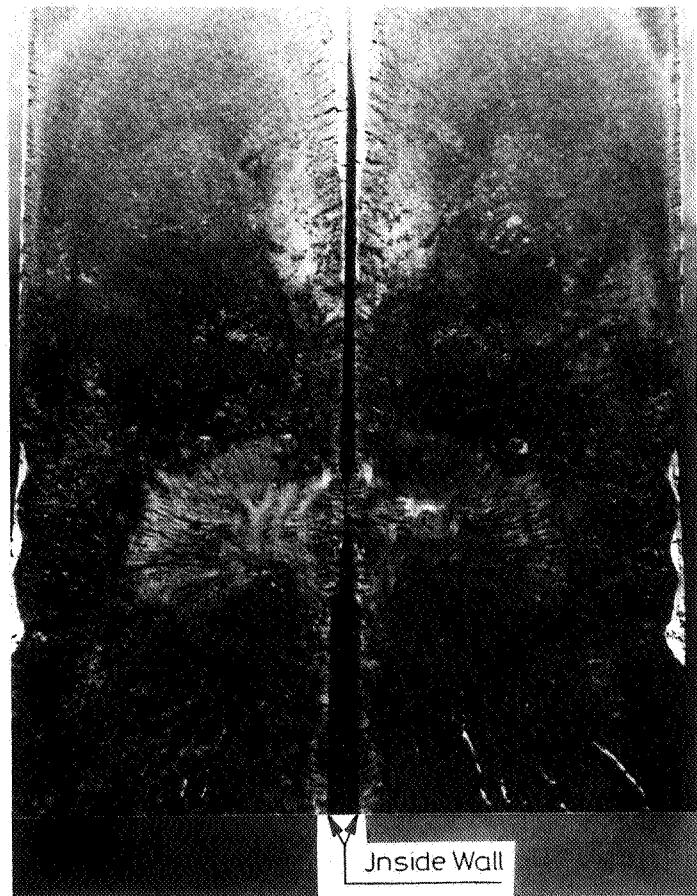
The two fracture surfaces of the large crack in the converter are reproduced in Figure 7. Two zones can be clearly distinguished: a) a grey section that lies within the weld metal and on the inside of the converter; and b) a reddish brown and black section that is very probably the extension of the crack.

The shape and size of the grey section are roughly similar to those of the other cracks in the weld. With the aid of X-ray diffraction pictures, it was determined that the very adherent and thick grey layer of oxide consisted mainly of magnetite. The thickness of this layer proves that the grey surface is the initial crack that was in contact with the process gas for a long time and that it is much older than the extension of the crack.

Figure 7. Surfaces of the big crack.

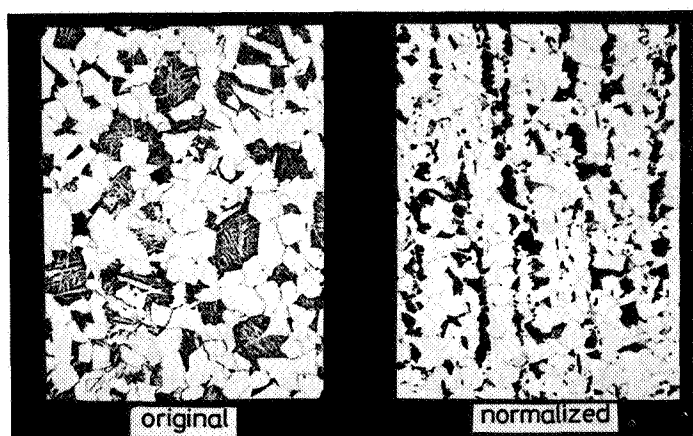
The structure of the plate metal in the original state and after normalizing in the laboratory (930°C/½ hr. cooling in furnace) is shown in Figure 8. The original material has a Widmannstaetten structure and consists of ferrite and bainite. After normalizing in the laboratory, the structure consists of a linear arrangement of ferrite and perlite such as can be expected from a material of this nature that has been subjected to optimum heat treatment. The hardness of the plate metal decreased from 180 Hv. before normalizing to 125 Hv. after normalizing. The conclusion is that the material had not received optimum heat treatment.

Figure 8. Structure of the plate material.

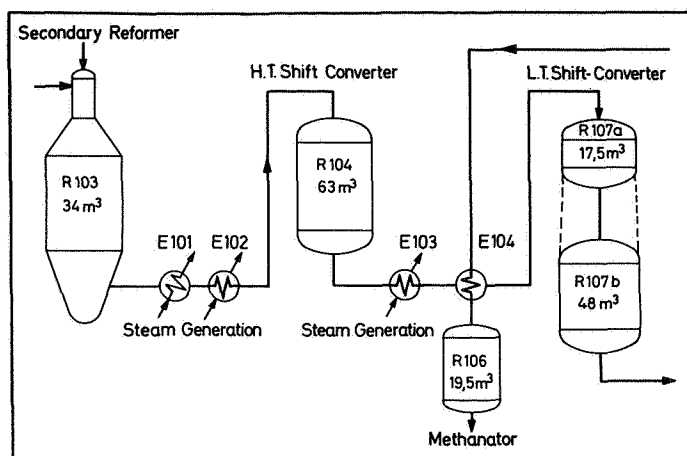
Figure 9. CO shift conversion ammonia plant at Pernis.

In view of the long delivery time for the new HT shift converter, the fifth solution offered the most advantages. It was decided to use the small LT shift reactor as a temporary HT shift converter. Therefore, the upper LT shift vessel was removed and installed in place of the defective HT shift reactor.
