High-Temperature Shift Converter Problems

Two specific case histories of failures follow a general review of the operating conditions in the four designs of ammonia plant shift converters

J.A. Lawrence
CF Industries, Inc.
Long Grove, Ill.

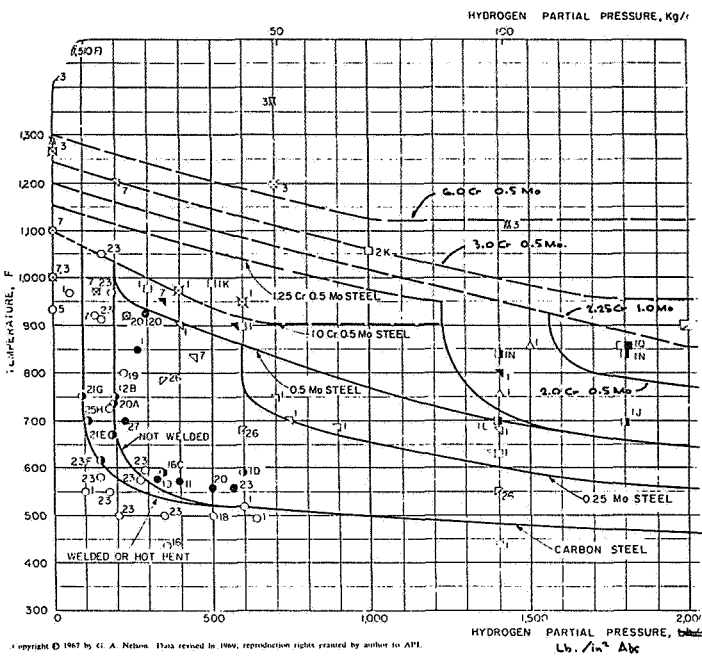
Figure 1. Nelson Chart: operating limits for steels in hydrogen service.

The best defense against hydrogen embrittlement in shift converters is to select an alloy steel with carbide stabilizer elements such as chromium and molybdenum. The data normally used to select this material is the "Nelson Chart." This chart, seen in Figure 1, shows in graphic form the safe operating limits for carbon and alloy steels in contact with hydrogen at high temperatures and pressures. It can be used by utilizing the partial pressure of hydrogen in the flowing stream versus the operating temperature of the

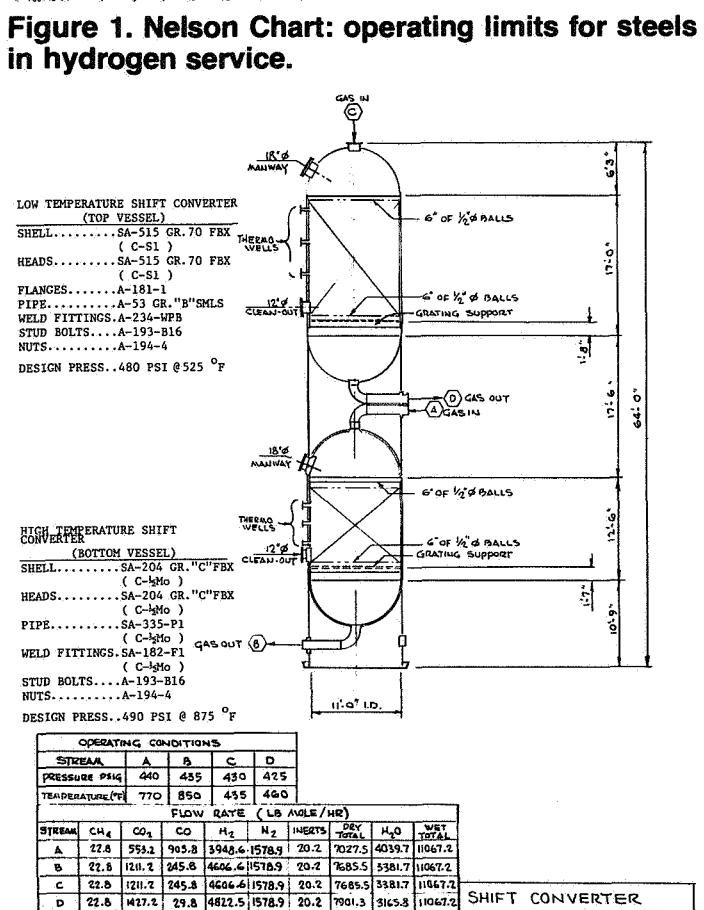
Figure 2. The shift converter that sustained cracking in the bottom head.

from ASTM A204, Grade C, Firebox Quality plate, which is carbon-0.5% molybdenum steel. With a partial pressure or hydrogen at 198 lb./sq.in.abs., this is the proper material according to the "Nelson Chart." The design conditions for this vessel are 490 lb./sq.in.gauge at 870°F, and the operating conditions are 440 lb./sq.in.gauge at 850°F. The vessel is 11 ft. inside diameter, and the lower head is hemispherical. The head is fabricated from seven segments, or gores, and one dollar-plate. The thickness is a minimum of 1.186 in.

In February, 1976, a leak developed in the lower head of this vessel. Investigation revealed a crack in the edge of one of the vertical welds joining the segments or gores. The cracked portion had propagated across the circumferential weld of the dollar-plate to a segment and into the base metal of the dollar-plate forming an "L" shaped crack 13 in. long.

Figure 2 shows one of the shift converters that sustained cracking in the bottom head. This vessel was fabricated

The ammonia plant was taken down for annual turnaround in June, 1976. At that time, another crack was observed on the bottom head of the shift converter. This crack was approximately 1 1/2 in. long on the outside surface of the previously repaired area. At this time, samples were taken for metallurgical examination of both the previously repaired area and adjacent head segmental weld.

Again, accessibility to the inside of the head was not possible and repairs were made from outside of the vessel by arc gouging to the root of the crack, and dye-checking to be sure all the damaged material was removed. The cracked area measured approximately 14 in. long. Transverse cracking in the lower dollar-plate base material had occurred, giving a "Y" type crack.

Preliminary reports from the laboratory running the metallurgical examination have indicated no evidence of graphitization, which had been suspected; however, there seemed to be an indication of hydrogen embrittlement, particularly in the heat-affected zone of the weld. It appeared that the initial crack originated in the heat-affected zone of a segment weld and propagated across the circumferential weld of the lower dollar-plate into the base metal. The metallurgical examination also revealed a hardness differential between the weld metal, heat-affected zone, and the base metal of the vessel itself.

Except for one period of 3 min., during October, 1974, the shift converter had always operated within the design temperature and pressure limits. The exception noted was during a plant malfunction when the temperature went above the design temperature for the vessel. It is hard to reconcile this 3-min. excursion as the cause of hydrogen embrittlement in the heat-affected zone of the weld on the lower head.

Since it was impractical to dump the catalyst and get inside the vessel at this time, the repair was made entirely from the outside. The cracked area was removed to a total depth of 1-1/16 in. and the groove was checked by the magnetic particle method to insure removal of the cracked material. Since the skin of the vessel was still at 600°F, the weld repair was made with no further pre-heating. Each weld pass was peened, using a needle gun.

During the repair, transverse cracking was encountered in two areas. Minor transverse cracking occurred in the circumferential weld, but only to about 1/4 in. depth. An additional transverse crack was detected in the dollar-plate base metal about 1/2 in. below the circumferential weld and extending about 2 in. from the original crack. These cracks were removed by gouging to a depth of 3/4 in.

After completion of welding, the repair area and adjacent areas were again checked by the magnetic particle method to insure freedom of additional cracks. The completed weld area was field stress-relieved with an oxy-acetylene torch at 1,100°F for one hour, covered with insulation, and held for one hour. No samples were taken for metallurgical examination.

Since the repair had to be made from outside the vessel, a backing ring was used of the same material as the base

material. The backing ring was inserted from outside the vessel. Welding was accomplished by welding from the extremities toward the center, thereby reducing the gouged out area and welding the center area last. During the welding operation, a pre-heat of 250°F to 300°F was maintained.

After the crack was filled with weld material, another small transverse crack was observed in the lower dollar-plate and extended to about 2½ in. to a depth of ¾ in. This was removed by arc gouging and was repaired by welding. The repaired area was checked with dye penetrant and no additional cracking was observed. The entire lower circumferential weld was stress relieved at 1,125°F for 1½ hr. using resistance electric heaters.

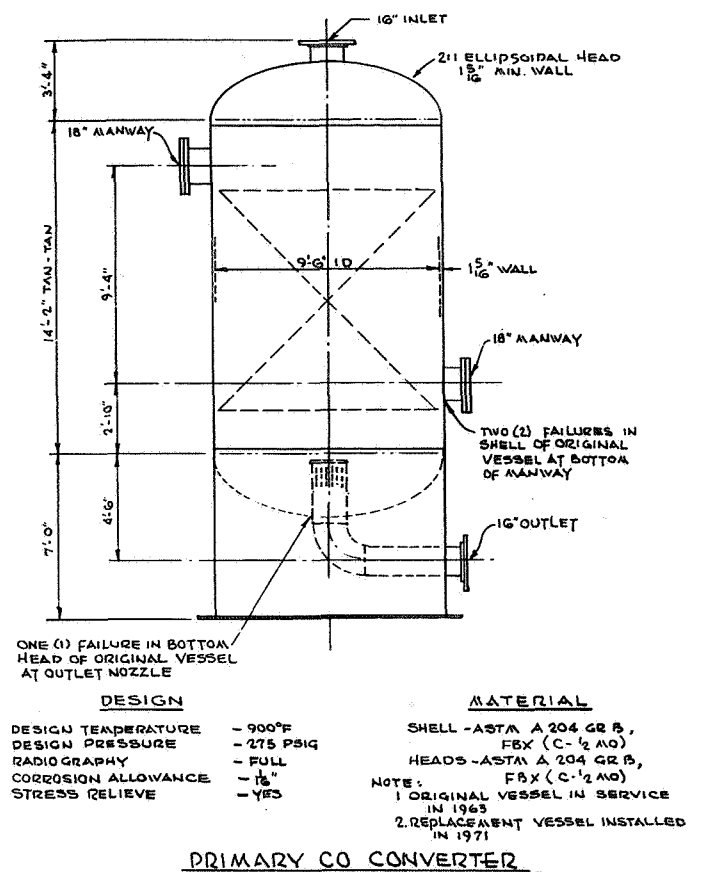
Figure 3. The shift converter that sustained three failures, two at the lower manway, and one in the bottom head on the outlet nozzle.

Figure 3 shows the second shift converter which failed in service. This vessel was fabricated from ASTM A204, Grade B, Firebox Quality plate, and was put in service in late 1963. The design conditions for the vessel are 275 lb./sq.in.gauge at 900°F. Operating conditions are 274 lb./sq.in.gauge at 815 to 875°F. With a partial pressure of hydrogen of 96 to 97 lb./sq.in.abs., it falls within the range of the material selected in accordance with the "Nelson Chart." The vessel is 9 ft., 6 in. inside diameter, and the minimum thickness of both the shell and ellipsoidal heads is 1-5/16 in.

The sketch in Figure 3 and detail in Figure 4 show experienced in this vessel; the first two at the lower manway and the third in the bottom head on the outlet nozzle.

In April, 1968, a leak was discovered in the vicinity of the bottom manway on the shift converter. When the insulation was removed, it was found that the vessel had cracked at the toe of the fillet weld attaching the reinforcing pad to the vessel. The reinforcing pad was fabricated from ASTM A204, Grade B, Firebox Quality plate and was

1-5/16 in. thick and 34 in. outside diameter. The crack extended approximately 120° around the circumference of the reinforcing pad.

In July, 1969, a leak was again discovered around the bottom manway of the shift converter. Removal of the insulation showed that cracking had again taken place along the toe of the fillet weld connecting the reinforcing pad to the vessel wall. This crack had started in the end of the area repaired in April, 1968, and continued on around the circumference of the reinforcing pad fillet weld. The crack was again ground out, repaired by welding, and dye checked.

A third failure in this vessel occurred in June, 1970. At that time a leak was found within the skirt of the shift converter, and the ammonia plant was taken down. When the insulation was removed, a crack was again found in the toe of the fillet weld of the reinforcing pad on the 16-in. outlet nozzle. The crack extended approximately 180° around the circumference of this fillet weld. The reinforcing pad was made of the same material as the vessel and was 1-5/16th in. thick by 31½ in. outside diameter.

It was felt that the cracking had been caused by the sharp change in section from the thick reinforcing pad to the thick shell. This would act as a stress riser due to the difference in stiffness of the heavy pad and head or shell

compared with the head or shell alone. With the sharp change in section, heat concentrations would be built up resulting in overstressing and failure from thermal fatigue.

The plant was taken down, the crack was ground out to within 1/16th-in. of the inside wall, and repaired by welding. No outside preheat was required since the vessel wall was approximately 300°F during the repair procedure. Each weld pass was peened to relieve the stresses, and therefore no external stress-relieving was done following the repair. The vessel was put back on line following the repair.

The welding procedure was the same as the repair for the original crack. During the plant turnaround in the fall of 1969, the catalyst in the primary shift converter was changed. When the vessel was empty and clean, the repair was inspected internally. It was found that good penetration had been made with all of the repair welding and that no new cracking showed from the inside wall.

It was still decided to grind out the area of repair from inside to a depth of approximately ¼ in., and tie welding in from the inside to the repair welds which had been made from the outside. This was done using the proper pre-heating and welding procedures, ground smooth, and dye-checked. No cracks were found following this repair.

Welding repairs were made using proper welding procedures and preheat; and following repairs the area was dye-checked for additional cracking. No additional cracking was found and the unit was put back on line. As with the second crack in the bottom, an internal check was made on the bottom head during the turnaround in the fall of 1970. This involved grinding out from the inside to tie into the repair weld which had been made from the outside. Dye-checking of this repair showed no further cracking either internal or external.
