Ammonia Tank Floor and Foundation Failure

Repairs and inspection after the incident support the conclusion that inspection during construction should be independent of the contractor.

W. H. Lichtenberg,
Camex, Inc.,
Borger, Texas

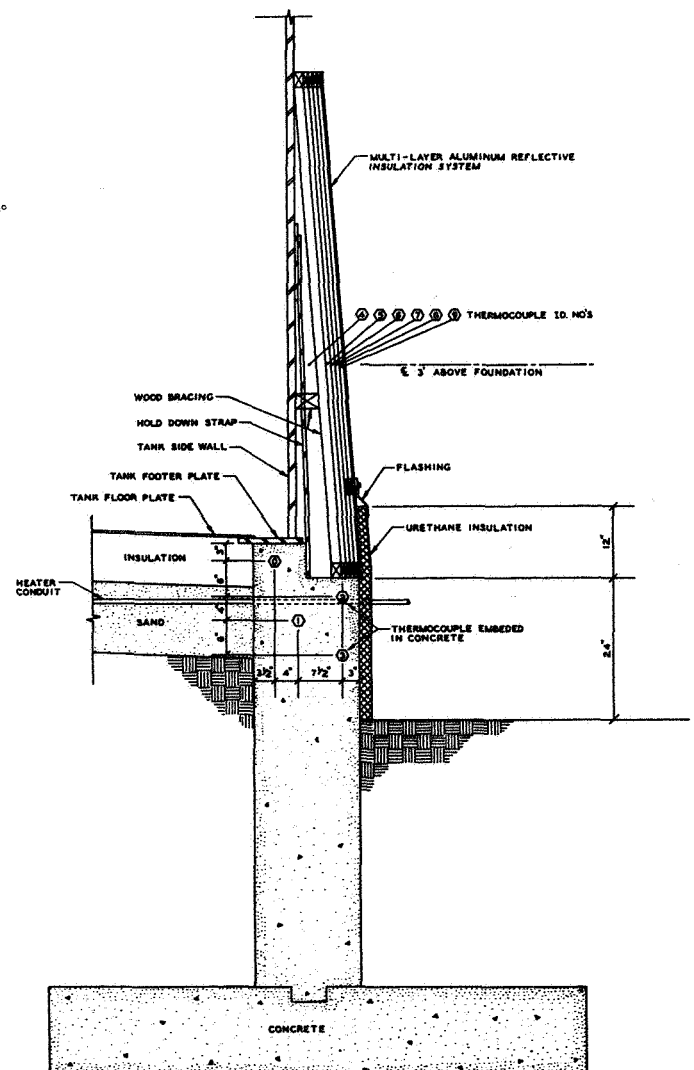
Figure 1. Section, showing concrete foundation, tank construction, insulation system, and thermocouple locations.

outer cell drain was installed in the insulation system to provide for condensate build-up. Thermocouples were installed in the concrete and sidewall insulation system to provide data for evaluation, the readings are exhibited in Table 1. Figure 1 shows thermocouple locations.

No.*	Jan.	Feb.	Mar.	Apr.	May	Jun.	Jul.
0	... -7 -6 -5 -11 -5 -1 -2
1	... 7 10 9 15 16 22 21
2	... 15 26 24 28 36 38 34
3	... 14 16 17 22 29 30 30
4	... -17 -15 -7 -11 -15 -16 -16
5	... -6 4 -2 3 10 11 3
6	... 4 19 11 18 29 27 8
7	... 15 29 18 26 30 30 11
8	... 37 54 35 43 65 69 39
9	... 50 71 49 55 85 87 53
A	... 36 58 52 58 82 81 71

*Identification numbers of thermocouples shown in Figure 1.
A = Ambient

The multilayered aluminum insulation system was replaced as originally designed with a modification for accommodating a urethane foam insulation system on the foundation overlapping onto the original insulation system. A flashing strip was added 12 in. above the lower termination. Two inches of urethane foam was sprayed 2 ft. on the concrete and 1 ft. on the insulation system, tying into the flashing system. Elastomeric coating 45 mils thick was applied over the urethane to protect it from deterioration. An
