Avoiding Stress Corrosion Cracking

W. D. Clark and A. Cracknell,
Imperial Chemical Industries, Ltd.
Billingham, England

The Billingham plant of Imperial Chemical Industries has three of the early Kellogg 1000-ton/day ammonia units designed to run on naphtha, and later (1970-71) converted to natural gas. All three of the 0.5% Mo steel (A204B) vessels have now been replaced, after operating periods of 6-7½ years.

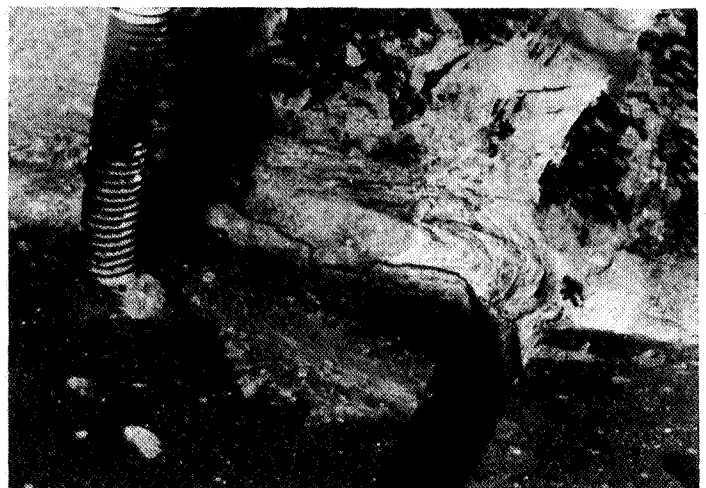
It was decided to examine the No. 3 unit vessel again in June, 1975, though no troubles were expected. Bad cracking was found, especially at the welds of the brackets supporting the catalyst support beams. While much of the cracking was at the bracket side of the weld, seen in Figure 1, some of the cracks ran into the pressure shell, at one point to a depth of 1¼ in. over a length of 5 in. The top of the barrel appeared laminated but not blistered.

Figure 1. Crack at Support ring/shell weld.

The fillet welds attaching the catalyst support ring and the heavy brackets which support the beams have been cracked in all three vessels and also in a number of other vessels, some of 1% Cr Mo. Such cracking, which has been found 30 mm. into the shell plates, is a constant concern. In one brand new 1% Cr Mo vessel it was present and was certainly due to lack of adequate preheat.

Inadequate preheating is a danger with all attachment welds inside vessels, and the smaller the attachment the greater the risk. We cannot be certain that the cracking found in the HT shifts was not the extension of fabrication cracks. We now examine all such welds in new vessels very carefully, toe grinding if the profile makes crack detection uncertain. Where possible we do without support grids and support the catalyst on beds of ceramic balls.
