# Ammonia Pipeline Rupture

A brief case history reviewing a failure in a line between an ammonia manufacturing facility and a nearby customer in the Texas City area.

M. B. Sterling,  
Amoco Texas Refining Co.,  
Texas City, Texas

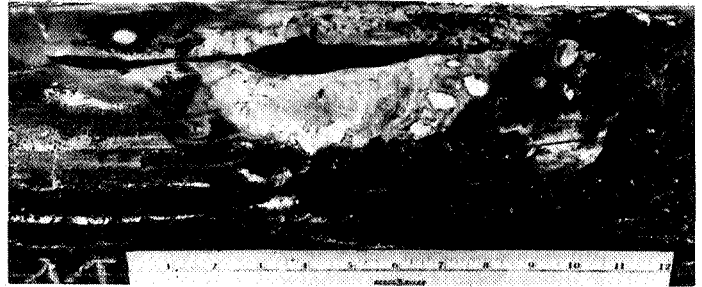
The cause of the failure was external corrosion of the pipe due to mechanical damage of the pipe coating and an interference in the cathodic protection. The metallurgical quality of the pipe was satisfactory and did not contribute to the failure.

**Figure 1. The 12-in. long rupture in the ammonia pipe line.**

When the line was depressured, a split in the pipe wall about 12 in. long could be seen. It is shown in Figure 1. A clamp was installed so that the purging could be completed. Mechanical damage to the pipe coating was then discovered at several locations in a length of 70 ft., including the leak location. The line was repaired by replacing 90 ft. of pipe. A hydrostatic test confirmed that the remainder of the pipe was satisfactory for continued use.

At the rupture location extensive pitting corrosion was found in an area 12 in. long covering a third of the pipe circumference. The pitting had reduced the wall thickness of a 2-in. diameter area to about 0.05 in., and the rupture initiated at this location. The fracture was arrested after it penetrated a few inches into the full wall thickness at each end. The inner surface of the pipe was not corroded.

**STERLING:** The problem was that the area of pipe which was corroded no longer had any coating. And therefore when there was a cathodic interference by another pipeline, that particular area was attacked. No other area could be attacked because the line was protected by the coating. So very severe corrosion occurred at the point of damage of the coating.
