# Ammonia Plant Converter Basket Failure

Investigation showed outside insulation had made possible a chloride concentration that, with existing temperature, results in stress corrosion conditions.

R.L. Thompson and J.B. Brooks,  
Agrico Chemical Co.,  
Donaldsonville, La.

The objective of this article is to report on the circumstances surrounding a catalyst basket failure at the Agrico Chemical Co.'s Faustina plant 1,000-ton/day Kellogg process ammonia unit.

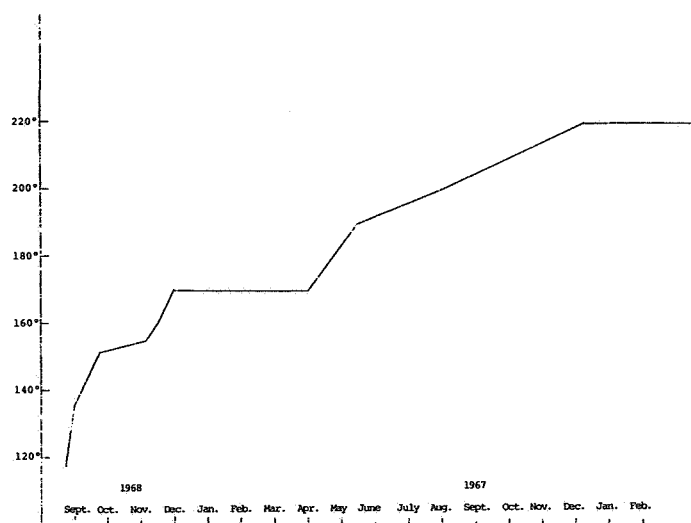
During the months that followed startup, it was noted that the temperature of the gas leaving the annular space between the converter basket and the pressure shell was above design and gradually increasing with no corresponding increase on the inlet or on the interior of the basket. Figure 1 shows the trend. The conclusion was drawn that there was a leak between the hot gasses in the beds and the annular space.

Figure 1. Temperature of recycle to syngas compressor vs. time.

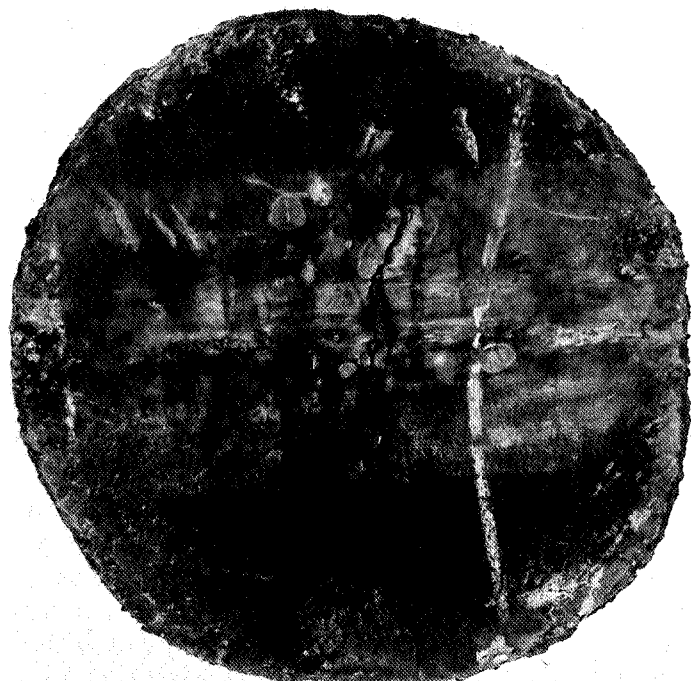
Two plates, seen in Figures 2 and 3, were tested extensively in the Shilstone Lab with the following conclusions:

1. The plates showed nitriding to a depth of 0.001 to 0.0097 in., with the depth of the nitriding being the same inside the cracks as on the surface. This indicates the cracks were there before or during startup.

2. The primary mode of cracking was noted to have been by branching transgranular penetration from external surfaces.

Figure 2. Inside surface of the 7-in. sample, as received by the test laboratory.

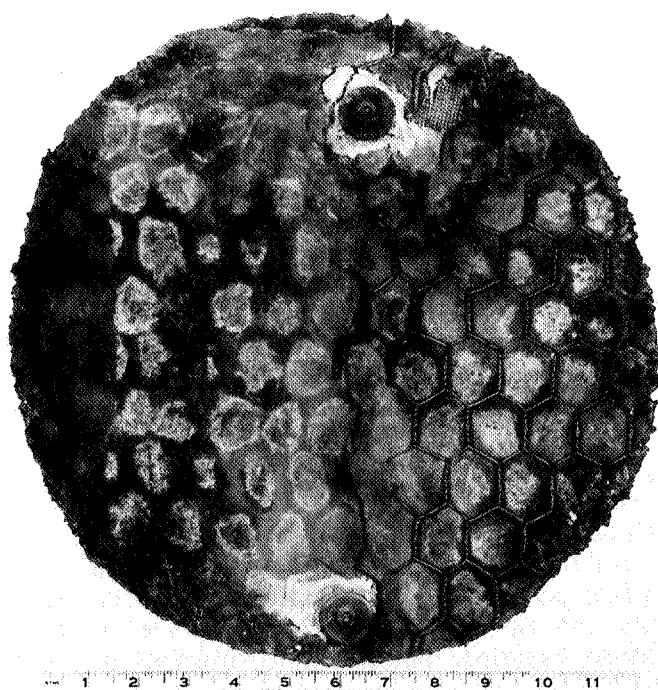
Figure 3. Outside surface of the 12-in. sample, as received by test laboratory.

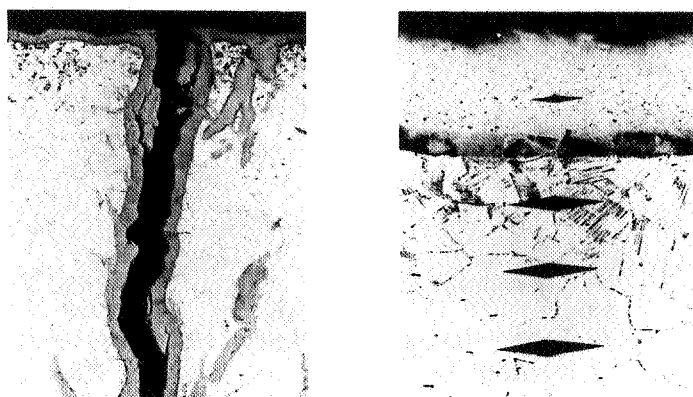
Figure 4. Photomicrographs illustrate nitriding at the outer surfaces and along the surfaces of cracks. Knoop microhardness impressions are visible in the photomicrograph at the right, a 12-in. sample at 200X. The one on the left is a 7-in. sample at 50X. (Oxalic acid, electrolytic etch.)

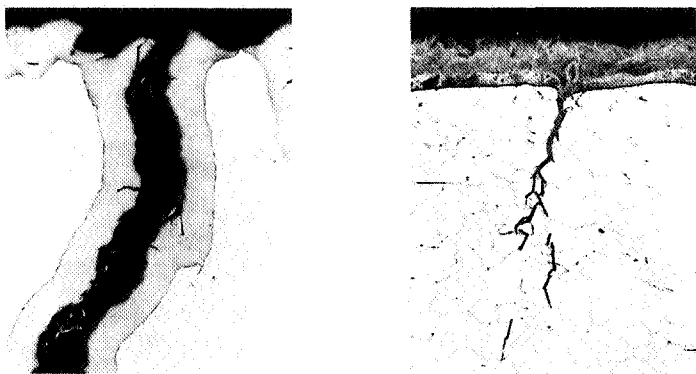
**Figure 5. Photomicrographs of a section of the 12-in. sample, illustrating nitriding at the outer surface and along cracks. The one at the right shows nitriding along a transgranular crack extending inwardly from the outer surface. Note that the degree of nitriding along the crack is less than at the surface: this is the only instance in which nitriding was not of similar depth along crack surfaces to that at plate surfaces, and therefore probably represents the tip of a larger crack extending from another location. (Oxalic acid, electrolytic etch. 100X.)**

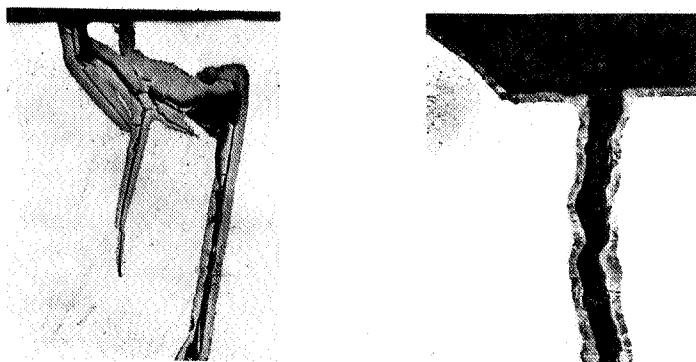
**Figure 6. Photomicrographs of sections of the weld in the 7-in. sample, illustrating nitriding of the external surface and crack surfaces. The nitrided layer on the external surface in the view at the left (a longitudinal section of the weld) is absent, probably because of flaking or spalling during sectioning and preparation. The view at the right is a transverse section of weld and adjacent plates. (Oxalic acid, electrolytic etch. 50X)**

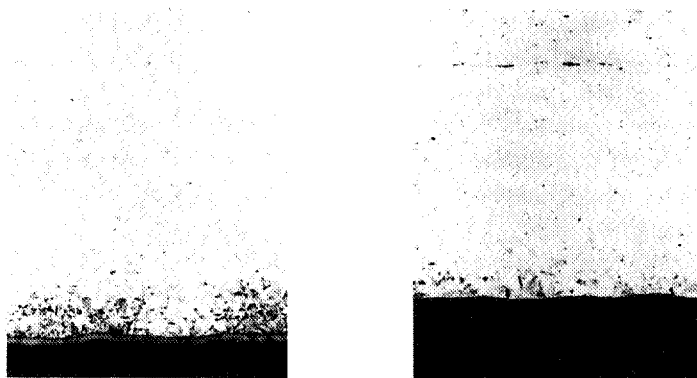
**Figure 7. Photomicrographs illustrate nitriding of the inner surfaces of the two plates. Note that the degree of nitriding is less in the 7-in. plate (at left) than in the 12-in. plate (at right). (Oxalic acid, electrolytic etch. 50X.)**

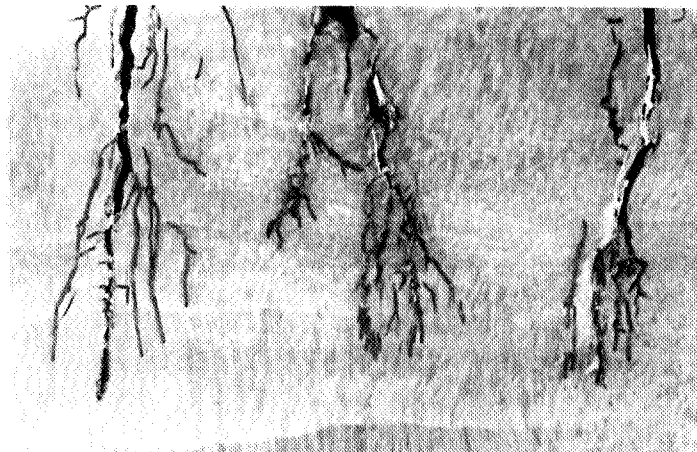
**Figure 8. A photomacrograph of the inner portion of a longitudinal section of the weld in the 7-in. sample, illustrating the branching crack patterns. (Oxalic acid, electrolytic etch. 5X.)**
