# Cause and Effect of Explosion in Ammonia Converter

Thorough inspection of internals following the incident, after 30,000 hours of operation, indicated no mechanical defects or hydrogen attack problems, and some nitriding.

H. J. Wahl and E. F. Neeb,  
Erdoelchemie GmbH,  
Cologne, West Germany

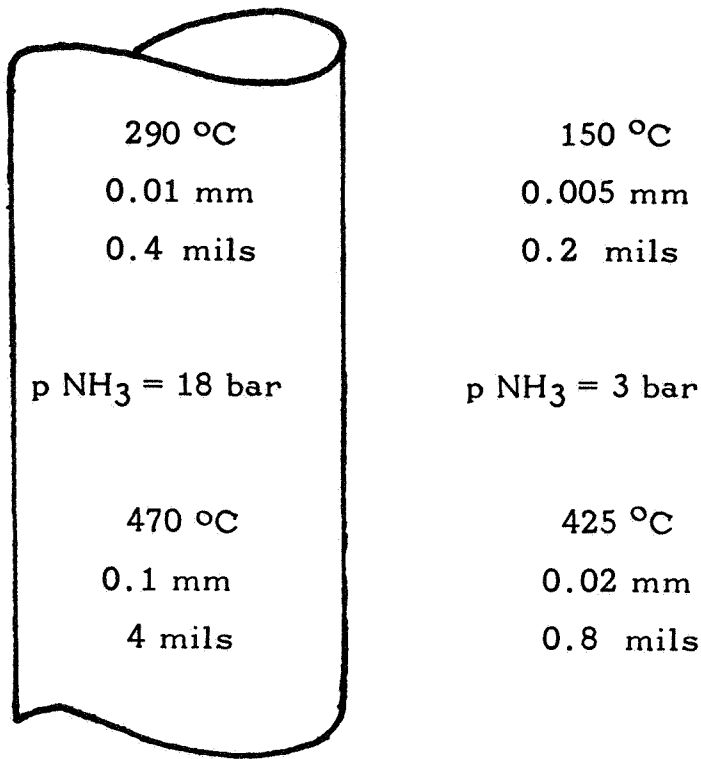
**Figure 1. Effects of location on nitriding: higher operating temperature at bottom area of tube bundle and inside tube (where ammonia partial pressure is greater) caused maximum nitriding.**

321 V2A, were nitrified differently. Maximum nitriding of 4 mils was found at the bottom area of tube bundle at the inside of the tubes, whereas nitriding at the colder top area was 0.2 mils only. Figure 1 shows that nitriding was more severe where partial pressure of ammonia and operating temperature were highest. This result illustrates very clearly the influence of operating conditions on nitriding reaction.
