Ammonia Loading Line Rupture

A brief case history describes a major rupture accident at the Swedish fertilizer plant receiving terminal docks at Landskrona.

R. Hakansson,
Supra Aktiebolag,
Landskrona, Sweden

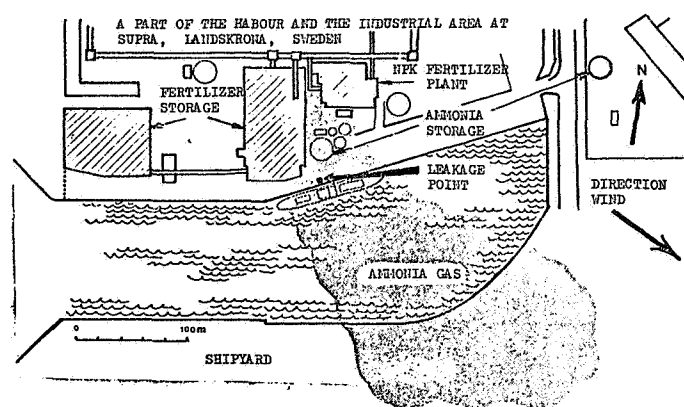
Figure 2. Plot plan of Supra's dock arrangement, showing how the ammonia gas spread during first few minutes after the rupture.

After about ten minutes, the firemen arrived. Two of them were provided with protective clothing and breathing equipment. The tanker was by that time completely enveloped in a cloud of ammonia gas, as shown in the plot in Figure 2, and liquid ammonia was still spurting onto the quay. The two firemen with the protective clothing went on board and closed the ball valve on the discharge line.

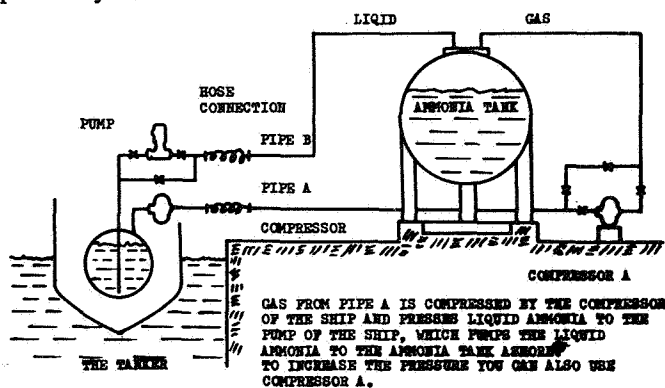
Normally the tankers use their own equipment. The rubber hoses for connection to Supra A.B.'s pipe lines on the quay, seen in Figure 1, always belong to the tankers.

Figure 1. Schematic diagram illustrating Supra's arrangement for unloading anhydrous ammonia from tanker to dock storage sphere.

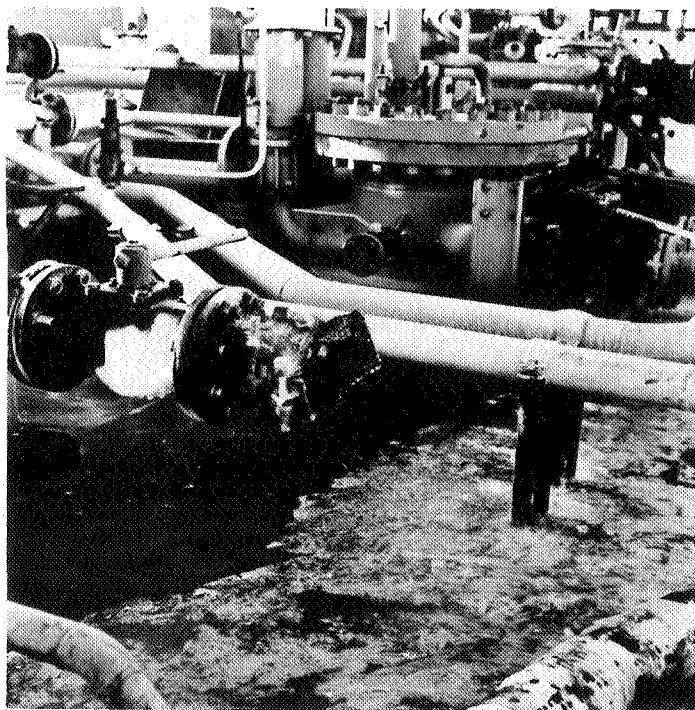
Figure 3. Hose connection on board the tanker.

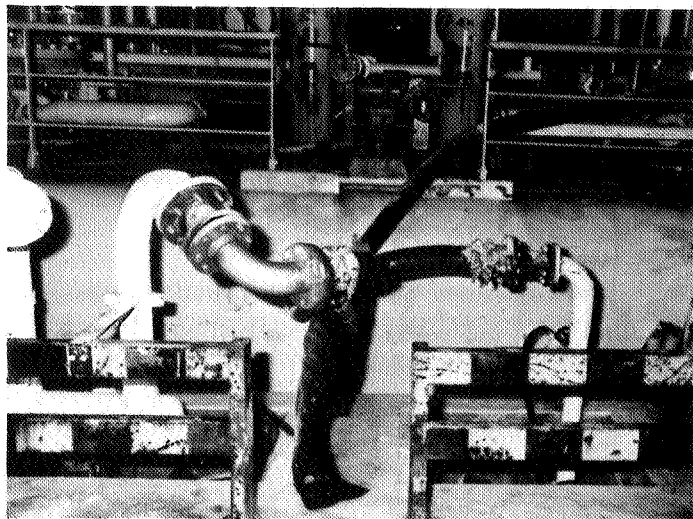
Figure 4. Hose connection on the quay.

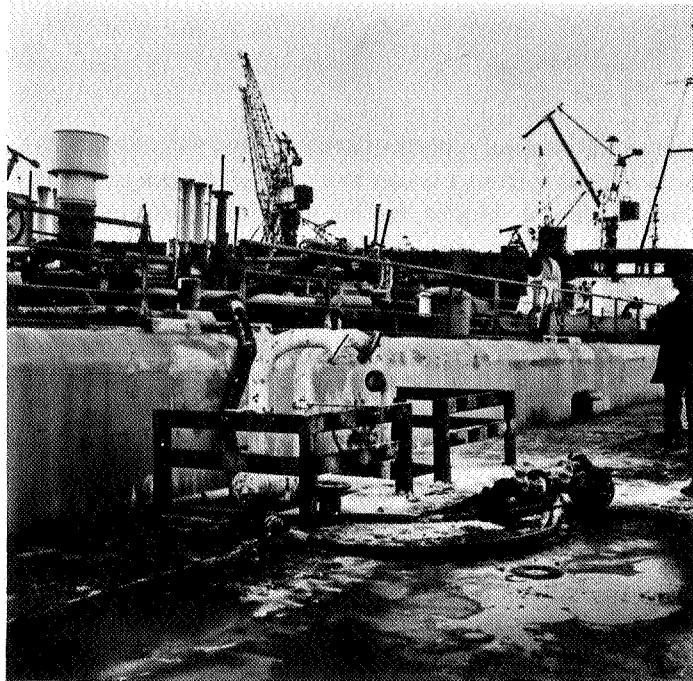
Figure 5. Condition of connections after the accident.

“The polyester in the ruptured hose was totally destroyed by a form of hydrolysis resulting from the action of ammonia. The products of this ammonolysis are glycol and acid amides.

“The cotton layer was not attacked but the copper wire had in some parts of the hose totally disappeared. If cupric salts are dissolved in ammonia the compound formed can attack cellulose.

“The inner rubber layer had hardened and showed a number of cracks. The breaking stress had decreased from 134 to 56 kp/cm² and the elongation of rupture from 304 to 84% . The hardness of the rubber had changed from 80 shore A to 65. The Testing Laboratory summarize the testing results as follows: The rubber hose is of a very high quality if it is used for propane and butane. The rubber quality and the reinforcements are resistant to these substances. But this rubber hose is completely unsuitable for anhydrous ammonia.”

2. Before the discharging starts it should be controlled so that the right kind of hose is used and that the hose is properly connected. The master should on request from a harbour officer present a certificate of the hose showing that the hose is made of material resistant to ammonia. The hose should have been tested within the last 12 months.

Supra A.B. is now building a 30,000-ton capacity ammonia storage terminal for atmospheric pressure. Contractor CBI is Chicago Bridge & Iron. The unloading will then be done with loading arms instead of rubber hoses. #
