Failure in Urea Plant Carbamate Condenser

Cause was stress-corrosion cracking on water-side due to freon used for leak tests during maintenance, and result has been adoption of other leak test methods.

G. Cabrini and G. Cusmai,
Snamprogetti,
Milan, Italy

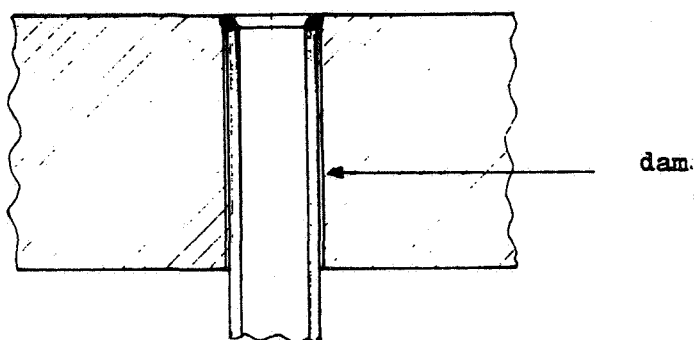
Figure 2. Tube and tubesheet detail.

It was decided to remove some of the broken tubes to ascertain the nature of the trouble. On four of these tubes, various longitudinal cracks were found, and some of them appeared to extend through the entire wall thickness. All tube cracks were in a limited area within the upper tubesheet thickness, about 200 mm. away from the weld. Figures 2, 3, and 4 show details.

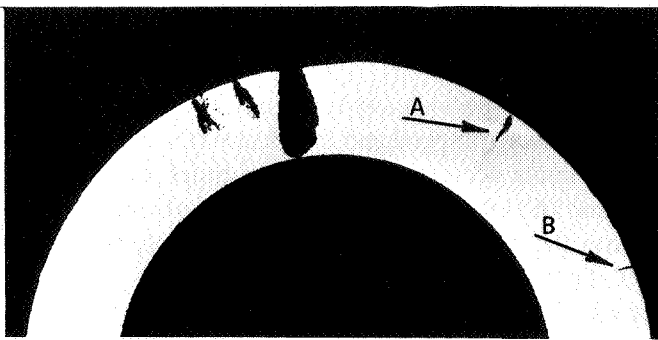
Figure 5. Cross section of defects shown in Figure 4 (Breda Institute).

Macrographic examinations of tube sections containing the cracks were most interesting, as they showed that the cracks start from the external surface of the tube, as seen in Figures 5 and 6.

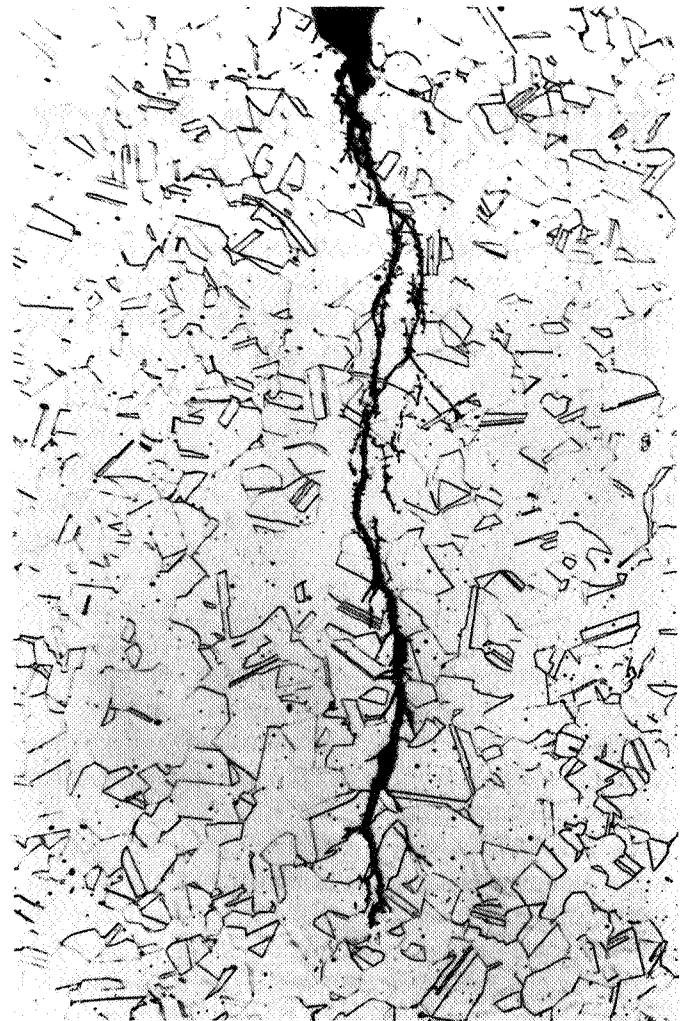
Figure 7. Micrograph of crack B of Figure 5 (Breda Institute).

The micrographs of two of these cracks, in Figures 7 and 8, show a transgranular ramification typical of stress-corrosion cracking on austenitic steels. A microprobe (SEM) examination was then carried out inside some of these cracks

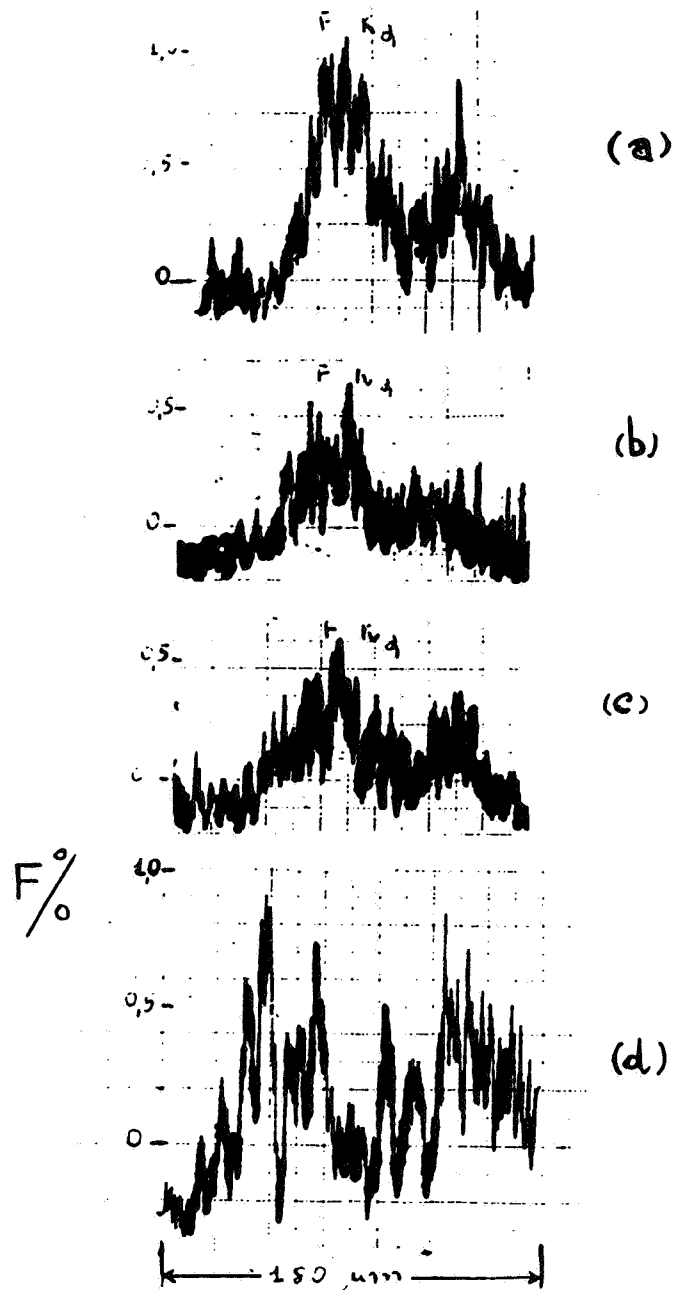
Figure 9. Fluorine spectrum (C.S.M.).

and the presence of chlorine was detected in some of them. As is known, chlorine is a specific stress-corrosion cracking agent in austenitic stainless steel. Furthermore, a microprobe examination of the external surface of the tubes was carried out near some of the defects. The presence of chlorine and fluorine was noted. Figures 9 and 10 show the recordings of spectrum FK and CLK on some zones and along a line.

It is well-known that if the ambient/material combination is highly critical, as in this case, even slight stresses may be sufficient to cause stress-corrosion cracking. A confirmation of the above hypothesis is provided by the fact that the microprobe examinations revealed the presence of fluorine too on the tubes.
