# CATASTROPHIC OXIDATION

G. Sorell The M. W. Kellogg Co. New York, N. Y.

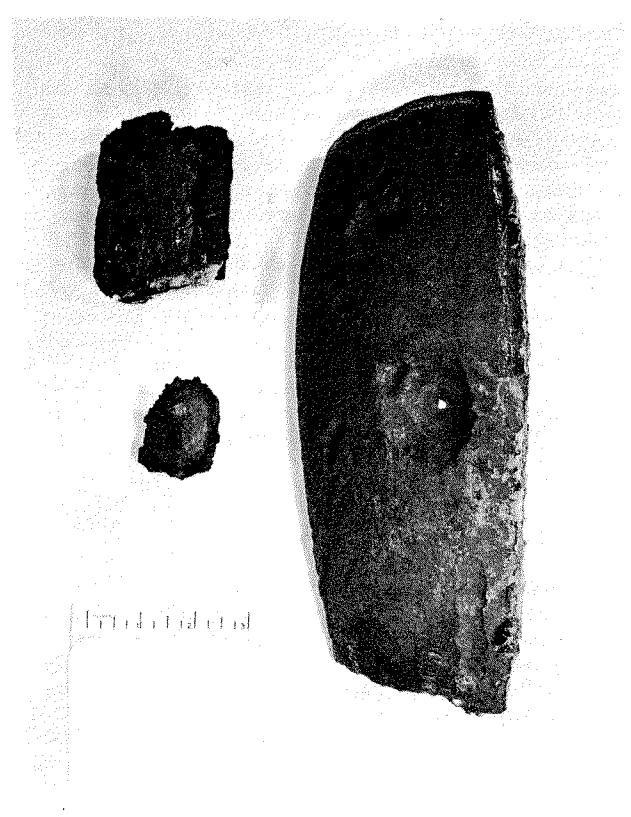
Figure 1 shows a piece of an elbow taken out of a pyrolysis furnace transfer line; it probably ran approximately 50°F hotter than most reformer plant transfer lines. I do not remember the exact wall thickness of this line—it was probably between 1/2 and 1 in. Note that it is completely perforated in one area and that the surface is heavily encrusted with a loosely adherent oxide scale. The small piece shown on the left is a porous oxide plug which had formed directly over the hole. Figure 2 shows a cross section of this plug, revealing the stratified friable nature of this oxide layer. As is evident by visual inspection, this particular oxide scale is highly pervious and nonprotective.

Figure 1. Large piece is perforated Type 316 stainless steel elbow section from naphtha pyrolysis furnace outlet line. Small round chunk is a porous oxide plug which had formed directly over hole. Also shown is a square piece of sootcontaminated asbestos insulation.

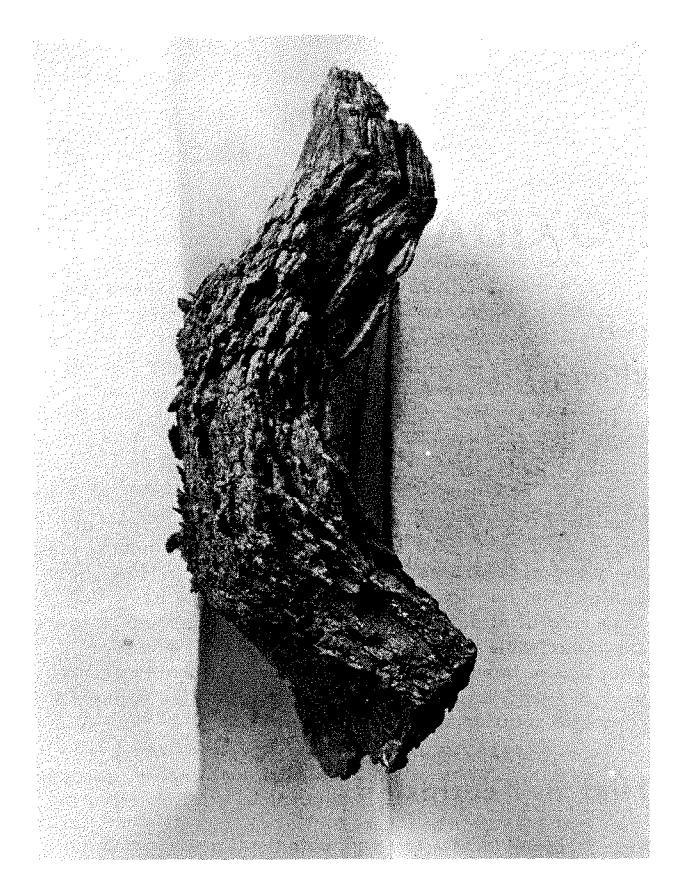
Figure 2. Cross-sectional view of bulky oxide plug shown in Figure 1. Stratified appearance and friable nature of corrosion product is characteristic of catastrophic oxidation.

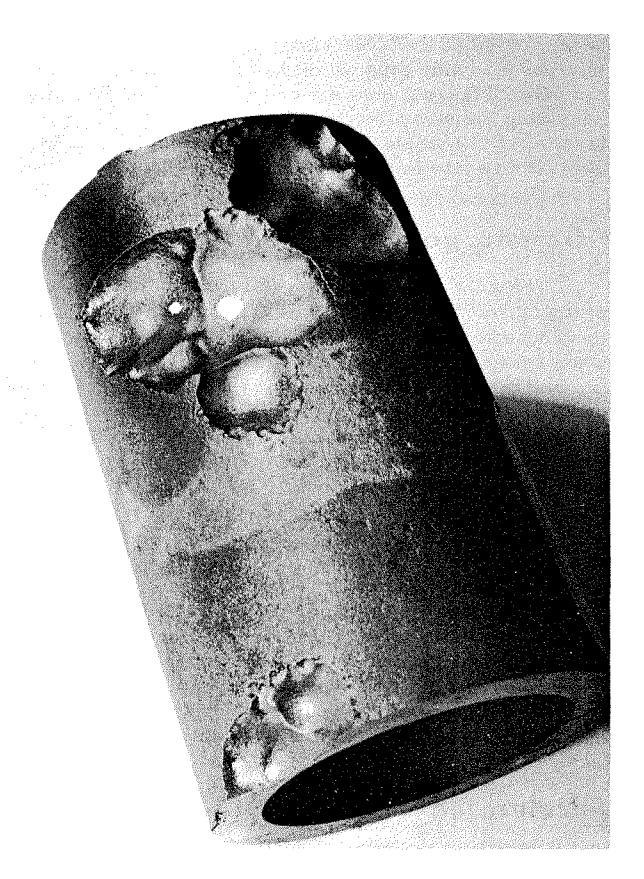
Figure 3 illustrates a failure experienced in a primary reformer outlet line. The photograph shows the pipe after sandblasting; it too was heavily encrusted when removed from service. The failure of this 5/8in. wall pipe occurred within less than a year. It is exceptional indeed to find such a marked "go—no go" type behavior in high temperature corrosion experience, where the metal either corrodes very severely or remains essentially unaffected. This is quite an unusual phenomenon and differentiates ordinary from catastrophic oxidation.

Figure 3. Catastrophic corrosion of insulated Type 316 stainless steel reformer furnace outlet pipe. Sandblasting clearly reveals sharply demarcated zones of attack associated with localized formation of molybdenum oxide rich slags.

First, observe scrupulous cleanliness—any surface contaminants should be removed, which incidentally is a good idea with all stainless steels and high nickel alloys. Second, do not insulate—since this is admittedly quite impractical in most instances; insulation materials should be limited to those free of potentially flux forming ingredients such as sodium silicate. Finally, the use of Type 316 stainless steel can, of course, be avoided altogether in favor of molybdenum-free alloys. Replacement of Type 316 stainless steel in existing units would be difficult to justify because catastrophic oxidation is after all an unusual occurrence and apparently controllable by using compatible insulation materials.
