Ammonia Plant Salety Vol 12. 1969/1970. Frost Heaves and Storage Vessel Foundations

D. M. Morrison and H. T. Marshall Chicago Bridge & Iron Co., Oak Brook, III.

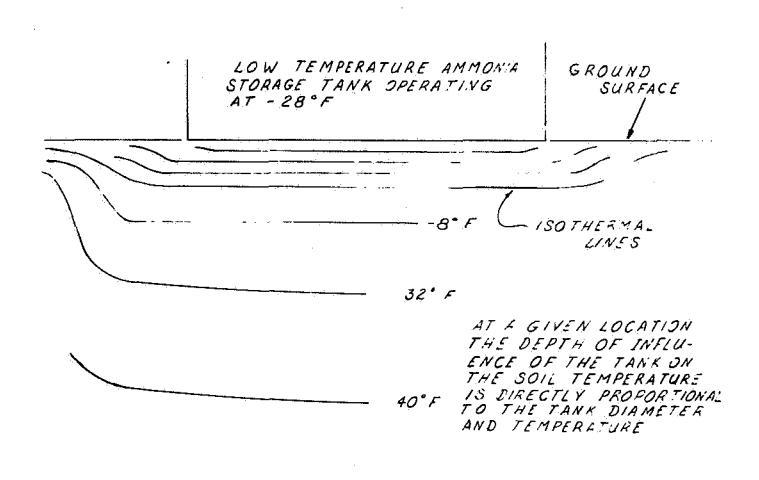
Figure 2. Isothermal lines beneath a low temperature ammonia tank.

Figure 2 shows a situation in which the subgrade beneath a low temperature tank has not been adequately protected from the subfreezing temperatures of the tank product. The figure shows, qualitatively, the isothermal lines which are generated when the temperature at the base of the structure is significantly lower than the mean soil temperature or the temperature of the ground water.

An idealistic view of a system of isothermal lines (lines connecting points of equal temperature) has been presented, Figure 2. It has been demonstrated experimentally, and theories have been developed to show that soil moisture travels in the direction of heat flow. Figure 3 illustrates the suction process by which water is drawn upward to the region of frozen soil where it freezes and thereby contributes to the formation of the ice lenses.

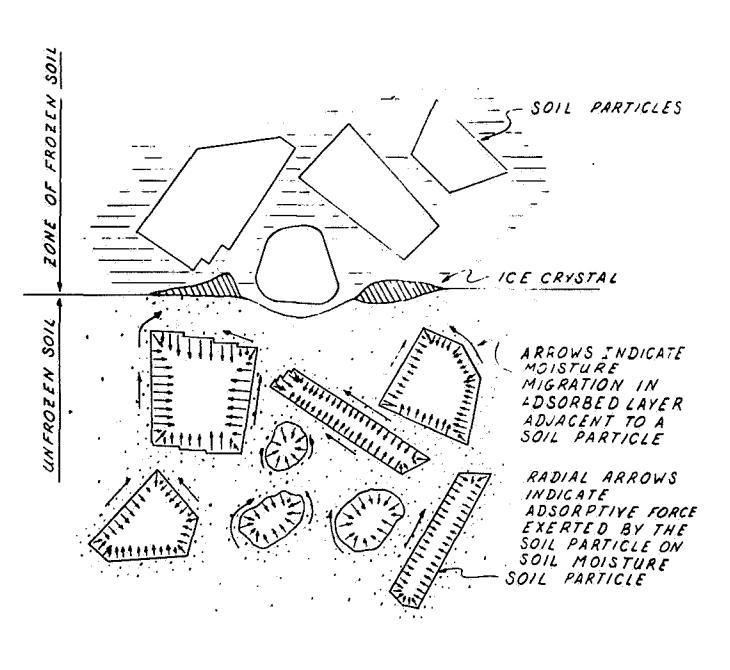
Figure 3. Suction process by which soil moisture is drawn upward to the region of frozen soil.

In Figure 3, the arrows pointing inward from the perimeter of the soil particles illustrate the adsorptive force which holds a film of moisture about each mineral grain. The electrostatic force which binds the moisture film to the mineral grain decreases with increasing distance from the surface of the particle. As heat is withdrawn from the ice lens at the base of the frozen zone, water molecules adjacent to the ice crystal, but also part of the adsorbed water film on adjacent soil particles, freeze to the ice lens. The mineral grain which has lost the water molecule must then attract another molecule to balance its adsorptive force. This process gradually draws moisture from the surrounding soil or from the ground water table. The process does not stop until either the supply of available moisture is consumed or until heat flow stops. The ice lenses form parallel to the isothermal planes and grow normal to these planes. Therefore, heave occurs in the direction of heat flow, or generally in a vertical direction.

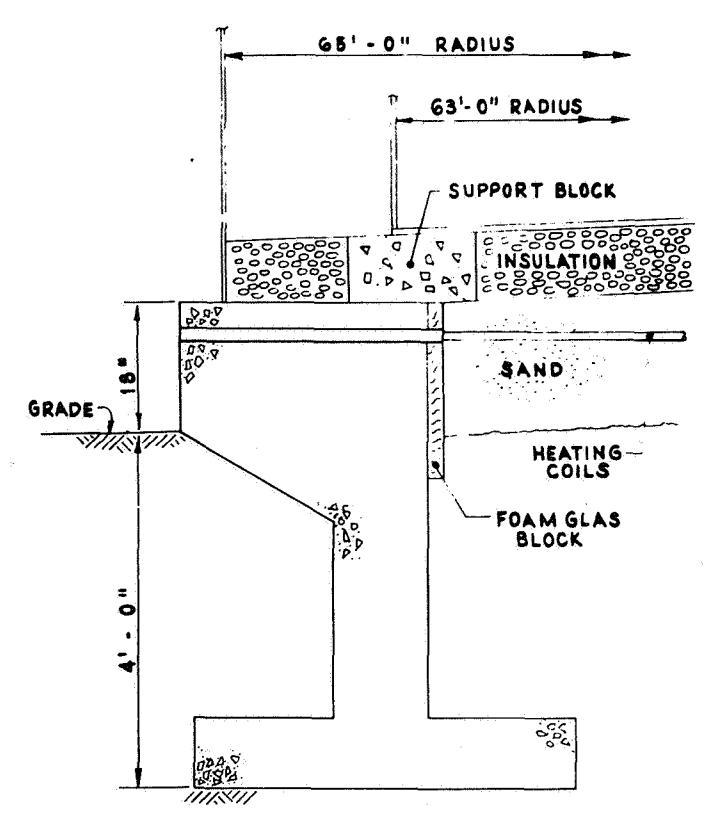
Figure 4. Tank foundation and support system.

It may now be useful to review a few situations which have demonstrated the theory of moisture migration and frost heave associated with low temperature and cryogenic equipment often used in the air and ammonia industry. The first of these involves an 18,000 ton, 126 ft. dia. double-wall tank for ammonia storage at -28°F. After approximately two years of operation, buckles were noticed at two points in the outer tank, Figure 4.

Investigations revealed that portions of the subgrade under the tank was heaving causing distress to the structure. After taking the tank of service, it was determined that the subgrade in an area between 5 ft, and 10 ft. inside the ringwall was at temperatures below freezing. Elevation profiles across the inner bottom indicated the approximate amount of heave in the subgrade, Figure 5. The curve representing the elevation profile across the bottom has an appearance similar to the inverse of the temperature profile plot, Figure 6. Borings made from the inside of the tank indicated the depth of the frozen soil varied from 2 ft. to 4½ ft. and that there were ice lenses in the clay up to $1\frac{1}{2}$ in. thick. The ground. heave under the tank was substantial enough to actually lift the tank shell pulling a portion of the ringwall foundation with it. In one area, there was a void under the ringwall foundation of approximately 31/2 in.

Samples of the insulation taken from the tank bottom showed variations in moisture content, which probably resulted from exposure of the insulation during construction. The area surrounding the tank was not adequately drained and ground water was trapped adjacent to the tank. Further investigations revealed that one phase of the three-phase electrical foundation heating system had been inoperative for an indefinite period of time, reducing the capacity of the heating system by approximately 50%.

Several factors leading to frost heave were present here. The silt and clay soil in the area were highly susceptible to frost heave and the normally high water table, plus the increased head from the free-standing water adjacent to the tank, provided the moisture necessary for the growth of ice lenses. Low storage temperature in the tank provided refrigeration to freeze the soil under the tank. Variations in the moisture content of the bottom insulation caused variations in the thermal conductivity which allowed uneven temperatures under the insulation. Unfortunately, the thermocouple control points were not all located in the coldest places and thereby unable to detect that portions of the subgrade were below freezing.

The repair consisted of removing the inner bottom steel, the bottom insulation and most of the outer bottom. Soil under the tank was thawed and holes were excavated around the inside and outside of the ringwall for inspection and for pumping water from under the tank. Thawing the frozen subgrade allowed the heave to settle and the ringwall returned to its original position.

Broken and cracked areas of the ringwall foundation were restored. The outer bottom, bottom insulation and inner bottom plates were replaced after recompacting the soil inside the ringwall. The area around the tank was graded for permanent drainage and the foundation heating system was reconditioned before placing the vessel back in service.

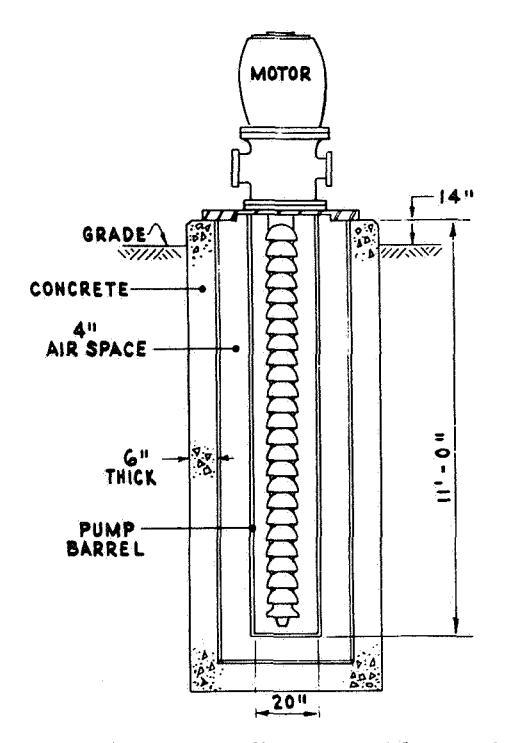
Figure 7. Vertical deep well pump and foundation arrangement.

such instance involved three pumps which were installed in a line on 6 ft. centers. Each pump was in a foundation casing 20 in. inside diameter by 11 ft. deep with an air space provided for insulation between the pump barrel and the foundation casing, Figure 7. Pump foundation heating and additional thermal insulation were not provided since the pump installations were intended for intermittent seasonal operation.

After operating the pumps intermittently for approximately three years, plant operators noticed distortion in the piping around the pumps. It was apparent that each of the three pumps had risen out of the ground by approximately 2 in. The soil report for the facility indicated that the soil around the pumps consisted of gravel, clay, and small amounts of weathered shale and peat. A high water table existed in the area and, at the time of the inspections, considerable water was standing on the ground which would not drain from the area.

A suspicion that the moisture and soil around the pumps had frozen was confirmed by taking several soil borings in the area. The borings indicated the presence of an ice lens of indeterminate thickness located approximately 10 ft. deep and adjacent to two of the pumps. Other areas around the pump casings were cold, but not below freezing. Temperatures taken from the borings were only approximate since the ground could have warmed up slightly in the pump areas during the time interval between taking the pumps out of service and actually making the borings. The lowest temperatures were located in the range of depths between 6 ft. and 12 ft.

There was no positive evidence that an ice lens had developed under the pump foundation casings, however, it was reasonably apparent that some portions of the soil under the casings had been frozen. Based on the data obtained, it is reasonable to assume that the ground had actually been frozen around the pumps from an approximate depth of 7 ft. to approximately 14 ft. below grade. Allowing for 2% to 3% expansion due to freezing would account for the 2 in. of upward heave experienced by the pumps. This is another instance where excessive moisture, frost-susceptible soil, and a low temperature source combined to cause equipment damage.

Repairs were started by disconnecting the pump piping and removing the pumps from the foundation casings. The casings were then filled with water and loaded with large concrete blocks while a heating element was inserted into the water to provide heat for warming the frozen or cold soil. The surcharge remained on the pump foundations until settlement readings indicated that the foundation casing was no longer settling. New elevations for the pumps were slightly lower than the original elevations before heaving.

Permanent heating coils and insulation were added to the pump barrels to prevent additional freezing. After the casing settlement had ceased and water was removed from the casings, the pumps were re-installed and the piping re-connected. The piping was modified to fit the new pump elevations and to remove the stresses in the piping imposed by the pump heaving.

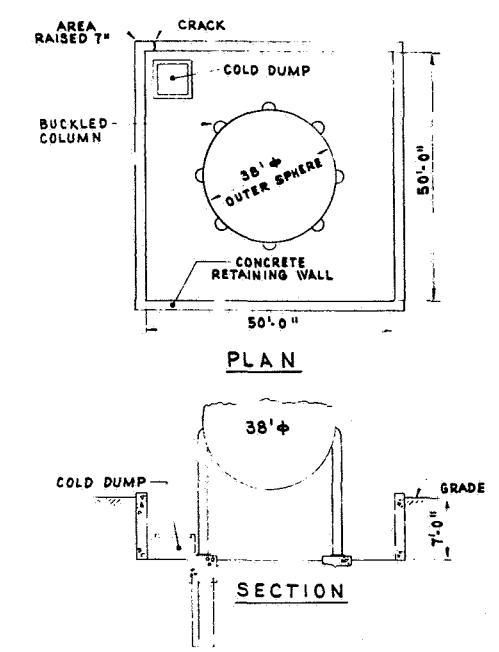
Figure 8. General arrangement of the sphere and pit.

A very unique incidence of frost heave occurred under the foundation of a double-wall aluminum sphere for the storage of liquid oxygen. The inner sphere is 32 ft. in dia. and insulated with 3 ft. of perlite insulation. The sphere is column-supported by eight reinforced concrete piers, each supported by two piles to a depth of about 75 ft. below grade, Figure 8. The sphere and its foundation is located in a hole 50 ft. square and approximately 7 ft. deep. The 50 ft. square hole is surrounded by a concrete retaining wall which holds back the existing grade. A reinforced concrete box, approximately 5 ft. square and protruding out of the ground about 3 ft. is located in the corner of the hole. The concrete box was used for a cold dump for disposal of excess liquid oxygen. After approximately seven years of service, a large buckle developed on the outer sphere due to an abnormal punching load into the sphere from one of the support columns. The column also buckled where it attached to the outer sphere and there was a tear at the connection, Figure 9.

It was obvious from the condition of the concrete box that substantial amounts of liquid oxygen had been dumped over the life of the vessel. The concrete was spalled and broken away in large sections exposing reinforcing bars. It was suspected that the cold dump had caused the ground and the immediate area to freeze and that the frozen ground had heaved and raised the foundation pier under the damaged column. This was verified by completely removing the pier and exposing an ice lens under the pier. The pier had risen approximately 2½ in. due to the ice lens which stopped short of adjacent piers by approximately 2 ft. The depth of freezing was not determined.

The repair consisted of removing the cold dump, re-pouring the concrete foundation pier, modifying and stiffening the damaged areas of the sphere, and adjusting the sphere so that the columns would carry approximately equal loads. The foundation for this sphere was originally constructed to resist frost heaving due to low ambient conditions, but the foundation design did not anticipate the extremely deep frost penetration from the cold dump which was installed adjacent to the sphere. Alternate methods of liquid oxygen disposal are now used, eliminating the use of the cold dump pit.

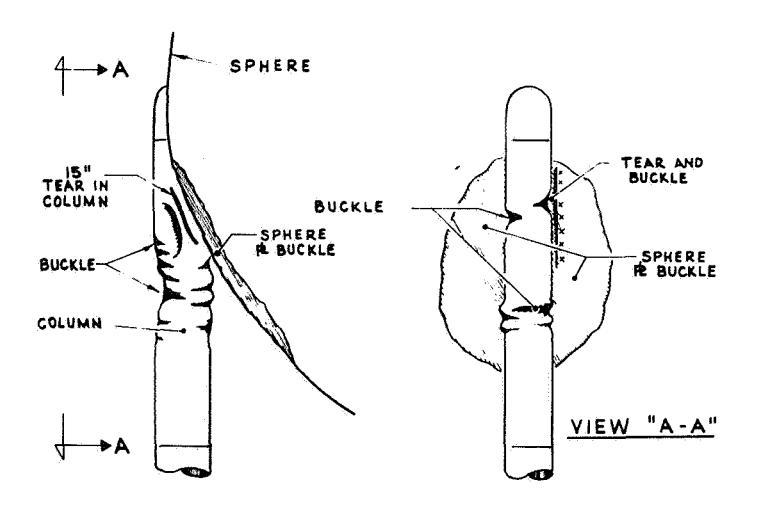
Figure 9. Sphere column sketches showing buckles.

Two ³/₄ in. dia. concrete reinforcing bars connecting each pile with the pier were necked down and completely failed by tension. The upward movement of the foundation pier caused an increase in load in that sphere column which resulted in its buckling. It was also determined that the reinforcing wall around the 50 ft. square hole had risen about 7 in. in the immediate area of the cold dump. In this situation, improper location of the cold dump, rather than the problem of the sphere itself, had contributed to the failure. Failure of the reinforcing bars and damage to the sphere demonstrated the strength of the ice lens. This case adequately demonstrates the fact that tying the pile cap to the piles will not prevent frost heave.
