# Materials and Corrosion Problems in Urea Plants

# P. E. Krystow, Esso Research and Engineering Co., Florham Park, N.J.

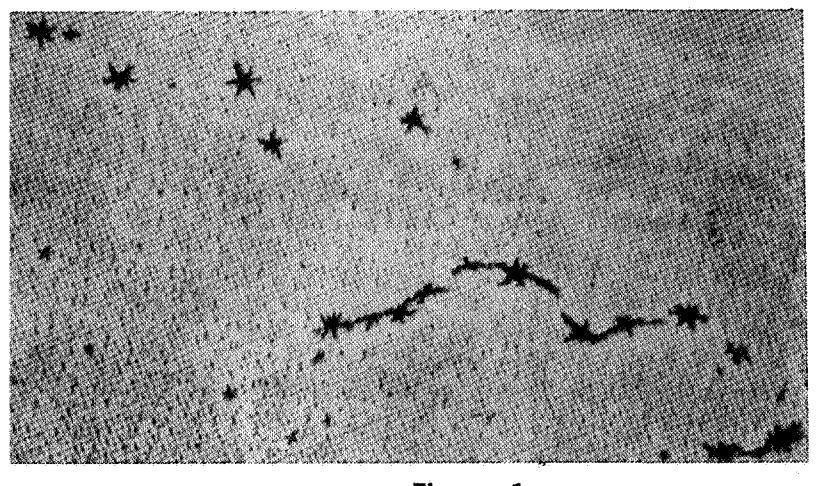
Figure 1. The starlike pits forming on the titanium lining are linked by cracks (mag. 20X).

Esso has experienced failures of titanium liners in reactors at two separate plants. The failures were located in the base plate at positions removed from welds, and were confined to specific plates near the center of the reactor. Visual examinations of samples removed from the titanium liner revealed that all the cracks observed were associated with small irregular pits. These cracks generally linked several pits, Figures 1 and 2. Leakage occurred only at the larger crack(s) and not at the superficial ones.

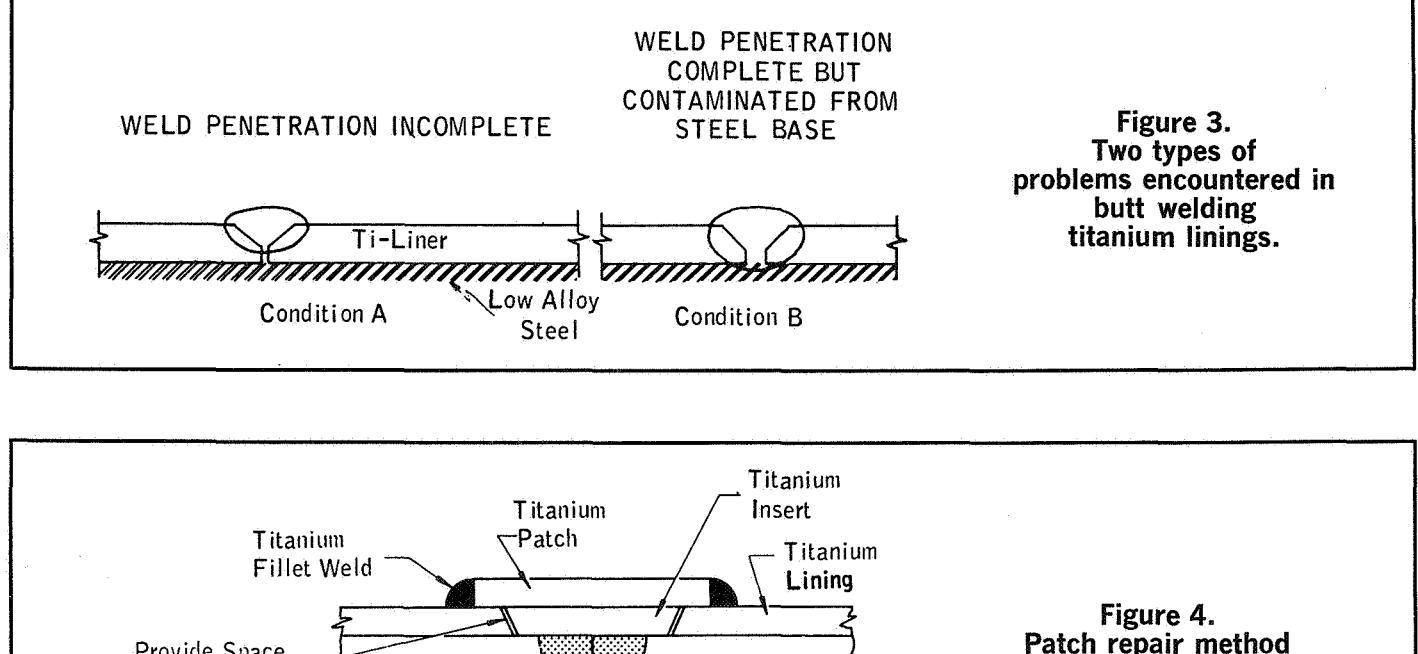
#### Provide Space For Thermal Expansion Carbon Steel Weld Weld Patch repair method for welding titanium linings. Patch repair method for welding titanium linings.

All repair work on existing equipment which is subject to iron contamination is covered with special patches of titanium over the weld. It must be emphasized that the patch technique is used no matter how small the area to be welded, including nicks. Under no circumstance are butt welded or weld overlay repairs made. Detail for patch repair are shown in Figure 4. It should be noted that others (2) sometimes use a silver insert which can be brazed directly to steel and titanium. However, Esso experience has found this to be unnecessary and the use of titanium inserts to be entirely satisfactory.

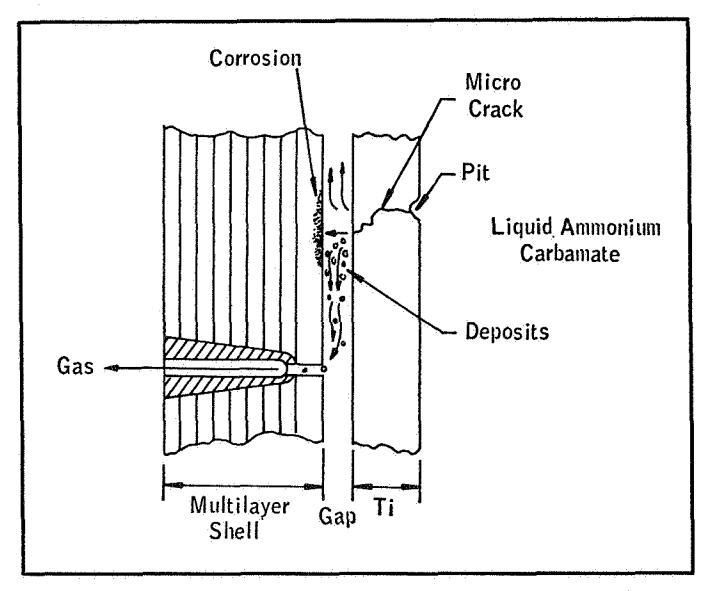
Figure 5. Mechanism leading to buckling of the titanium lining.

A most serious problem resulted due to corrosion of the steel multilayer underneath the titanium which caused it to buckle. Figure 5 shows the mechanism by which the difficulty is believed to occur, and the sequence of events that lead to failure are outlined below:

1. Microcrack through the depth of the lining occurs either at weld or pit. Liquid ammonium carbamate seeps through microcrack.

2. With minute crack the amount of liquid oozing through is small. Once the liquid reaches the gap be-

tween the liner and the multilayer construction, the liquid flashes since the pressure is essentially atmospheric, releasing  $NH_3$ ,  $CO_2$ , and depositing solid carbamate. The gap as illustrated, Figure 2, is highly exaggerated and is actually only a crevice where the titanium lining is resting directly on the multilayer shell because of the high operating pressures (3,300 lb./sq. in. gauge).

3. When the crack is small and the amount of liquid oozing is minimal, continual flashing of the off-gases occur and solids build up behind the liner. The offgases escape through the vent holes and little, if any, liquid is formed at this stage to escape through the weep holes. Such a condition can exist for weeks, even months without being detected.

4. Corrosion of the inner multilayer high strength steel occurs very rapidly since this type of steel is not corrosion resistant. Figures 6 and 7 show the progressive nature of corrosion which occurred at two separate reactors. Figure 5 illustrates the attack which occurred underneath a small pinhole, and Figure 6 shows the attack caused by leakage at a weld. The formation of solid urea and corrosion projects tend to plug the weep holes and permit a pressure build up behind the titanium liner.

5. Eventually the crack opens wider and larger amounts of liquid flow through until finally all the liquid cannot flash away and it finds a way through one of the weep holes. However, in a multicrack situation some of the other weep holes may remain plugged.

6. The leak is now discovered and shutdown of the reactor proceeds. If the reactor is drained too rapidly, a vacuum can be created which can cause collapse of the thin titanium liner (3- to 5 mm. thick). Also, the back pressure caused by plugged weep holes can exert sufficient pressure to buckle the liner if the back pressure equilibriates slower than the depressuring rate of the reactor during the draining period.

To overcome the buckling problem, an early warning device has been developed which will alert operators immediately in the event of a leak. This early warning device is described in detail in a subsequent paragraph. In addition, the following special operating practices are used:

1. Immediately, upon detection of a leak from the detecting device, the unit is shut down to avoid excessive build up of deposits behind the titanium liner.

3. It is most important to clean out deposits between the lining and the multilayer steel sections when a leak occurs. Under these circumstances it is important to hold reactor pressure and to replace the contents with hot boiler feed water or steam condensate using the carbamate pumps until all weep holes are unplugged and free of deposits. If extensive leakage of carbamate has entered underneath the liner, the injection of water may be required for 10 or more hours.

4. The reactor is then carefully depressured, drained and opened for necessary repairs.

5. Similarly, emergency shutdowns caused by power failures are carefully executed to avoid generation of a vacuum within the reactor.

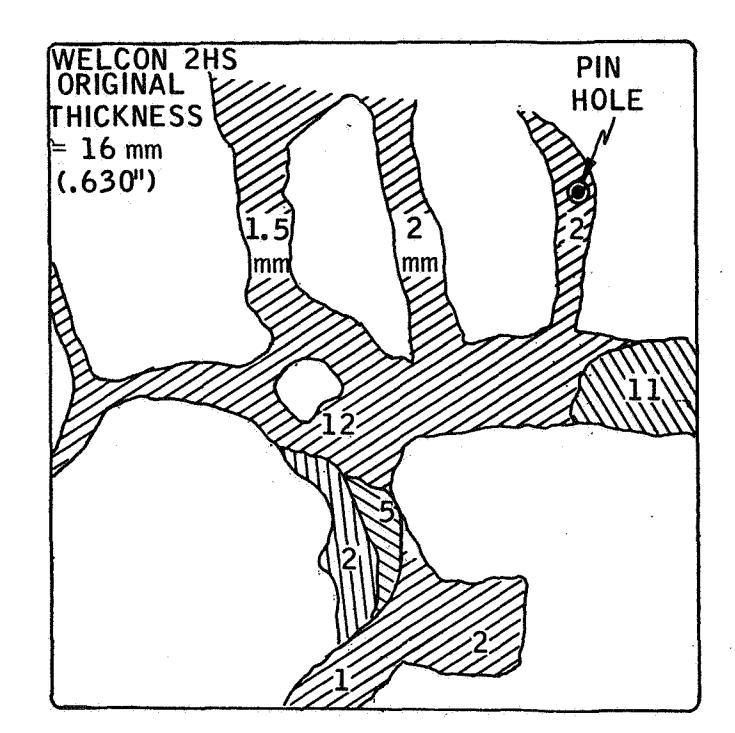
Figure 6. Corrosion attack depth of inner shell from pinhole leak in titanium liner of urea reactor.

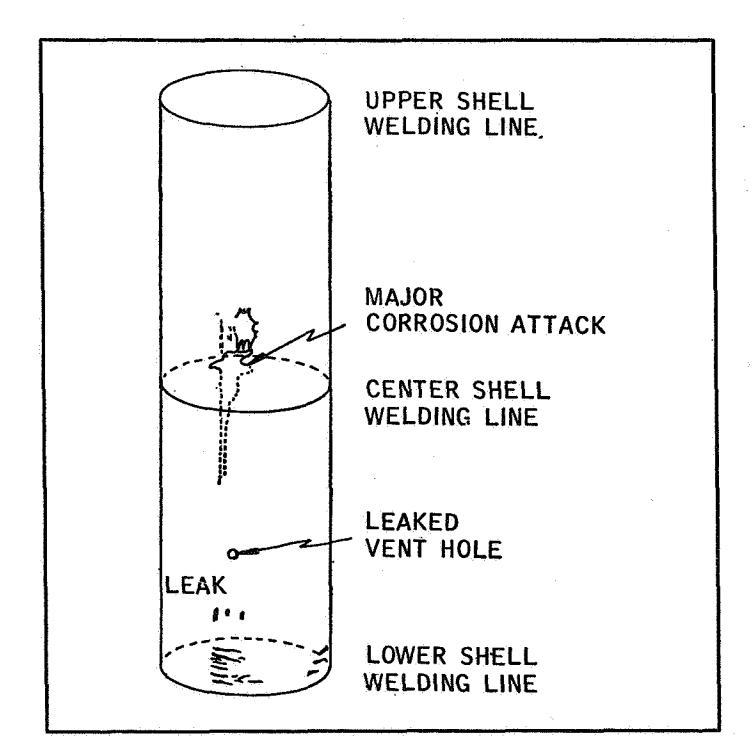
Figure 7. Corrosion attack under shell from failure at center weld or urea reactor as revealed by radiographs.
