A Case Study
Vulnerability and Risk of Fire Works at Sivakasi

R Venugopal
Controller of Explosives, Sivakasi.

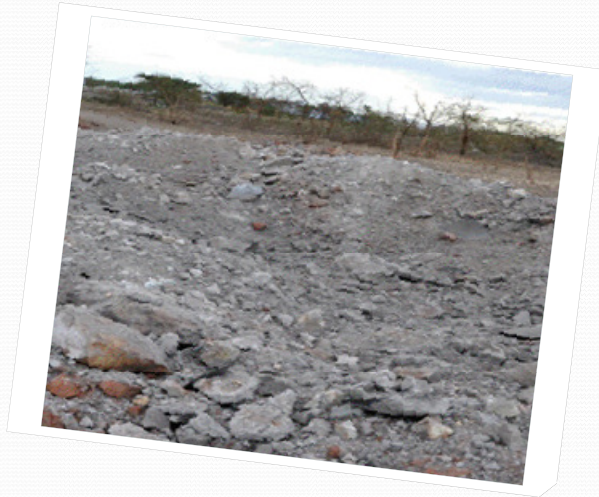
After blast

Deep crater formed at transit shed

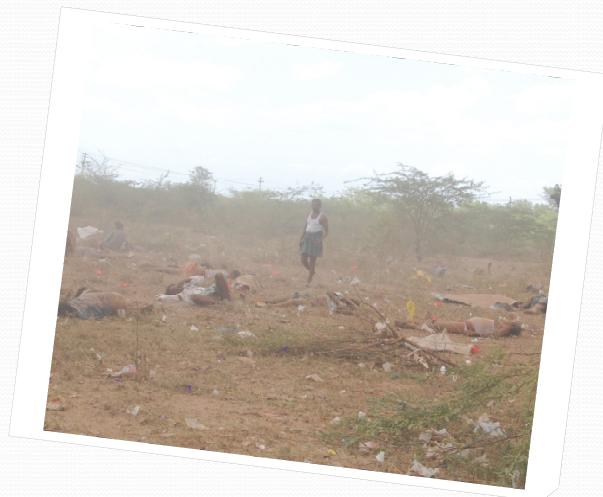
The sad end

Nothing left behind but regrets

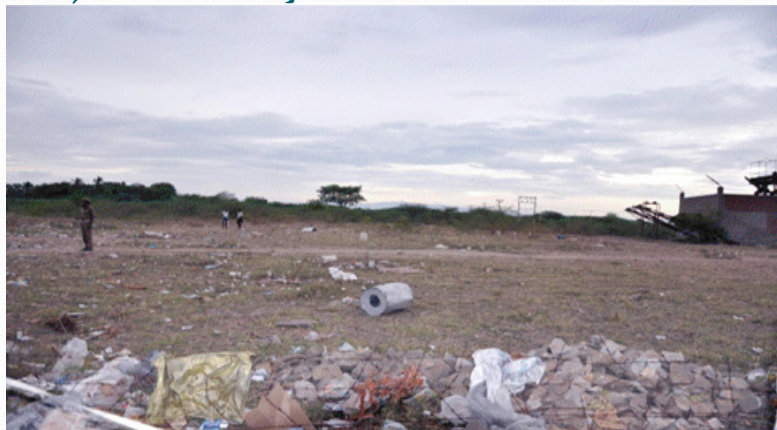
Major casualty found at Western Side

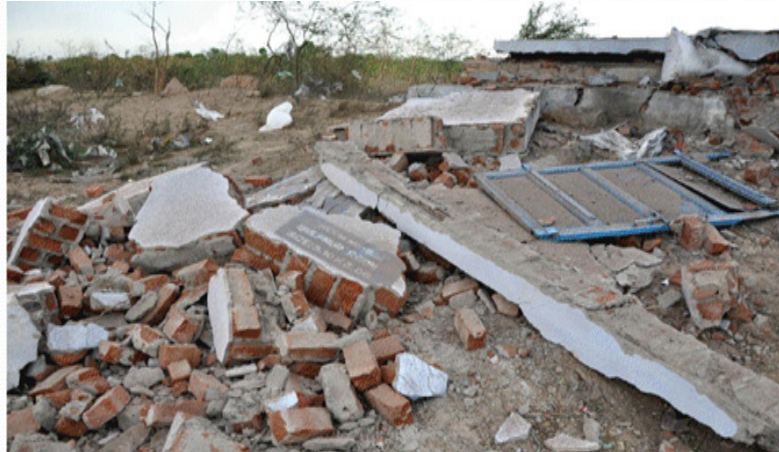
Sulphur room
