R. W. ROTZLER AND J. A. GLASS
Monsanto Chemical Company
W. E. GORDON AND W. R. HESLOP
A. D. Little, Inc.

Oxygen plant reboiler explosion

Laboratory study of plant clues indicate a co-crystal of acetylene and nitrous oxide, which built up over a six month period at the bottom of the reboiler, caused plant mishap.

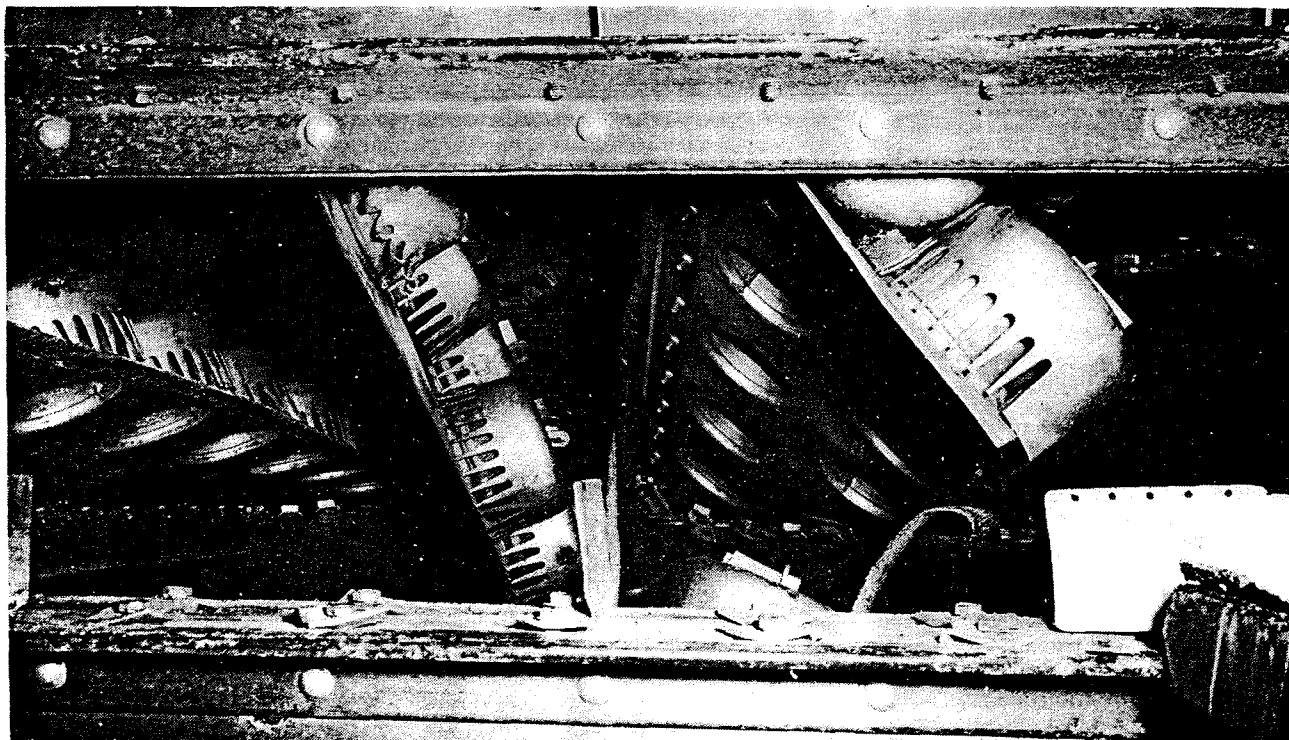
View of displaced trays in low pressure distillation column immediately above reboiler where explosion occurred.

About half the pressed-metal trays in the low pressure column were wholly or partly displaced (see introductory figure). Displacement severity decreased in a regular pattern upward through the column.

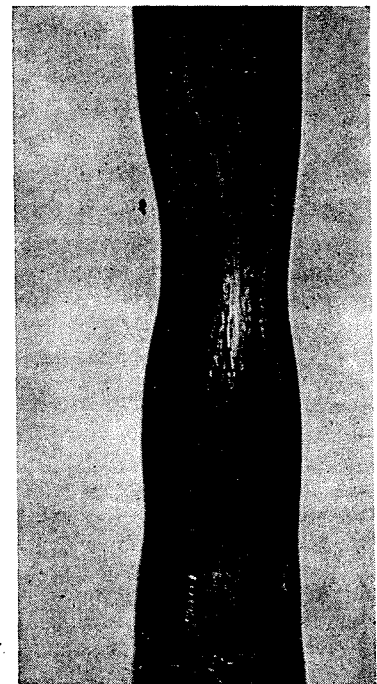
Figure 2. Typical example of tube from reboiler that had been crushed by explosion.

Detailed examination of the equipment after warmup showed the most extensive damage to have been sustained by the reboiler tubes. About 70% of the approximately 25,000 tubes showed some damage; about 31% showed severe damage. All tubes affected showed the same deformation pattern, which varied only in de-

gree; they were crushed by extreme external pressures, highly localized, just above the bottom tube sheet (Figure 2). Damage was generally more pronounced near the periphery of the tube bank (Figure 3).

From the over-all damage picture, it was concluded that the total explosive force was equivalent to that of about 2 lb. of TNT (or 1 lb. of acetylene). The local pressures of several hundred thousand lb./sq. in. necessary to deform the tubes in the way described could only have been produced by the detonation of a condensed (liquid or solid) material. Consideration of the location of the tube damage, the great number of tubes involved, and the relatively small weight of explosive, leads to the conclusion that the material was distributed in a very thin layer that lay quiescently on the bottom tube sheet. Only a very sensitive explosive material would be expected to detonate in this manner. Tray damage is thought to be a secondary effect resulting from sudden vaporization of liquid oxygen.

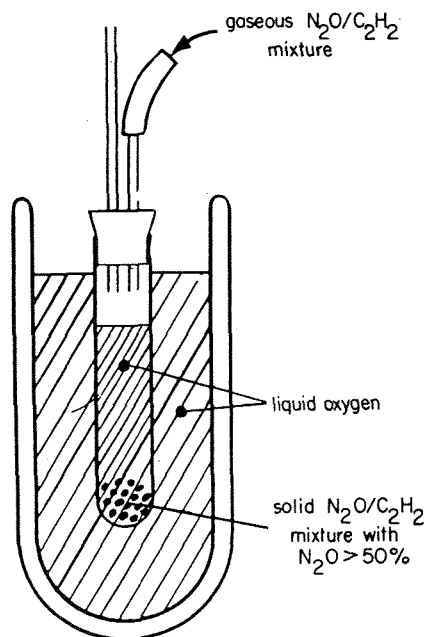
Figure 4. Laboratory apparatus for determining the density of mixtures of acetylene and nitrous oxide in liquid oxygen.

To carry out the tests, gaseous mixtures of various ratios of acetylene and nitrous oxide were made up at room temperature and blown through a glass tube onto the surface of liquid oxygen in a test tube which was surrounded by liquid oxygen in a Dewar (Figure 4). Cautious shaking overcame surface effects, and rather clearly defined limits of sinking or floating were obtained.

In the laboratory, co-crystals of acetylene and nitrous oxide were found to sink in liquid oxygen (at its normal boiling point) if they contain less than 50 mol % acetylene. Co-crystals containing more than 25 mol % acetylene were found to be easily detonated. Thus crystals with between 25% and 50% acetylene both sink and detonate.

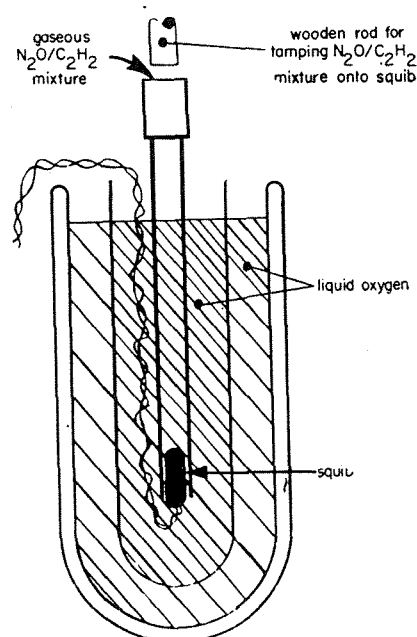
Figure 5. Laboratory apparatus used to experimentally determine the explosibility of mixtures of acetylene and nitrous oxide in liquid oxygen.

The equipment was modified slightly for the explosibility tests. The entrance tube dipped below the surface of the liquid oxygen. A 4-grain pyrotechnic squib was inserted loosely into the lower end of the entrance tube. After the gaseous mixture was introduced, the deposited solids were tamped lightly with a wooden rod (Figure 5). Tamping was necessary to get effective results. The Dewar was removed and the squib fired immediately. Both sets of experiments were safely carried out in a steel safety chamber with observation ports.

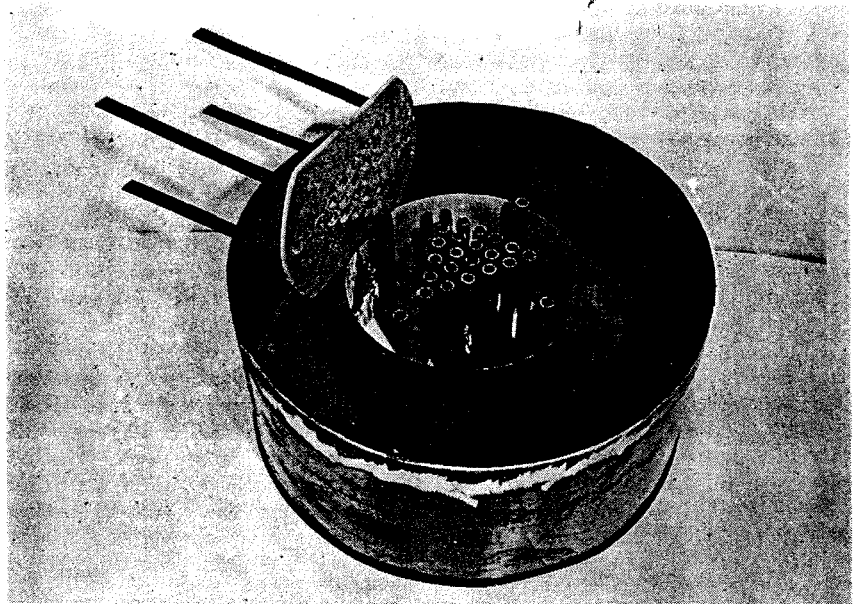
Figure 6. Reboiler mock-up used to simulate actual conditions in explosion tests.

To more closely approach plant conditions, a further test was made with a reboiler mock-up. Twenty one tubes similar to those used in the plant were set in holes in a brass plate (same spacing as in the plant) and held there with plaster of Paris. This assembly was placed in a 12-in. diam. can, which in turn was set in a 24-in. diam. can in a hole in the ground. The outer can was filled with liquid nitrogen. A layer of 60 mol-% nitrous oxide and 40 mol-% acetylene, about 1 mm. thick, was condensed on

the "tube sheet" in the small can and tamped lightly. Several inches of liquid oxygen were added to the inner can, and the mixture was fired with a No. 6 detonator cap. Results were surprisingly violent and gave a damage pattern similar to that in the plant explosion (Figures 6 and 7).
