J. H. CONKLIN
DuPont Co.

Nitrogen wash incident

Process safety modifications include replacement of carbon steel pipe subjected to low temperatures, better instrumentation and control systems.

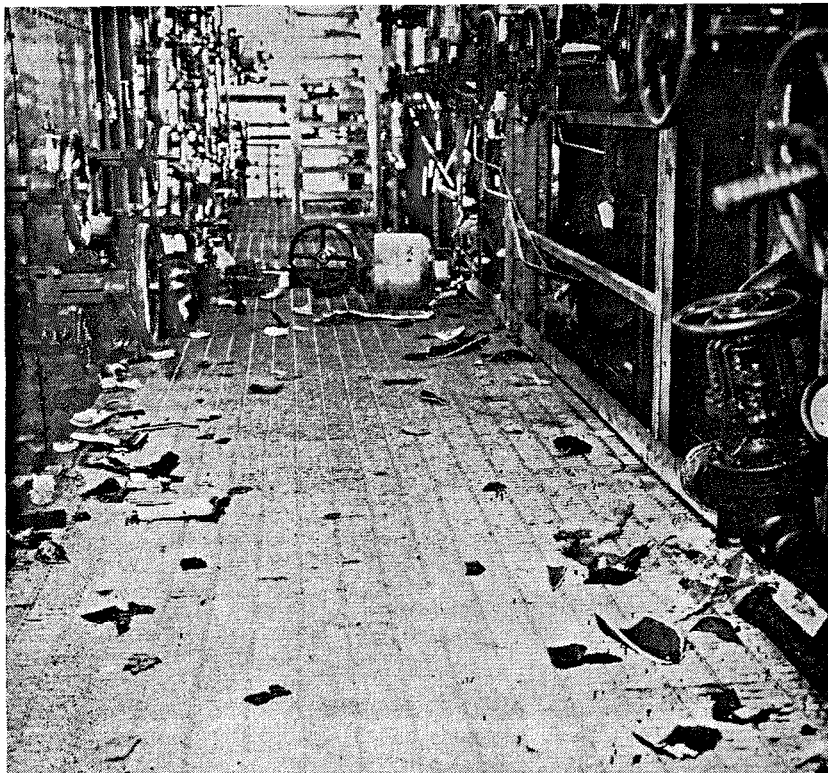
ON THE AFTERNOON OF MARCH 12, 1960, approximately 70 ft. of a schedule 40 carbon steel line containing H_2 at a pressure of 325 lb. was suddenly subjected to liquid N_2 temperatures causing the line to rupture with explosive violence. Despite the fact that fragments were thrown in all directions with sufficient force to embed themselves into the lagging of adjacent equipment, no one was injured and little damage was done to nearby lines or equipment.

Upper level operating platform after the line rupture at DuPont's nitrogen wash unit.

An instant before the line ruptured, a sudden pressure rise was noted in the carbon steel line. This pressure rise was caused by liquid N_2 vaporizing rapidly in the relatively warm piping. Thus, the carbon steel was simultaneously subjected to a rapidly increasing pressure and a very heavy thermal shock. It is not at all surprising that the rupture was a violent one.

All of the carbon steel piping that could be subjected to low temperatures, that is, the purified H_2 , the recycle N_2 , and the waste gas lines leaving the boxes were replaced with type 304 stainless steel piping. The carbon steel lines leading to the compressors joined the stainless steel lines 6 ft. downstream of a stainless steel automatic block valve. A stainless steel back-pressure control valve was installed some distance upstream of each block valve to maintain the desired pressure on the system and vent the excess gas to a stainless steel stack. Each of the stainless steel automatic block valves was tied to the signal of the proper thermocouple in the warm ends of the final exchangers in the boxes.

The instrumentation was so arranged that at -10°C a panel alarm would sound to indicate not only that a low temperature was imminent at the exit of a heat exchanger, but also in which exchanger the trouble existed. If the temperature continued to fall, a low temperature trip set at -20°C would automatically close the proper block valve to prevent cold gases from passing from the exterior stainless steel piping into the carbon steel piping leading to the compressors. Of course, when this automatic block valve closed, the stainless steel back-pressure control valve would then vent the cold gases up the proper stainless steel stack to the atmosphere. A so called "panic" button also was installed in the control room so that

The liquid level impulse lines on the scrub column and the liquid N_2 phase separator, as well as the column pressure tap, were back bubbled with purge N_2 . As an additional means of detecting column flooding, a properly back-bubbled recording differential pressure instrument was installed across the wash column.
