HYDROGEN COMPRESSOR CYLINDER EXPLOSION

Norton H. Walton
SunOlin Chemical Co.
Claymont, Del.

On December 18, 1961, at approximately 3 o'clock in the afternoon, an explosion, closely followed by a second, occurred in the Compressor House of the Hydrogen-Urea Plant of the SunOlin Chemical Co. in Claymont, Delaware.

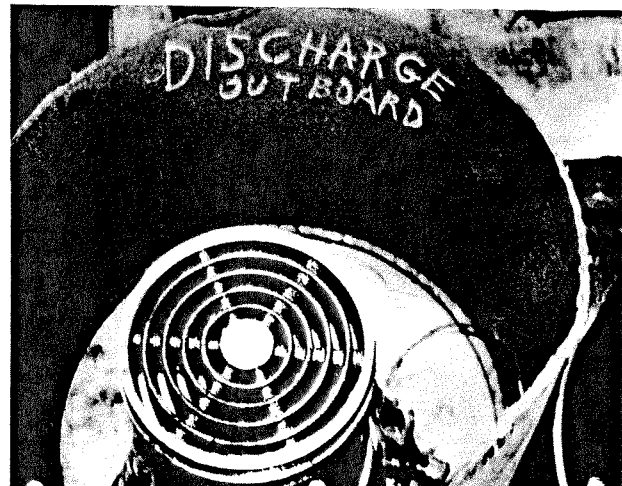
The cylinder from this compressor was then completely dismantled and the two suction and two discharge valves removed. These valves are standard compressor plate type valves consisting of a seat and guard with the valve plate and its spiral springs plus the large bolt and nut which fastens the valve plate assembly to the cage. The valve plate assembly is bolted to the cage with the guard against the cage when it is desired to assemble as a discharge valve, Figure 3; but if it is desired to assemble as a suction valve, this

Figure 3. Discharge outboard valve.

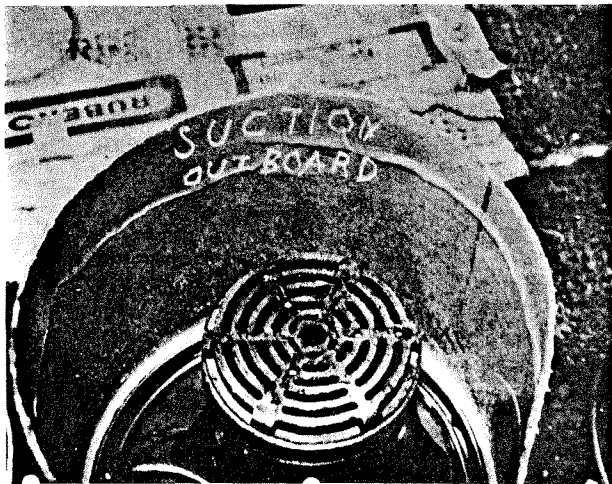
same valve assembly is turned upside down and the valve seat is against the cage, Figure 4. This has an advantage in reducing spare parts inventory, but does have other connotations as we will see.

Figure 4. Suction outboard valve.

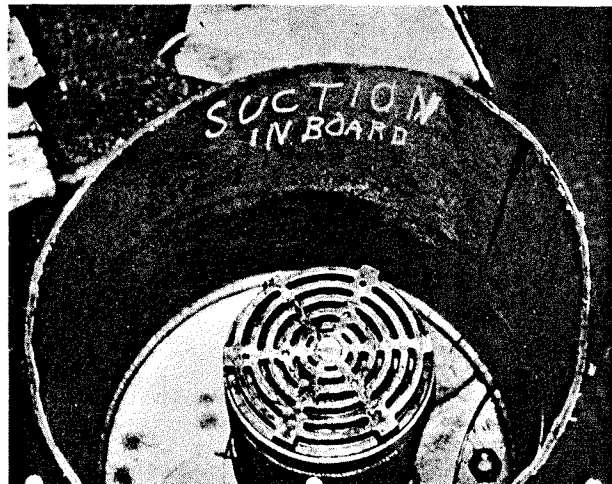
Figure 5. Suction inboard valve.
