FABRICATION PROBLEMS AND FAILURES IN VESSELS AND PIPING IN AMMONIA AND RELATED PLANTS

Severe service placed on materials in these plants increases possibilities for failure but proper quality control and planning can help reduce the frequency.

Helmut Thielsch
Grinnell Corp.
Providence, R.I.

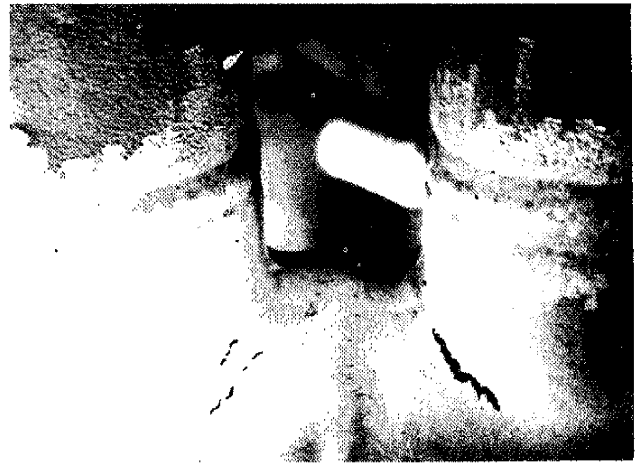
Figure 1 illustrates cracking in the crotch area of a series of cast tees installed in a methanol furnace. A closeup is shown in Figure 2. The castings are made of HK-30 alloy (25 Cr - 20 Ni stainless steel with about 0.35% C). At the ends, the outside diameter is 6¼ in. and the wall thickness is 0.63 in. In the crotch where the cracking is apparent, the wall thickness is 0.56 in.

Figure 2. Closeup of typical cracks revealed by liquid penetrant examination.

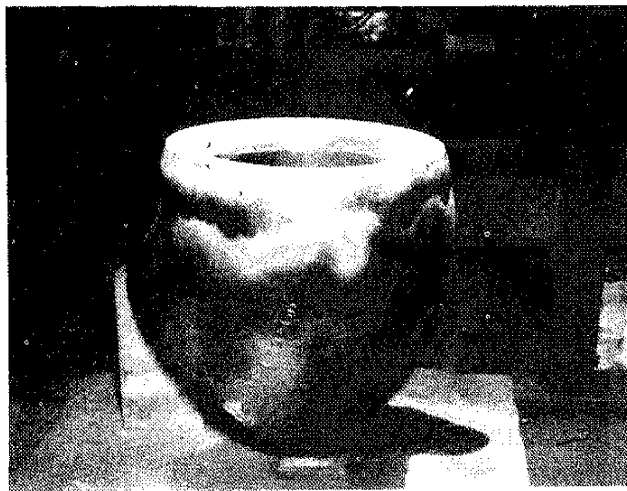
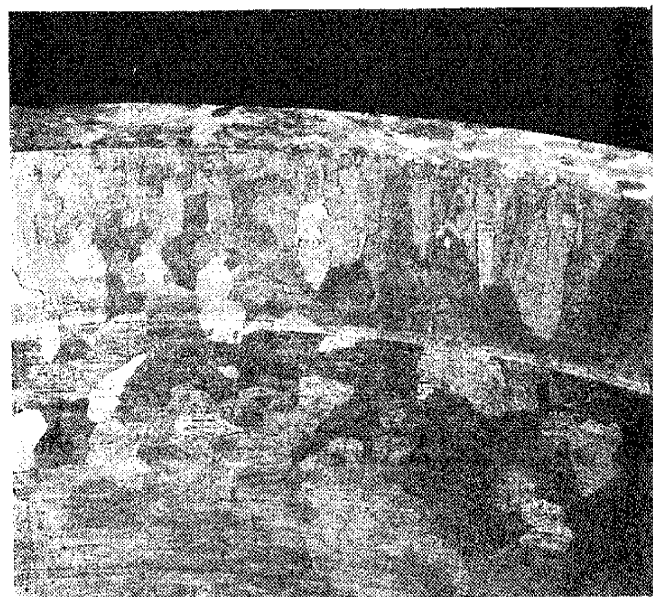
of severe hot shortness in a 15-in. O.D. by 2-in. wall cast elbow is shown in Figure 9. The severe intergranular fissuring occurred in the "as-cast" condition.

Although the tendency towards this fissuring tends to increase when the silicon content is increased from 1% to 1½%, many other factors are also involved. Thus, some HK-30 castings with silicon contents as low as 0.75% have exhibited severe hot fissuring in the as-cast condition; other HK-30 castings with 1.5% sili-

Figure 9. Photograph of 15 in. OD HK-30 stainless steel elbow (half-section) with severe hot fissuring apparent after penetrant

inspection and deep etching, which also revealed large grain size.

Where a casting does exhibit severe fissuring due to hot shortness, very little is gained by a weld repair in the foundry. Such castings should be considered extremely hot short and rejectable.

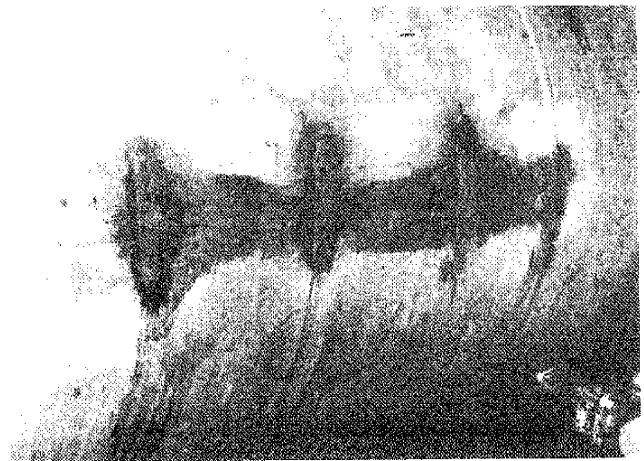
Figure 17 shows an ammonia tank, 42 in. in dia. by 3/8-in. wall, where an initial crack occurred across the seam weld after approximately 1 1/2 years of service. The crack was repaired but within a few months, a second crack was apparent on the surface. This was repaired, but was followed by a third, and later on, a fourth crack. Radiographs of the weld seam revealed two additional transverse cracks in the development stage, but not yet apparent since they had not reached the outside surface of the vessel, Figure 18.

Figure 17. Side of 42-in. dia. carbon steel ammonia tank with welds 10 1/2-in. apart representing cracks which had propagated across 3/8-in. vessel wall after 1 1/2 to 2 yr. of service.

The seam weld had been made by automatic submerged-arc welding. It was not stress relieved, as this was not a requirement of the applicable codes. Nevertheless, cracking would not have occurred if the weld had been stress relieved.

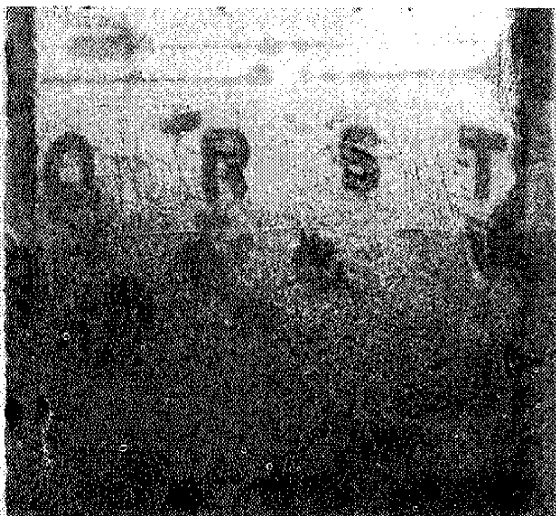
The shorting-arc type gas-shielded metal-arc welding processes may produce weld deposits with substantial lack of fusion between weld deposits, Figure 20. Such defects are not likely in weld deposits made by the shielded metal-arc welding and by the submerged-arc welding processes. A number of service failures in ammonia plant equipment has been due to the presence of severe lack of fusion in weld joints made by the shorting-arc welding processes.

Figure 20. Lack of fusion between weld deposits made with the short arc welding process. Fractured A.S.M.E. code bend test specimens confirm severe lack of fusion.

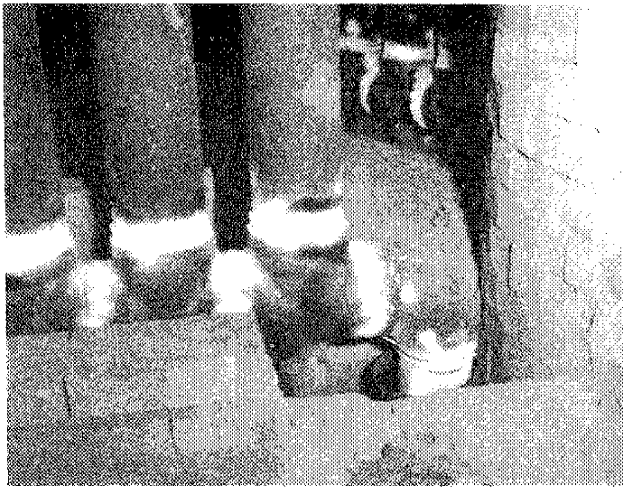
Severe movement of furnace elements as a result of design deficiencies or operational conditions can cause high stress levels in nozzles and other branch connections. An example of cracking in a ring header system related to bending moments caused by header rotation is shown in Figures 24 and 25.

Figure 24. Cracking inside reformer furnace in elbow to vertical pipe weld caused by rotation of ring header below furnace wall.

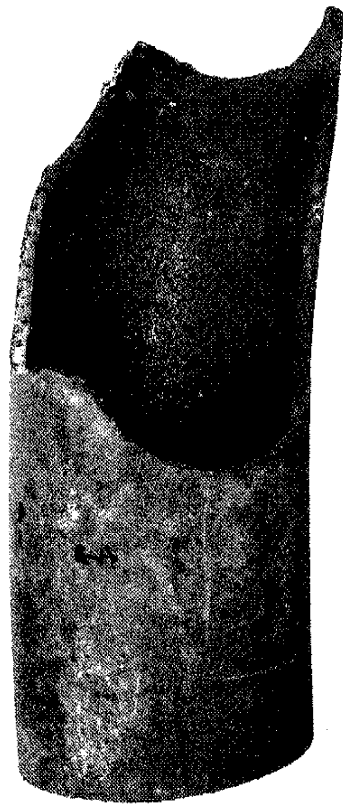
An increase in the service temperatures of the hot ammonia synthesis gas to 600°F. led to hydrogen embrittlement, blistering, and rupture in 8-in. Sched. 80 carbon steel pipe, Figure 23. At these temperatures, chromium-molybdenum steel piping only are considered adequate.

Figure 28. Rupture, blistering, and hydrogen embrittlement in 8-in. Schedule 80 carbon steel pipe.
