*Vol. 11 Safety in air and ammonia plants
1968.*

Preventing Ammonia Plant Fires

Operating tips show how to prevent and contain the possibility of flange fires and protect equipment and personnel from such incidents.

R. A. Watkins, Beaumont Works, E. I. DuPont de Nemours & Co., Beaumont, Tex.

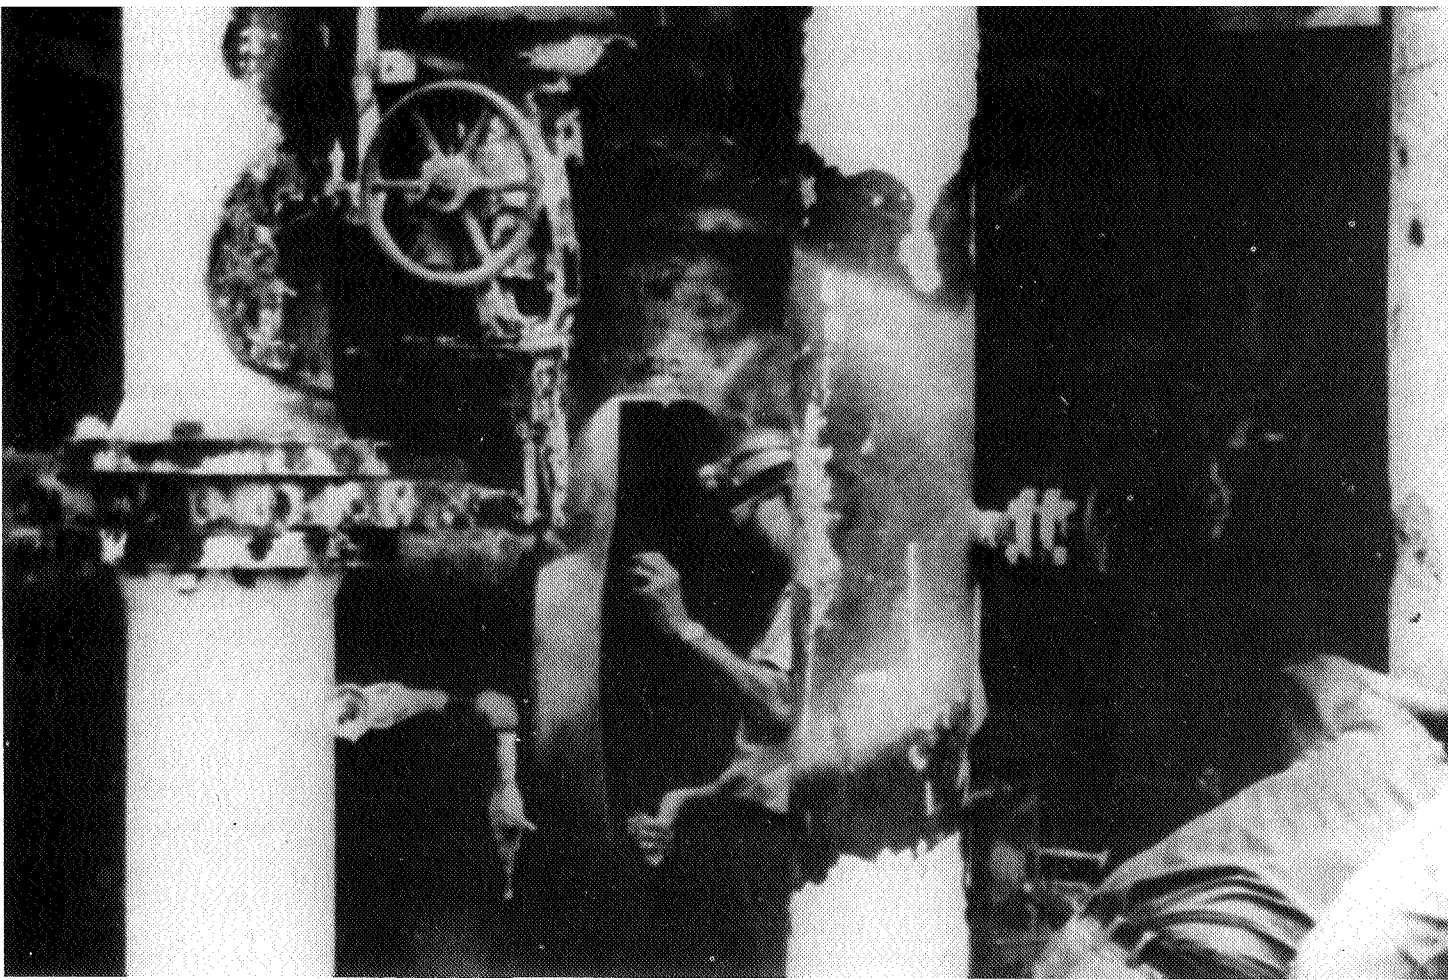
Figure 1. Damage to adjacent equipment caused by butterfly valve flange fire.

The two incidents involved butterfly valves in process lines under 400 psig pressure. In one case, the line was in cold service with asbestos sheet gaskets; in the other case, the line was in hot service with spiral wound, asbestos filled, metal gaskets. Both leaks were initially small but flame impingement caused the bolts to relax, allowing more gas to escape, increasing the size of the fire. Investigation revealed that the flange bolts were elongated, the asbestos gasket blew out of the flange, the spiral wound metal gasket asbestos filler blew out and the centering ring was deformed.

Figure 1 is a photograph taken after the first butterfly valve fire. It shows the effects of the fire on adjacent equipment which included a heat exchanger, steam lines and the adjacent compressor platform. The head has been removed from the heat exchanger for repairs as it was slightly deformed. The heat exchanger shell flange is being examined by a mechanic. The butterfly valve installation is typical. Note how the bolts extend across both flange faces and are exposed to any flange fires. The effect of the flame impinging on the adjacent pipe and on the concrete column can also be seen.

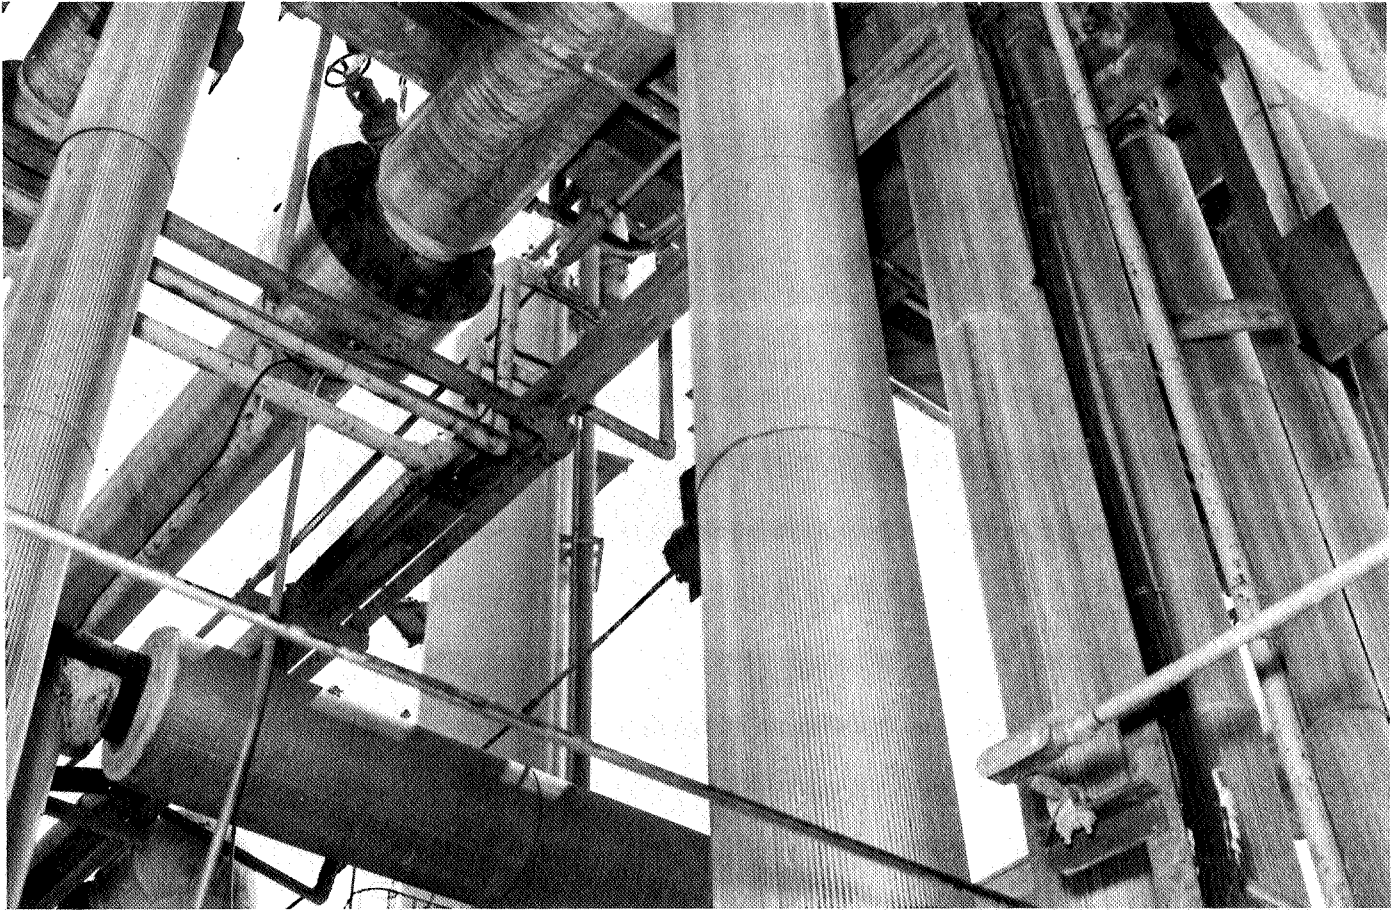
Figure 4. Location of pipeline flange with respect to adjacent piping and instrument tubing.

Figure 4 shows a horizontal pipeline flange opening directly into the pathway of conduit and cable tray carrying all thermocouple and instrument air control lines from the central control room to the ammonia converters. Protection of the flange with a guard will assist in directing any leaking gases away from the cable tray and should the gases fire, the flange guard will reduce the hazard to plant instrument control at this point.
