Anticipating Reformer Tube Life in Normal Service

Overheating, if severe enough, can override all other tube performance factors. Successful control depends on conscientious adjustment of burners for uniform tube metal temperature throughout the furnace.

W.J. Salot
Allied Chemical Corp.,
Hopewell, Va.

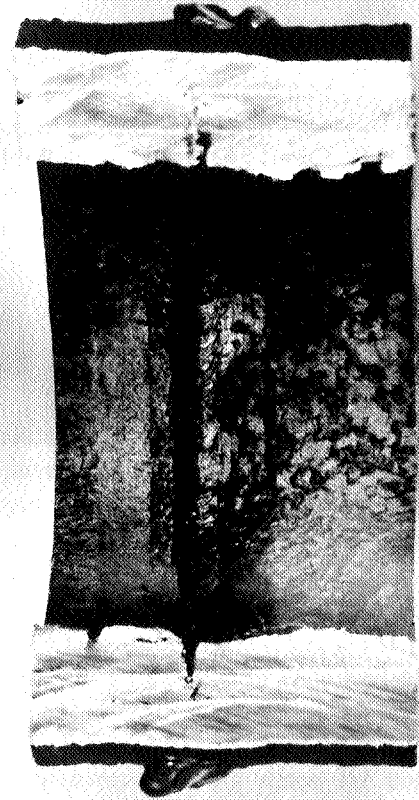
Figure 2. Circumferential Rupture Through Weld

Figure 2 shows the other rare mode of failure. Radiographic and borescope inspections during the past 2 yr. indicate that weld cracking is common near the flame in top-fired reformer tubes operating above 450 lb./sq. in. gauge. Table 3 shows these results:

It is remarkable that so many known cracks have existed so long without leakage. This very fact suggests that they tend to be self-relieving, as would be expected if they are caused by thermal stresses induced by temperature gradients through the wall thickness.

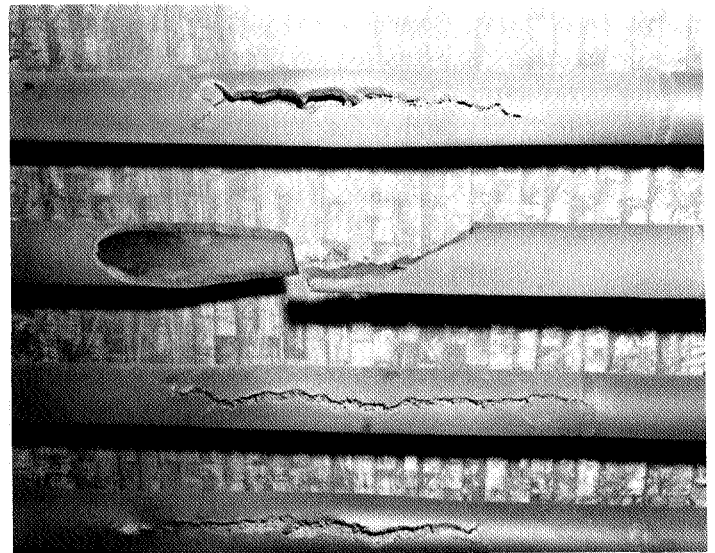
Figure 6. Reformer Tubes Shortly after a Series of Flame-outs

Like temperature histories, thermal cycle histories are also limited by proprietary restrictions and incomplete records. The sparse data did show a fair correlation with shutdown frequency, and an even better correlation with

frequency of feed gas trip-outs at operating temperature, sometimes called "crashdowns", but it was not sufficient to show more than a faint thickness effect.

4. There was evidence that thermal cycling from various causes is extremely detrimental, Figure 6.
