ATR REPORT-2021

**INDIAN FARMERS FERTILISERS CO OPERATIVE LTD.
PARADEEP UNIT**

ATR REPORT: 2021

DAP PLANT

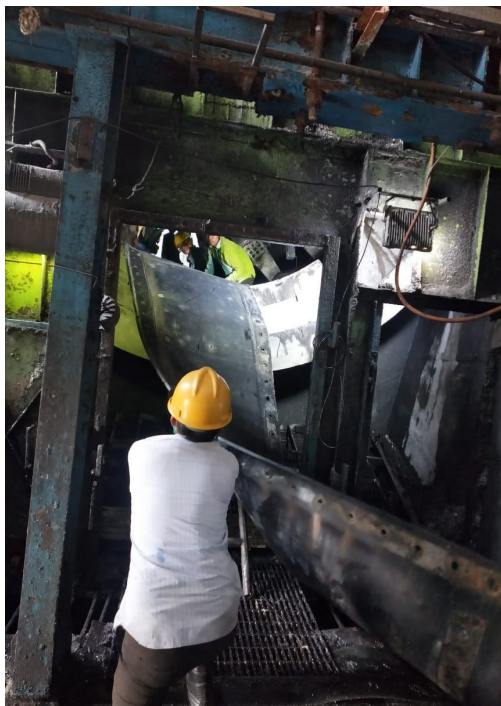
EPDM Panel replacement

- **GRANULATOR RUBBER PANNEL REPLACEMENT:** Granulator 14 nos EPDM rubber panels replaced.

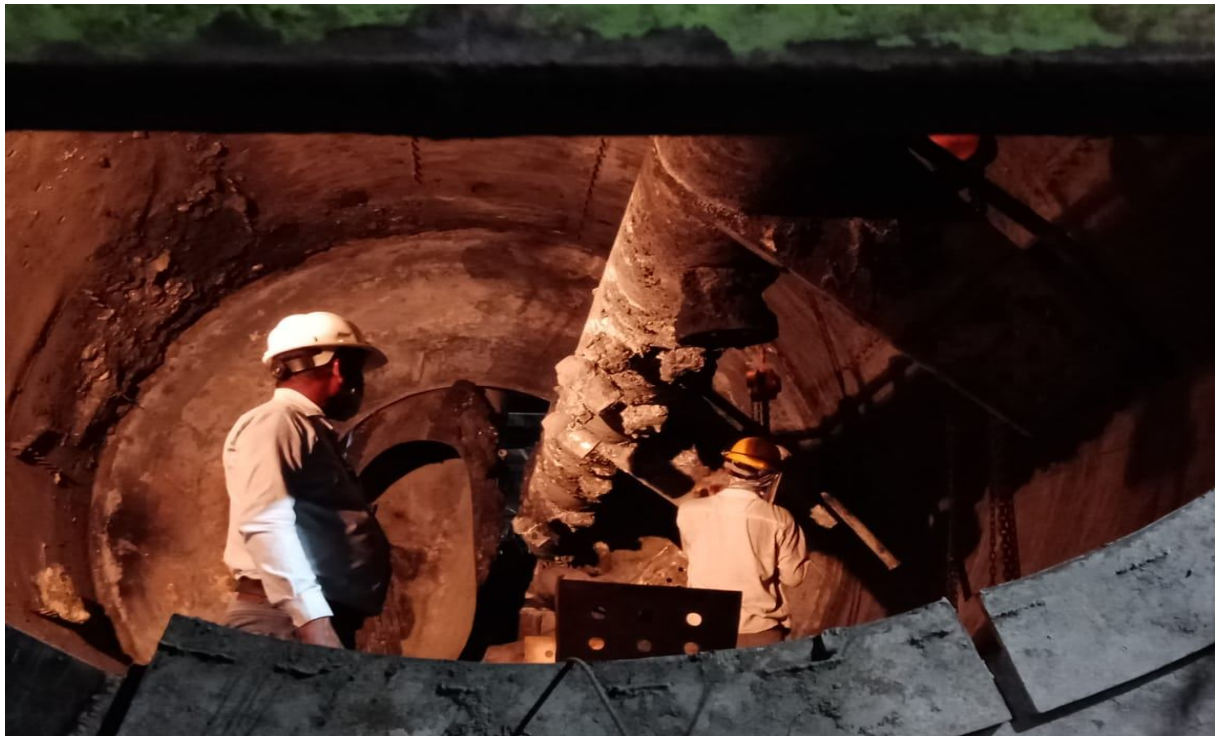
Ammonia sparger replacement

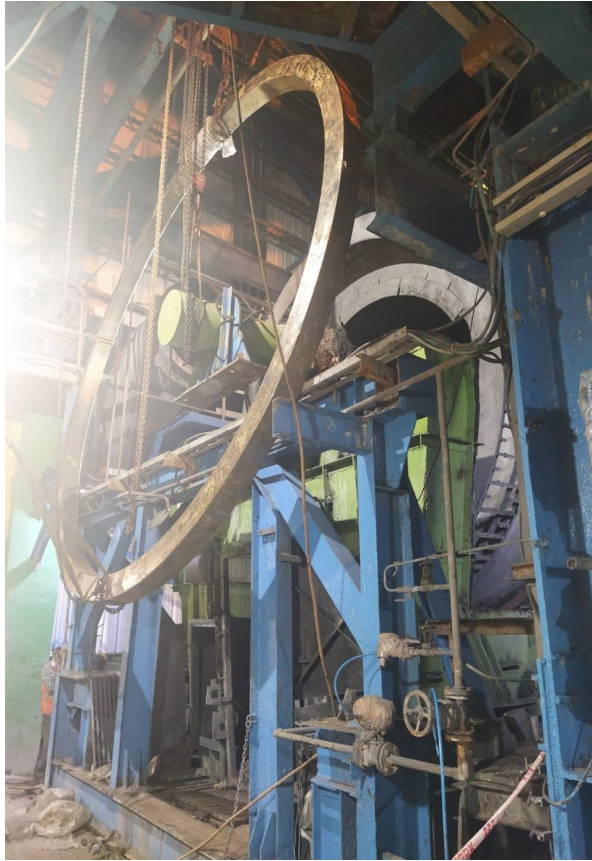
Discharge end tyre fitting

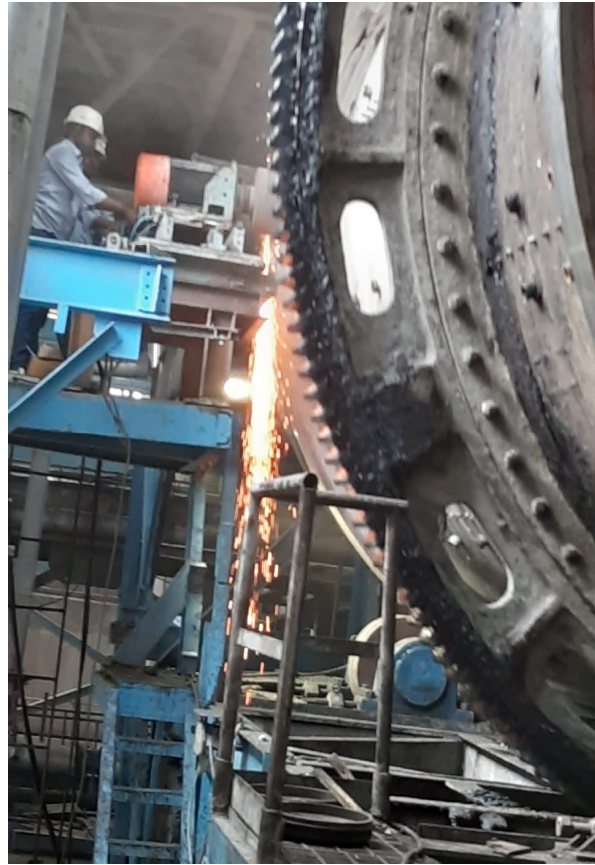
Feed end tyre grinding

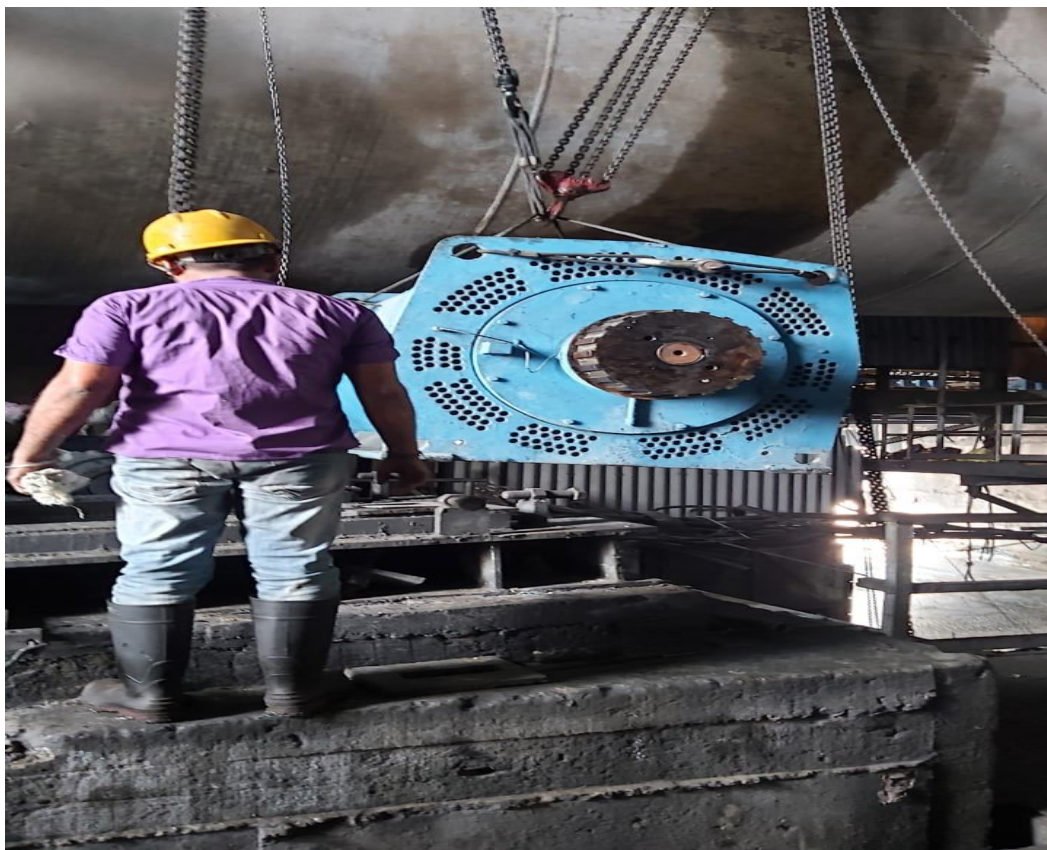
Dryer motor shifting

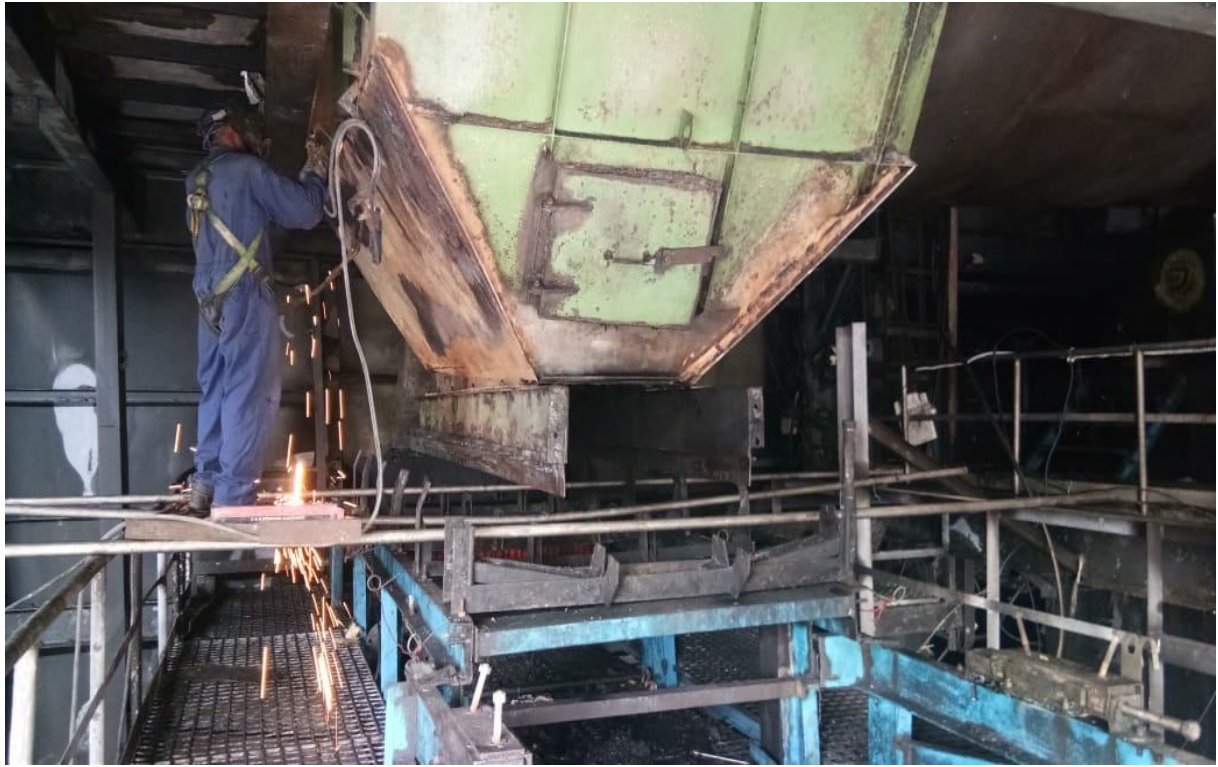
Dryer discharge hopper welding & new plate erection

Dryer discharge hopper aligned with conveyor axis.

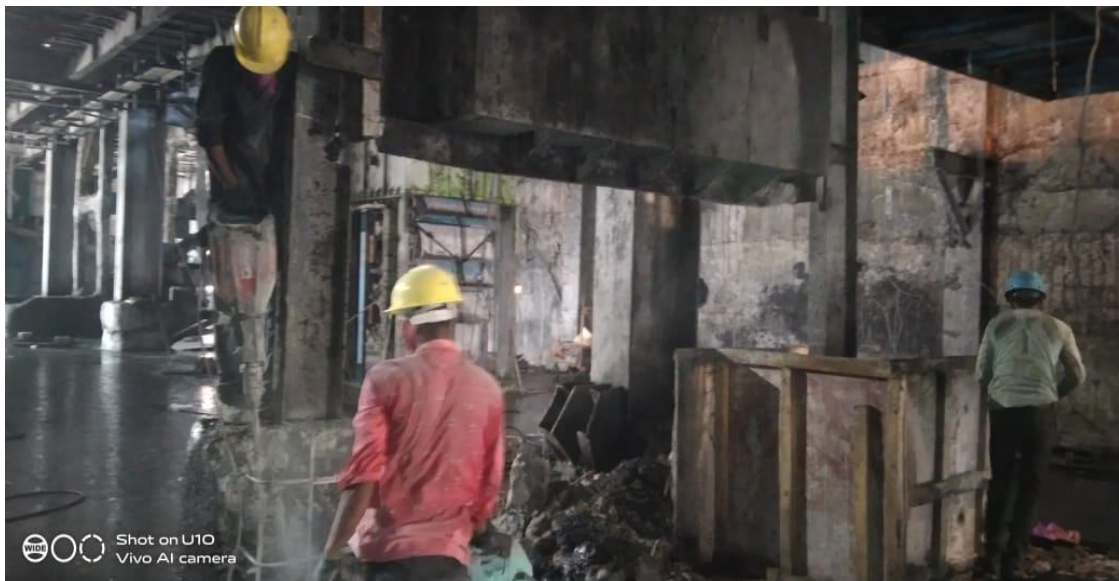
**Take up column grouting
New stand**

- **FINES CONVEYOR:** In fines conveyor skirt rubber fixed. Head, bend and tail pulley damaged rubber lagging replaced by new lagging. All bearings clearance checked and lubricated .all damaged idlers replaced. Take up bend column replaced.

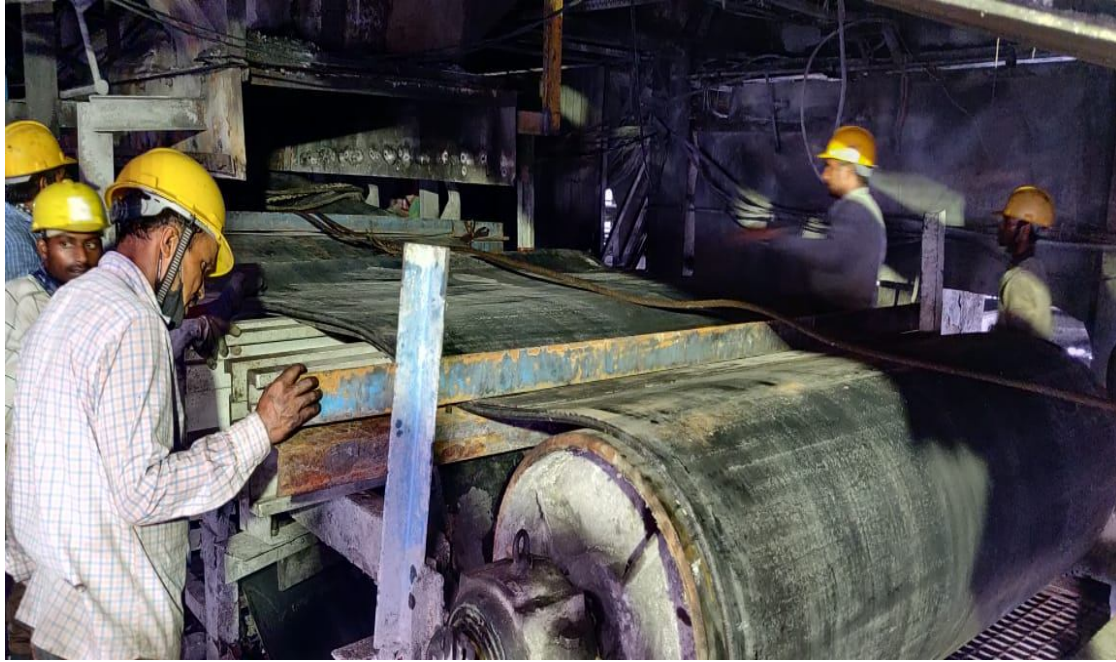
Fines conveyor splicing arrangement

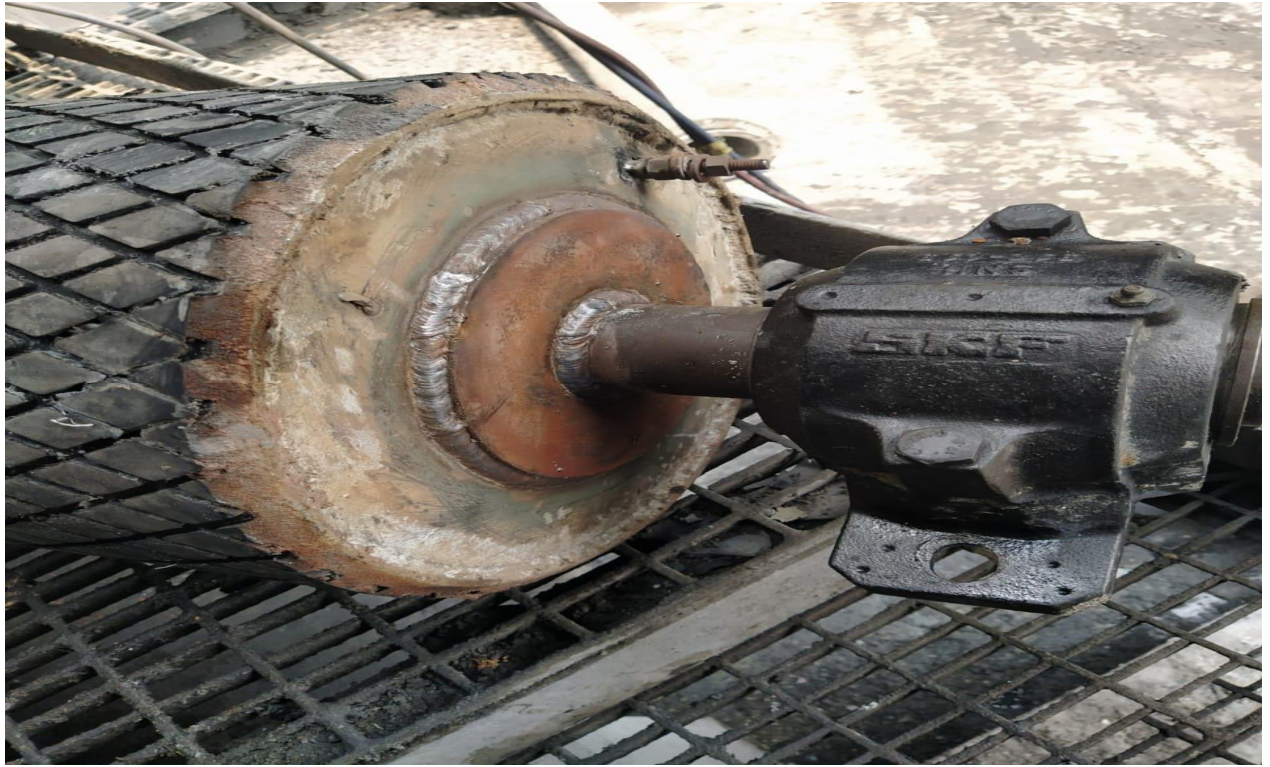
Tail pulley pad plate welding

DDC, RM AND PRODUCT STORAGE CONVEYOR: In all conveyors skirt rubber replaced by skirt rubber and all damaged pulley lagging replaced by new lagging. All bearings and gearboxes inspected and lubricated. In DDC conveyor all idlers replaced by HPPE idlers. DDC tail pulley pad plate welding done for strengthening. DC side inclined platform leveled.

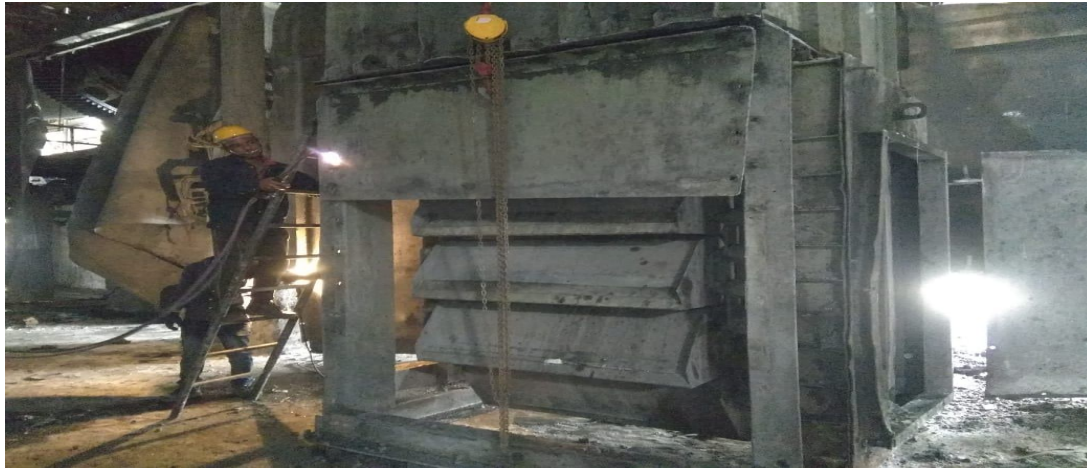
Primary elevator chain bucket inspection

- **Primary elevator:** Drive sprocket, gearboxes and head shaft bearings inspected and lubricated. And chain & bucket inspected by manually turning the elevator. CI blocks changed. Primary elevator tail sprocket replaced due to shaft & teeth wornout.

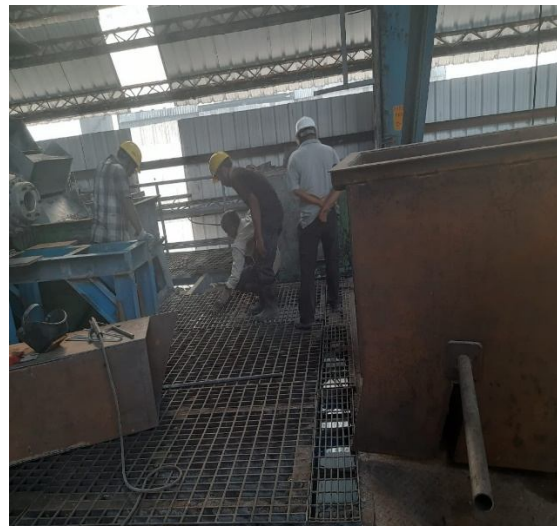
Discharge diverter fabrication

Product elevator: Drive sprocket, gearboxes and head shaft bearings inspected and lubricated. And chain & bucket inspected by manually turning the elevator. CI blocks changed. New fluid coupling replaced. Tail sprocket shaft build up by welding & grinding in position. Gear box base frame replaced. Product elevator discharge diverter provided for additional chute to polishing screen.

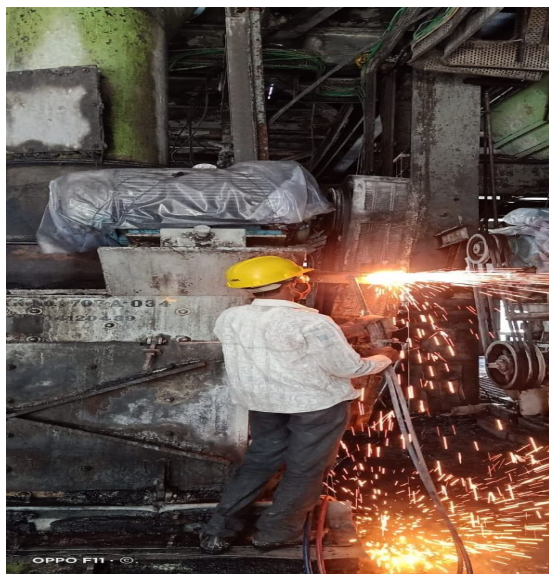
Old casing removal

CHAINMILL: All chain mill site fabricated casing with rotor with new bearing & blocks replaced. Hopper of chainmill 11 and 13 replaced and 11 no chain mill discharge hopper lined with UHDPE liner.

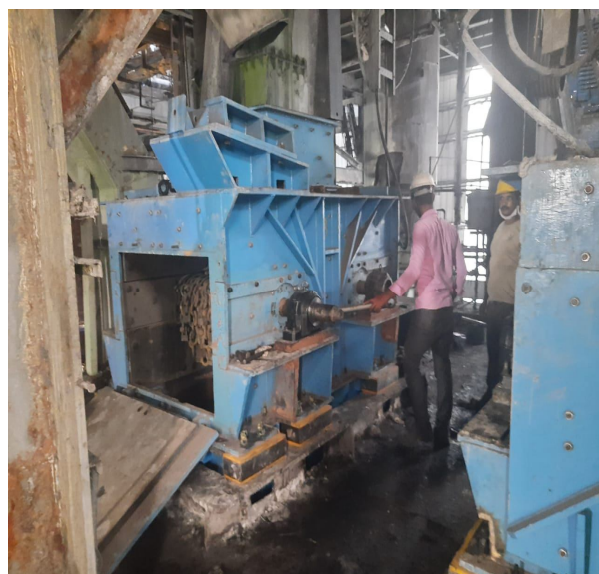
New casing erection

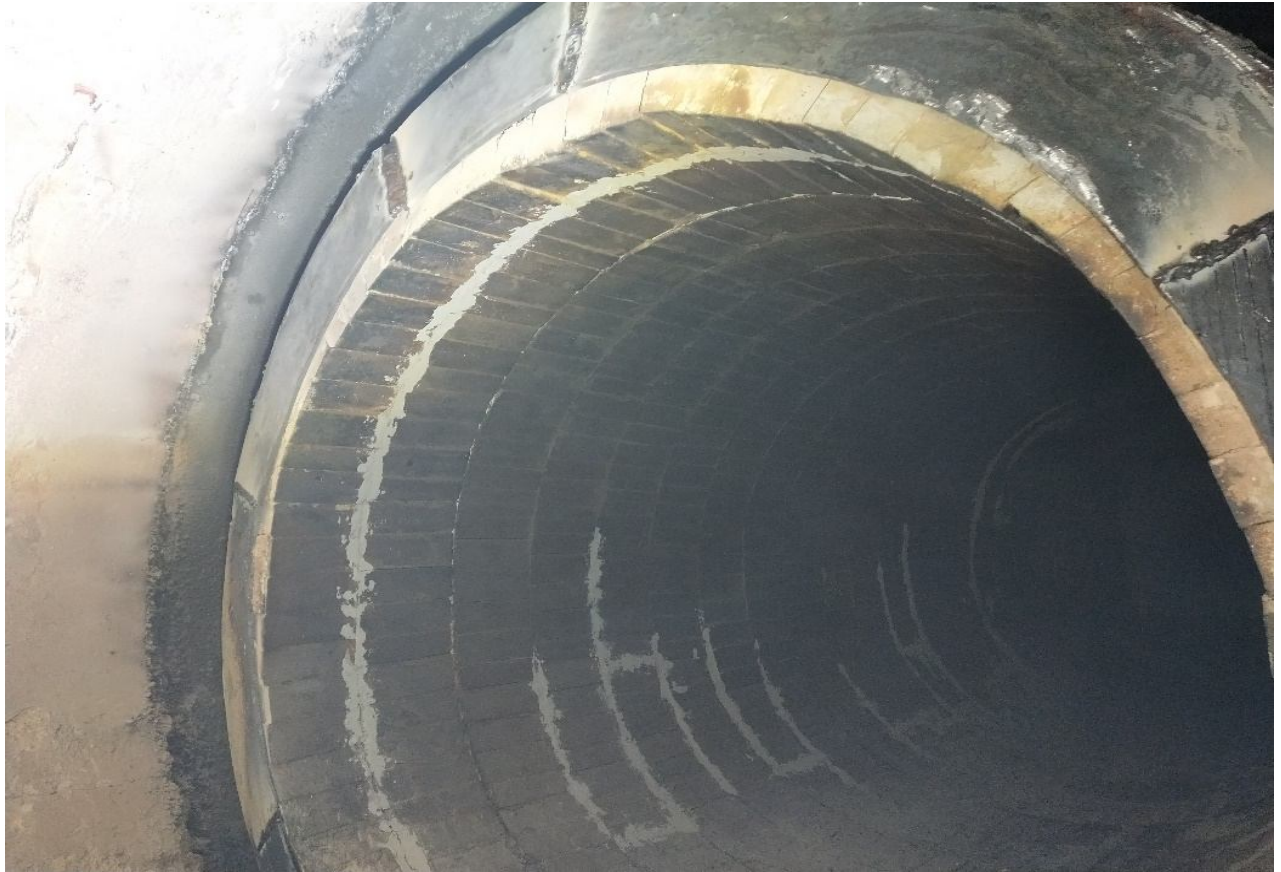
After refractory brick application

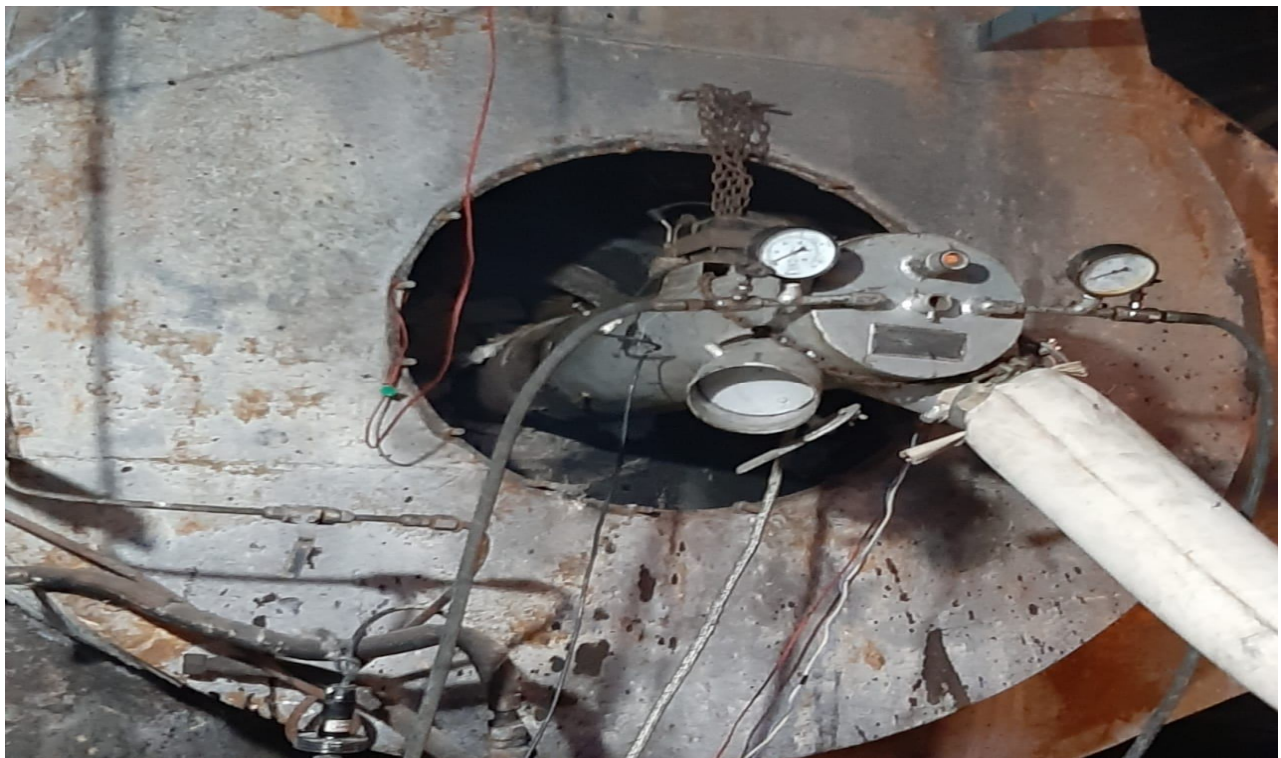
Heat dryout process after refractory application

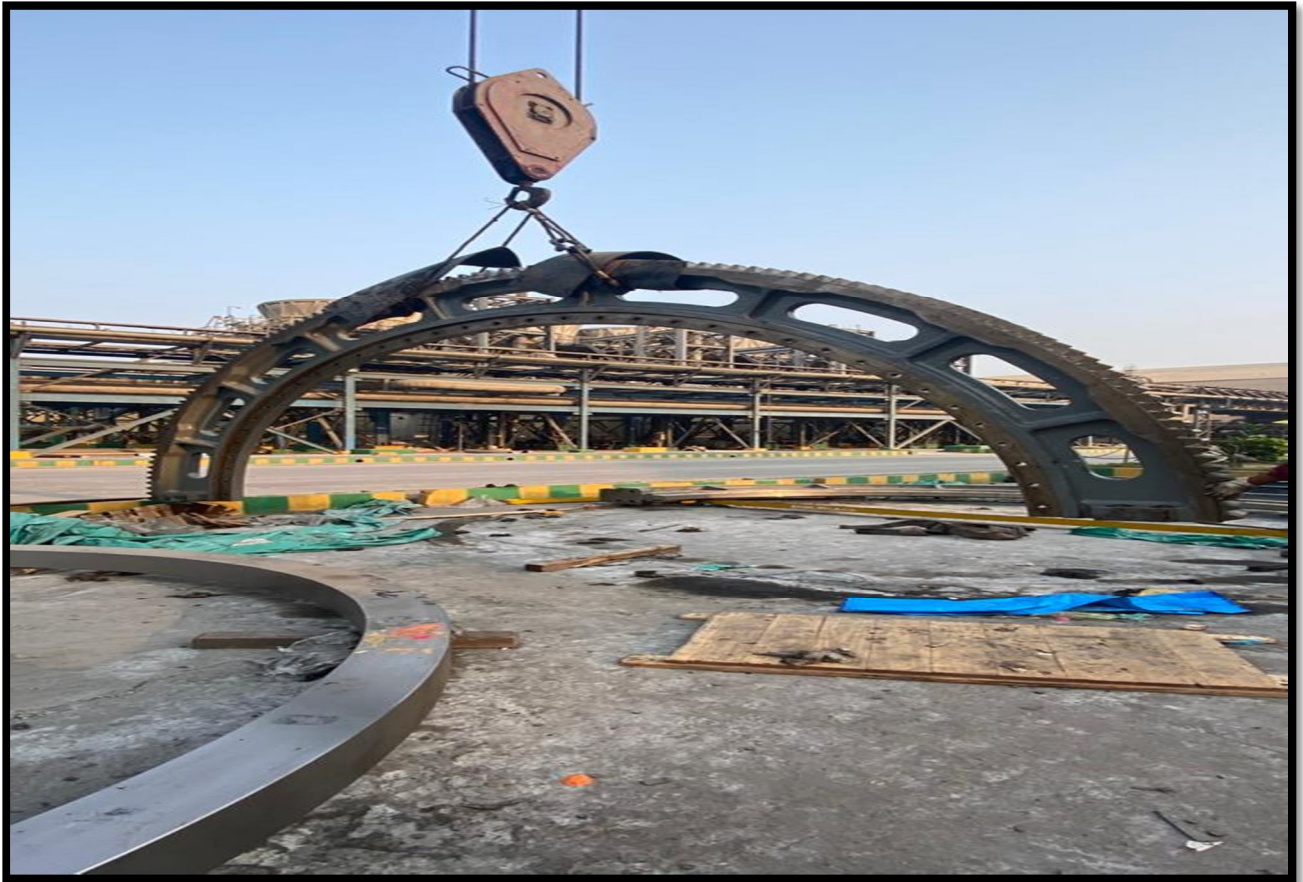
New girth gear shifting.

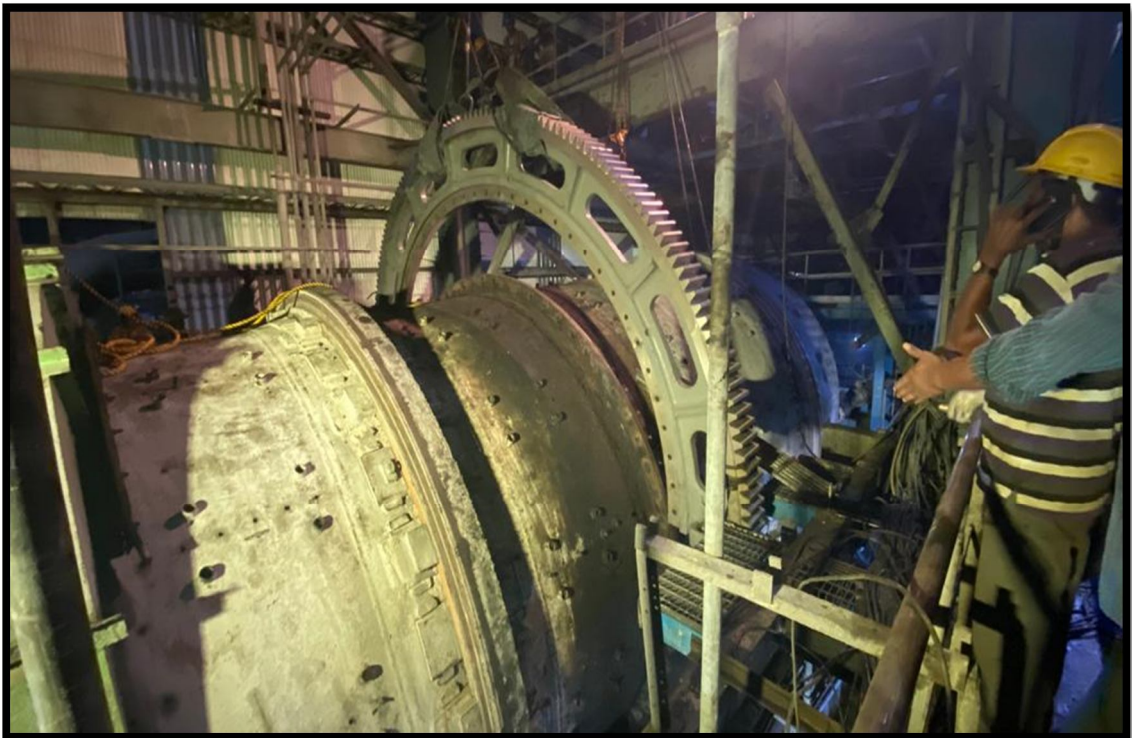
New girth gear erection

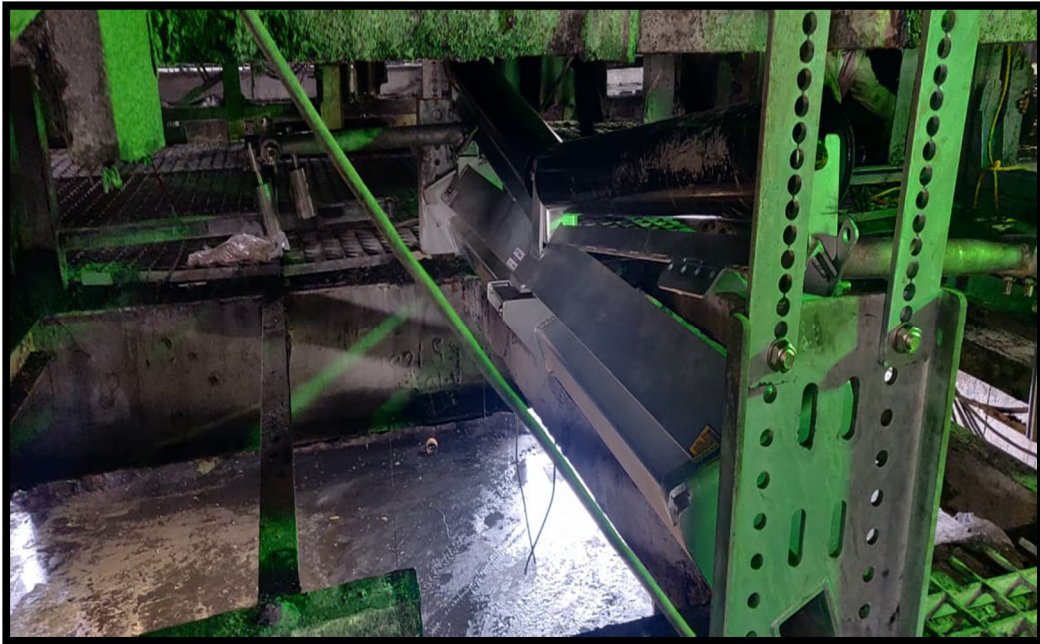
Fines Conveyor return belt tracker

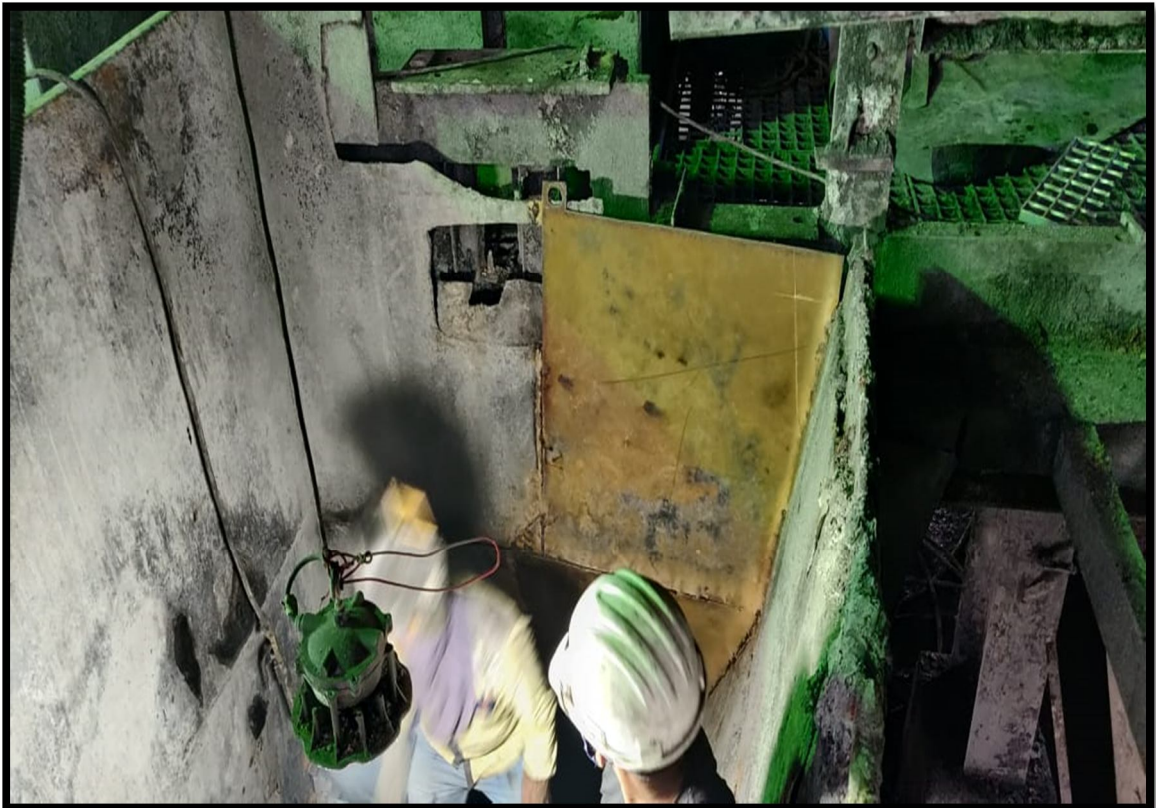
Fines Conveyor discharge hopper repair

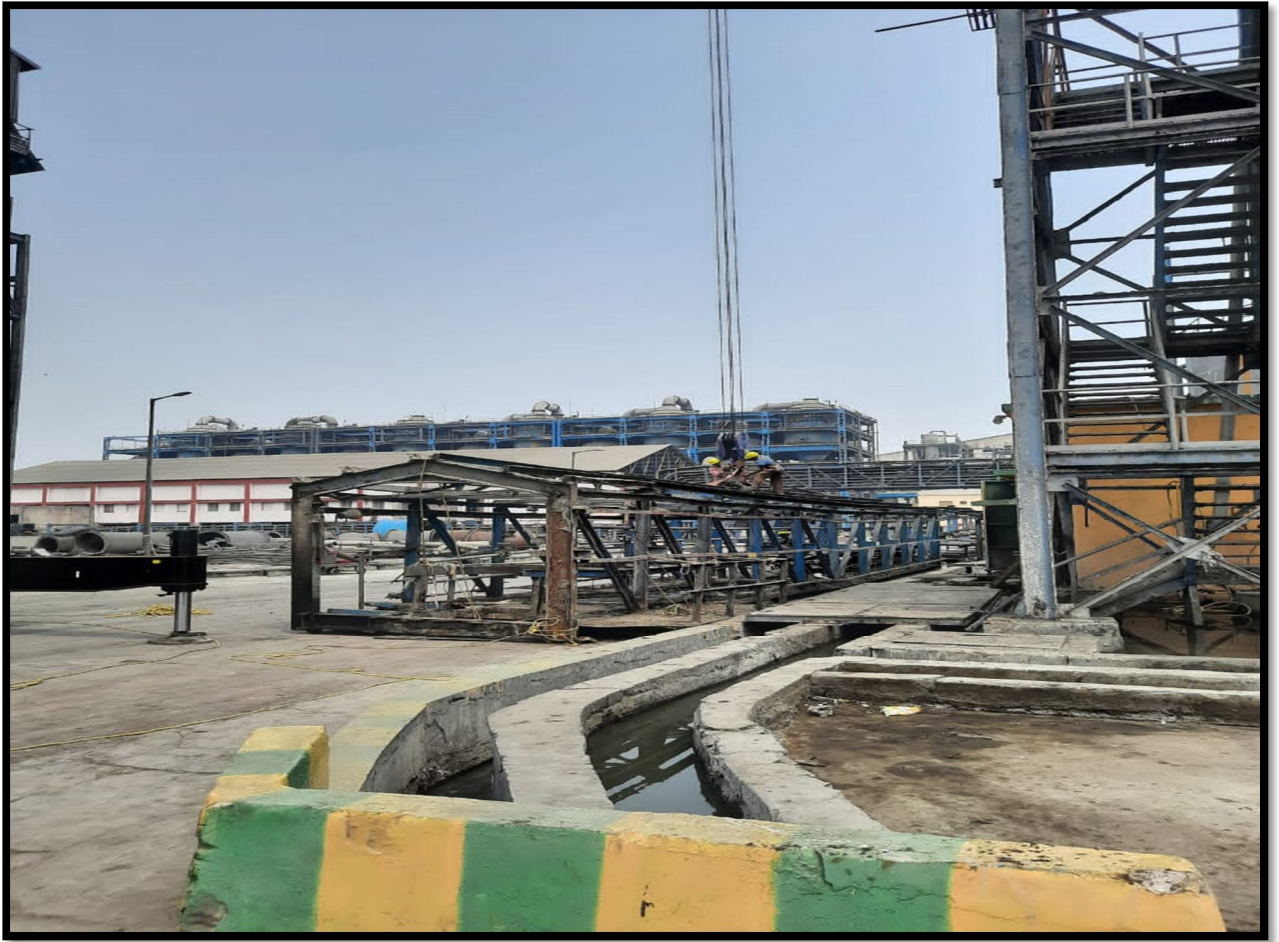
Product Conveyor Gallery dismantling

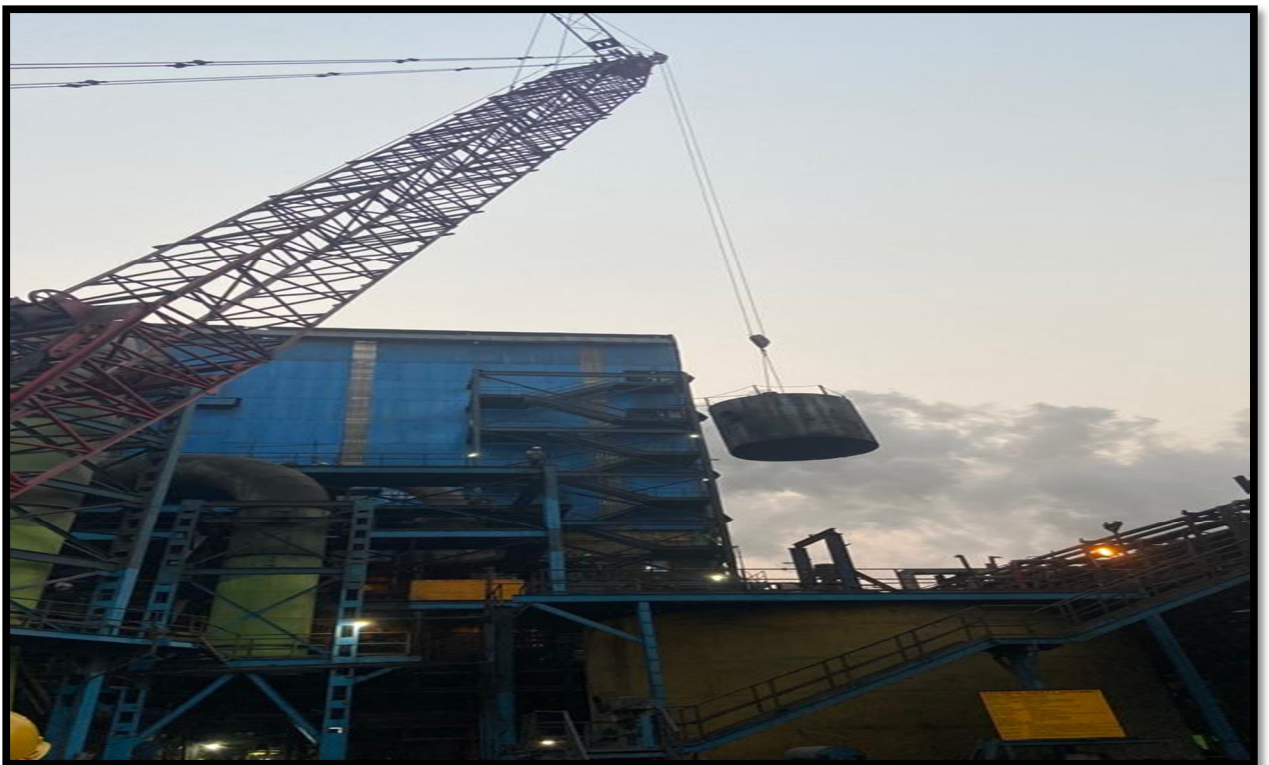
Dismantling and erection of pre scrubber separator shell

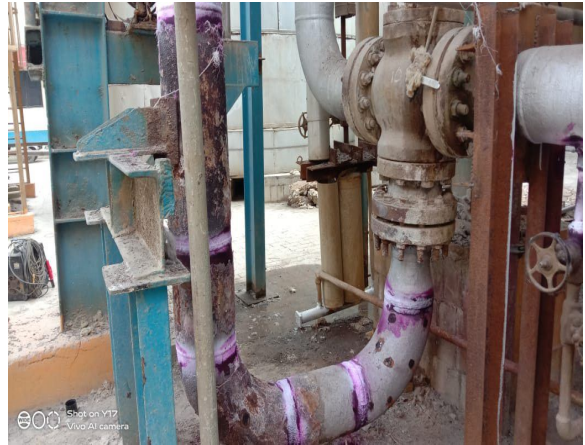
3 way valve joints DP test

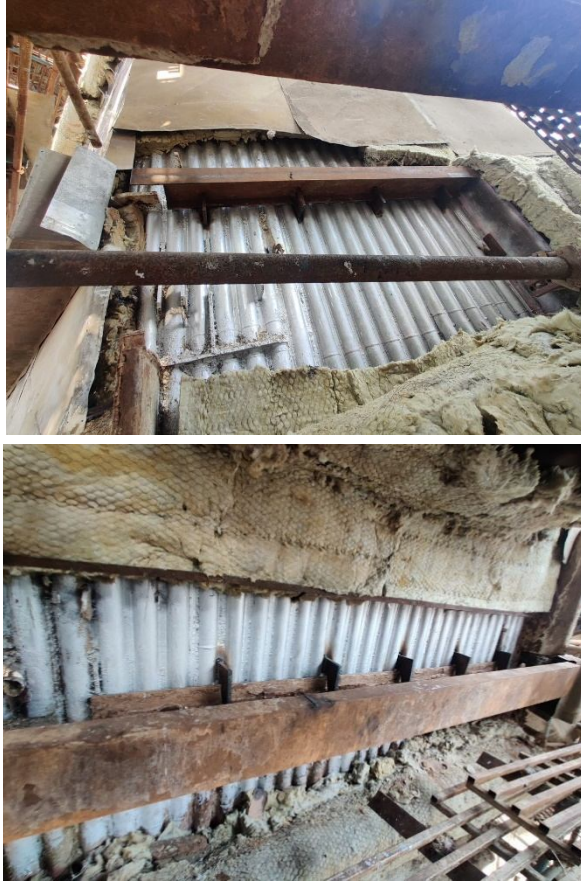
After completion of bypass nozzle installation Buck stay supported beams are installed on Panel No 2

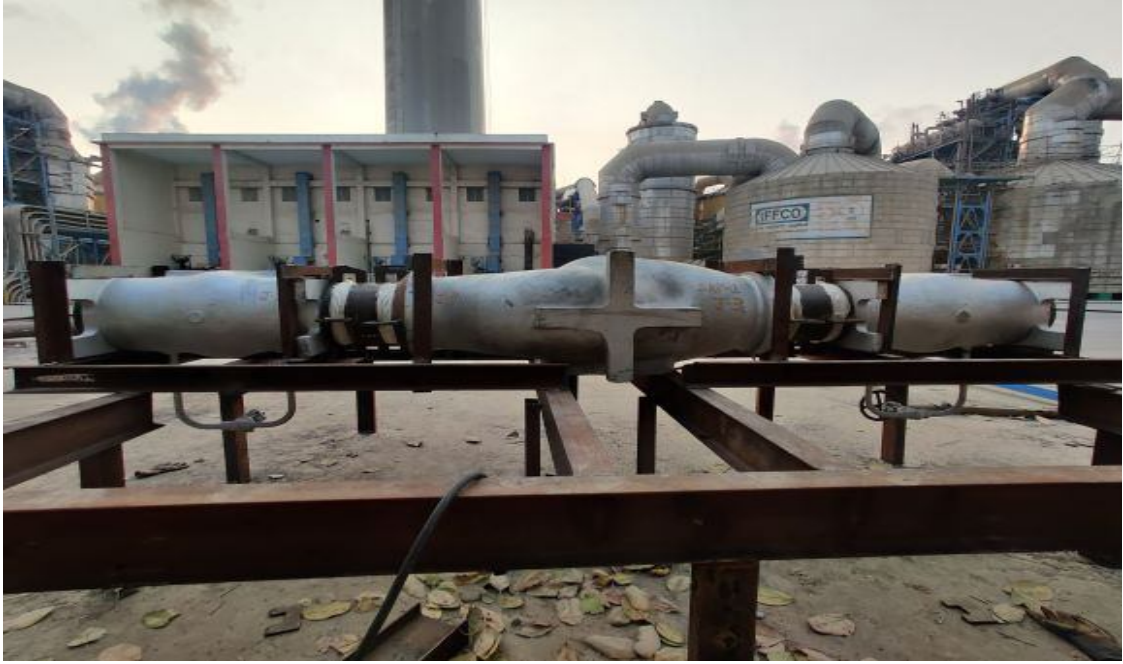
Total No of joints – 11 nos ; PWHT at 650 Deg C - Soaking Time - 60 min

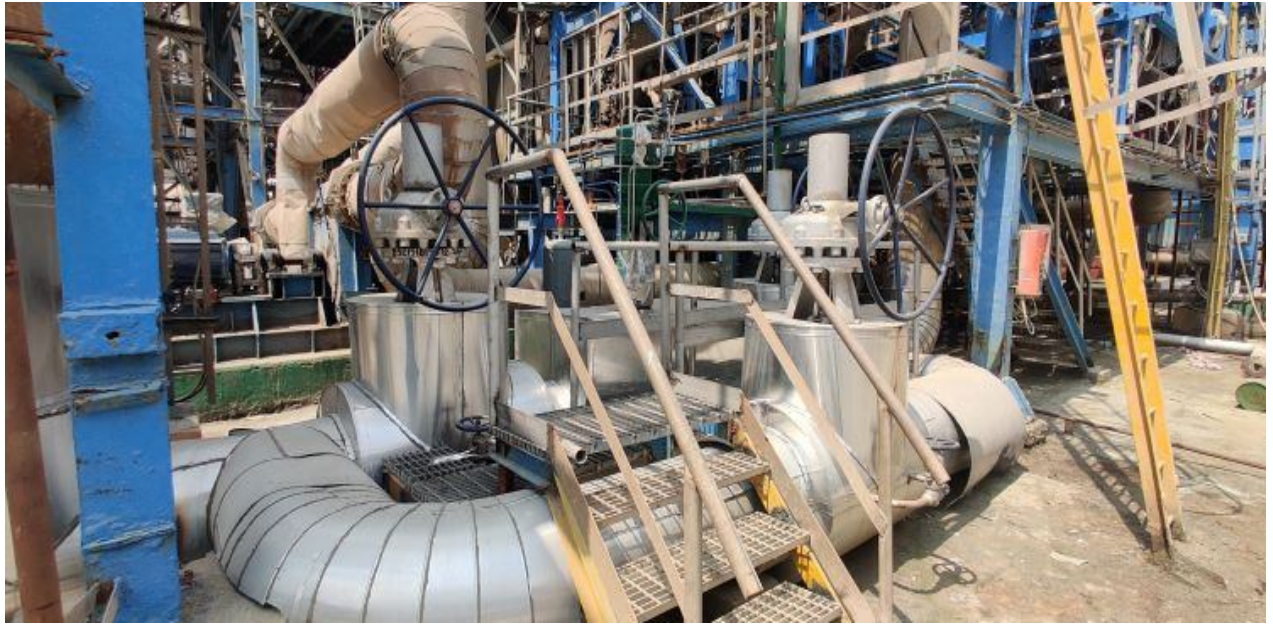
AFTER INSULATION AND PLATFORM INSTALLATION

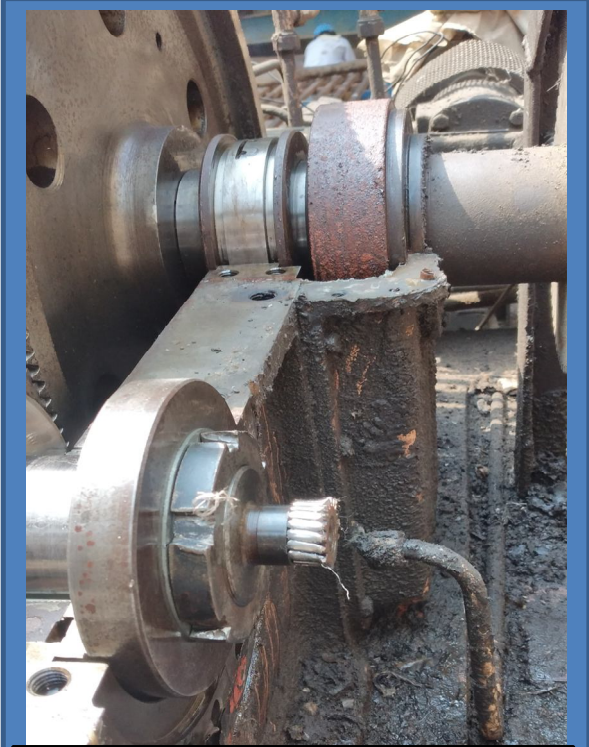
GEAR BOX BOTTOM OIL SEAL FOUND DAMAGE	OIL SEAL REPLACE WITH NEW.
PINION GEAR GOVERNOR GEAR FOUND DAMAGE.	GOVERNOR GEAR COMPLETE ASSEMBLY CHANGE.
CWP 01 SAP#1

BFW 101C GOVERNOR PINION FOUND DAMAGE

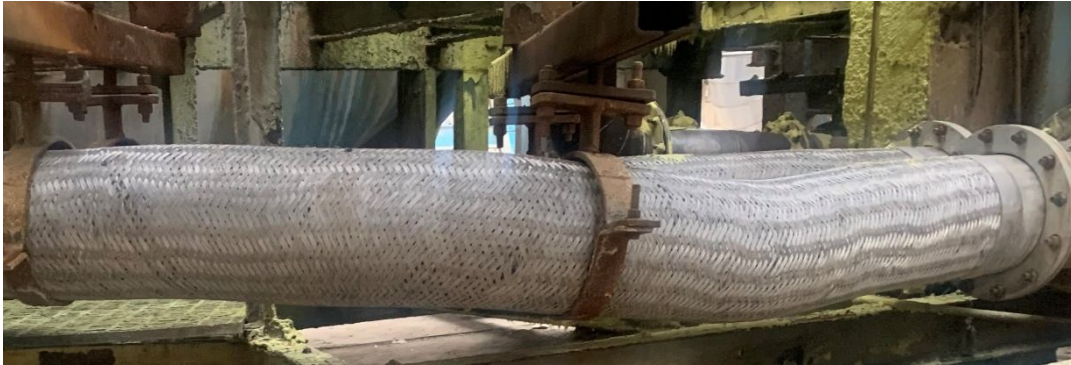
Fig 1(d) PA line Hose after replacement with new one

- ✓ Damaged Burner Hose Metallic Hose of Size 16 “replaced for both the burner with new hose.

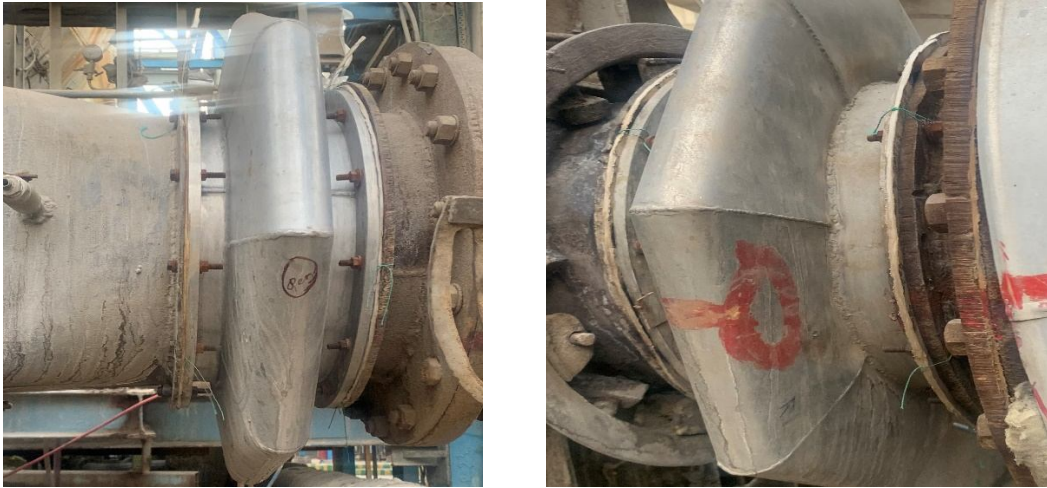
Fig 2.2(b) Suction and discharge bellow after replacement with new one

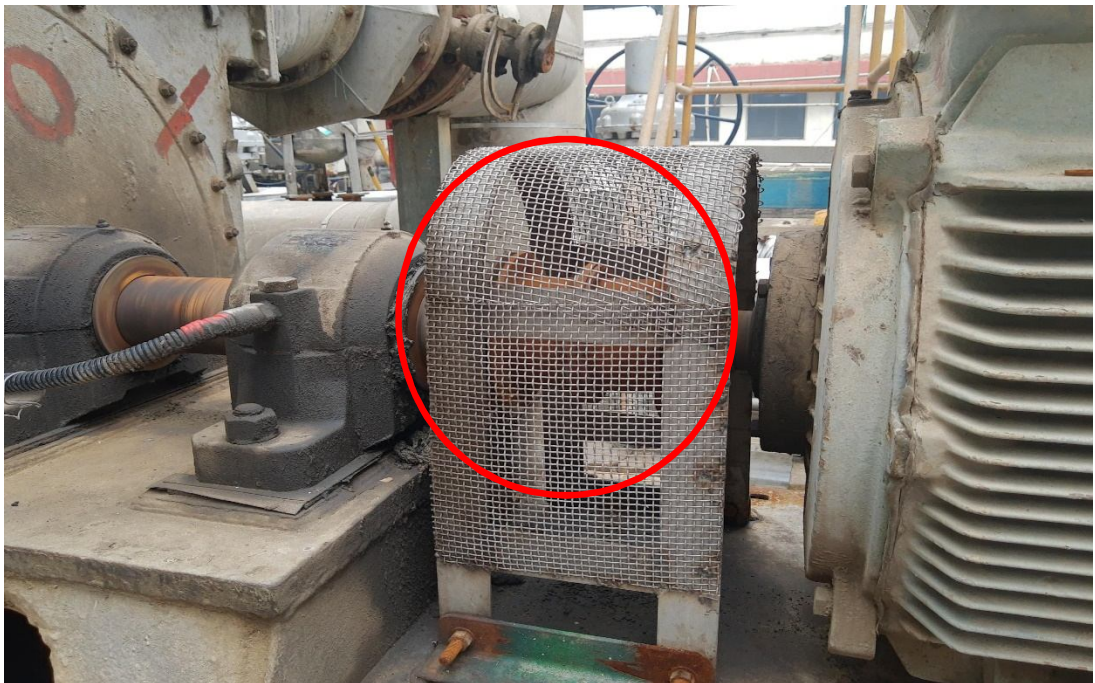
Fig 2.2(c) PA fan from pulley drive to direct coupling

- ✓ PA fan 2201 (Old) fan converted from pulley drive to direct coupling to run the Fan at increased rpm 3000 rpm to increase the PA header pressure for better combustion efficiency .earlier it was running on 2200 rpm.

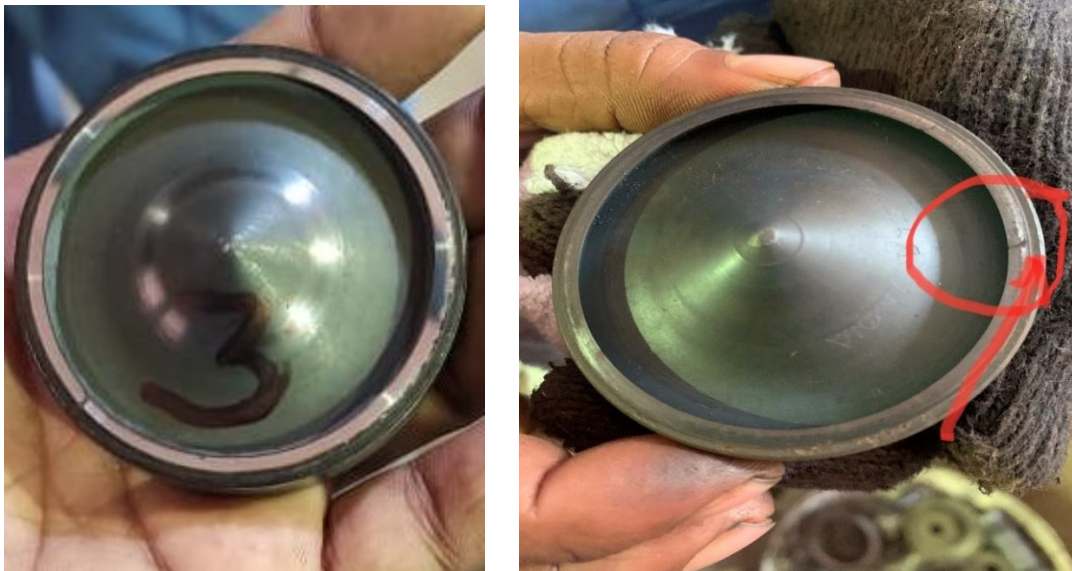
Fig 2.3(b) Scratch on Steam Drum& SH1 Safety valve disc

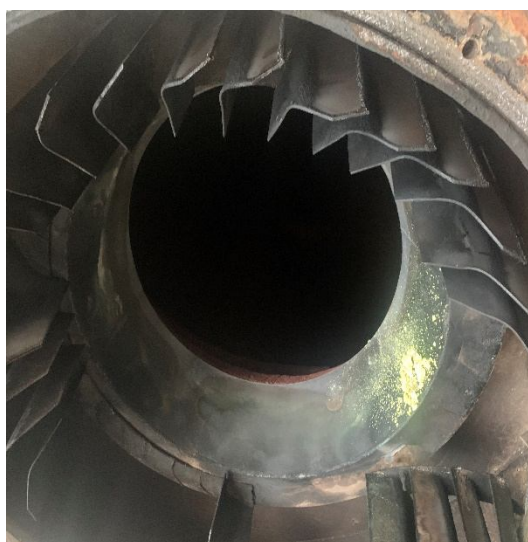
- ✓ Both Sulphur Burner removed and Balancing done with new rotary cup.
- ✓ Bearing and Seal replaced with new one.
- ✓ Wind box opened and found the air resister vanes are in damaged and broken condition.
- ✓ All damaged vanes replaced with new vanes made of SS 304.
- ✓ Matching plate of wind box SH Side was found wear out which causes so2 gas leakage in between burner face and wind box matching position.
- ✓ This matching plate is indigenously developed in our central workshop and replaced with that newly fabricated one and
- ✓ All seal rope replaced with new one and matching face lapped to proper contact with burner sealing face.

Fig 1.1(a) damaged vane of air resister

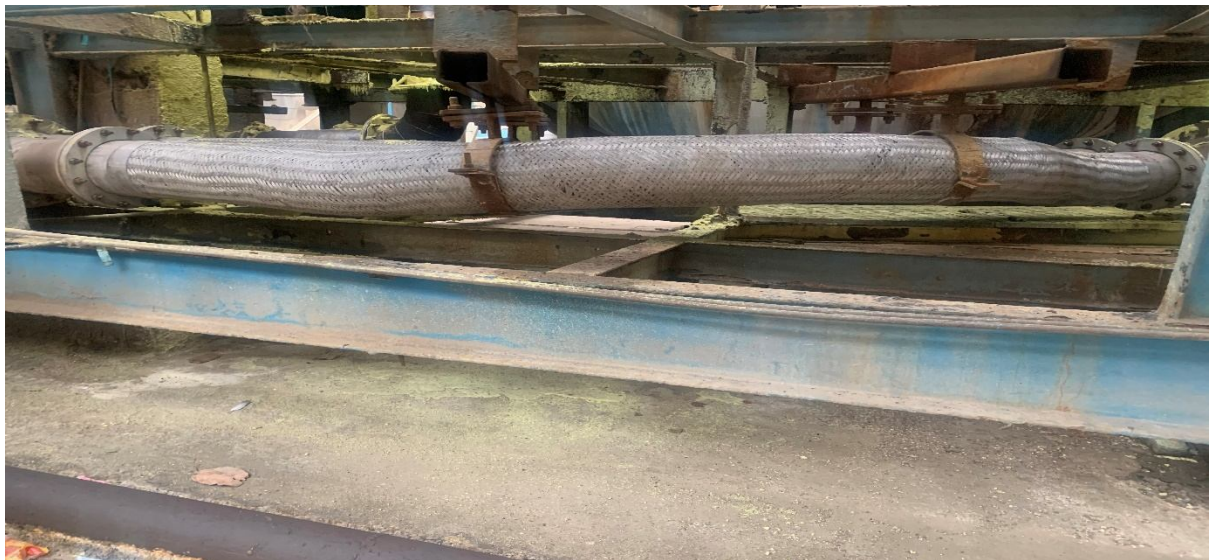
Fig 1.1(e) PA line Hose after replacement with new one

- ✓ Damaged Burner Hose Metallic Hose of Size 16” replaced for both the burner with new hose.
