ATR REPORT-2021

**INDIAN FARMERS FERTILISERS CO OPERATIVE LTD.
PARADEEP UNIT**

ATR REPORT: 2021

DAP PLANT

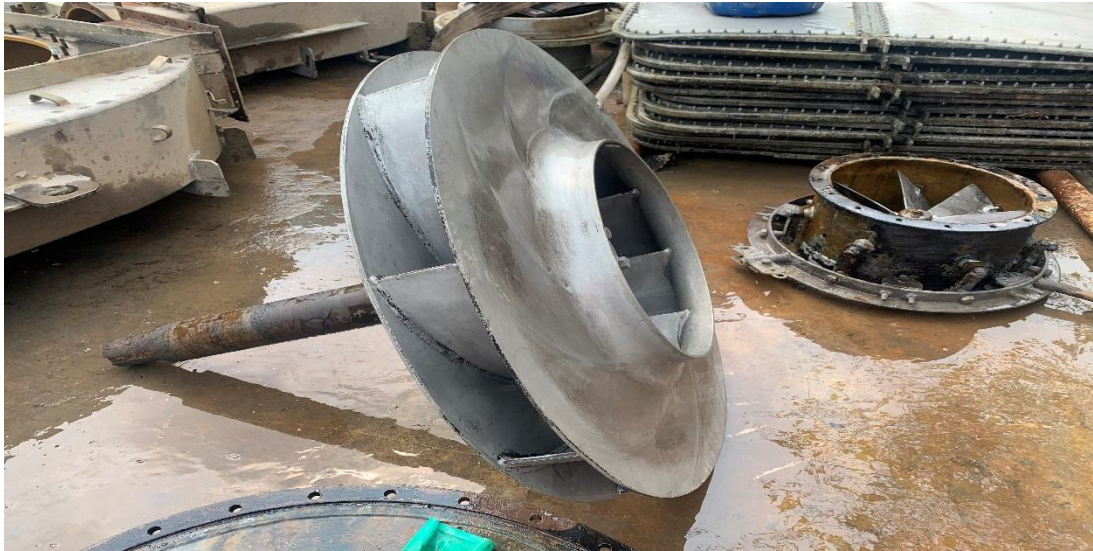
Fig 2.1(a) PA Fan impeller before balancing

- ✓ Both PA fan overhauling done fan rotor removed balancing checked, Bearing with sleeve replaced with new bearing and sleeve.

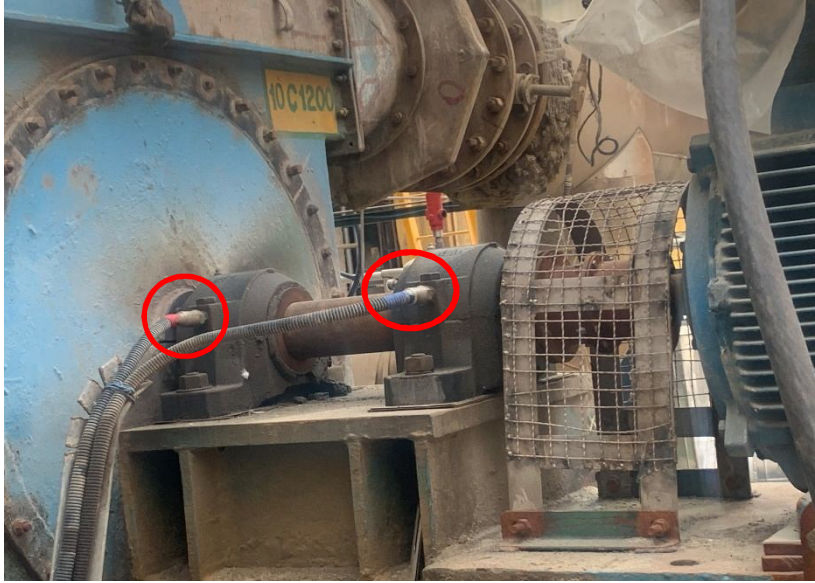
- ✓ Arrangement made in both PA fan for sensor fitting on bearing Plummer block to get the vibration feedback on DCS screen.

Fig 1.2(d) Vibration sensor arrangement in plumber block of PA fan

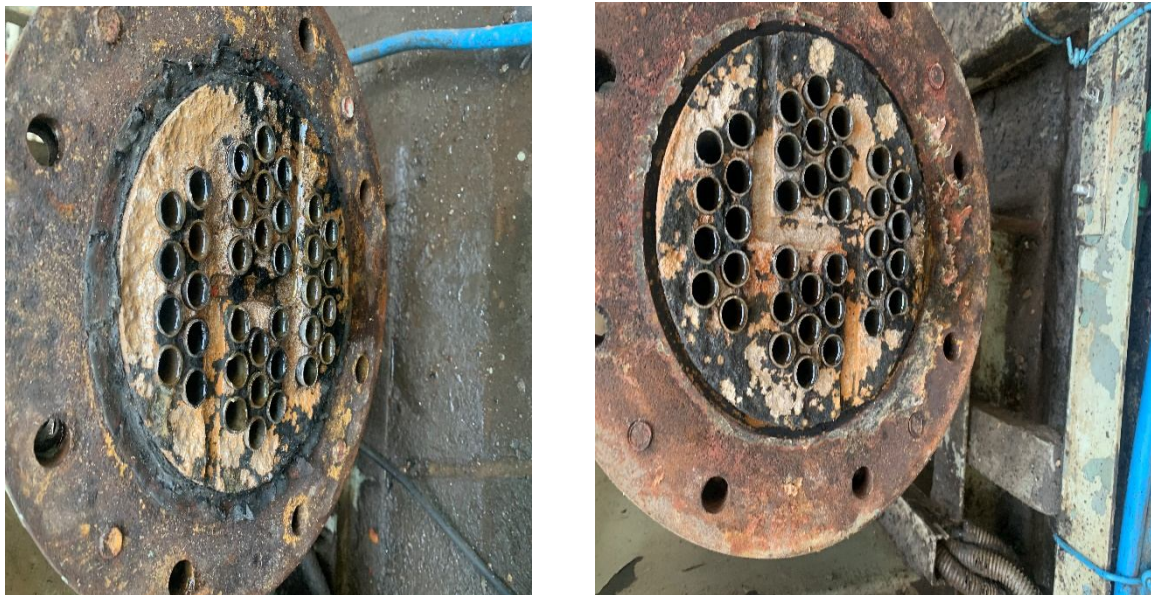
Fig 1.4.1(d) Lube oil cooler bfw turbine after cleaning

- ✓ Turbine Both Lube oil cooler cleaned with hydro jetting at pressure 150 kg/cm²
- ✓ Both Cooler of BCW pumps cleaned by hydro jetting machine at pressure 100 kg/cm².
- ✓ Condensate and gland steam cooler of Turbine cleaned by hydro jetting machine at pressure 100 kg/cm².

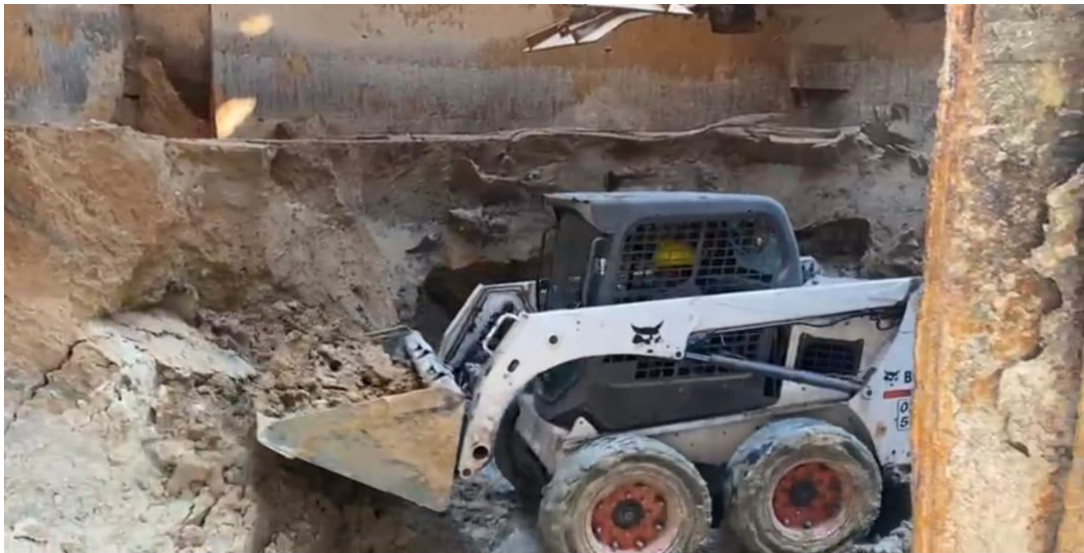
1. Slurry Surge Tank (SST) cleaning: Huge deposition of Material was found inside of SST. The deposition of material was cleaned with the help of skid loader. Agitator blades replaced. Damaged baffle plates were strengthened. Also patch up strengthening was carried out over thinned portions of the tank wall. Apprx. **400 MT** of rock was removed.

SST Cleaning with skid loader

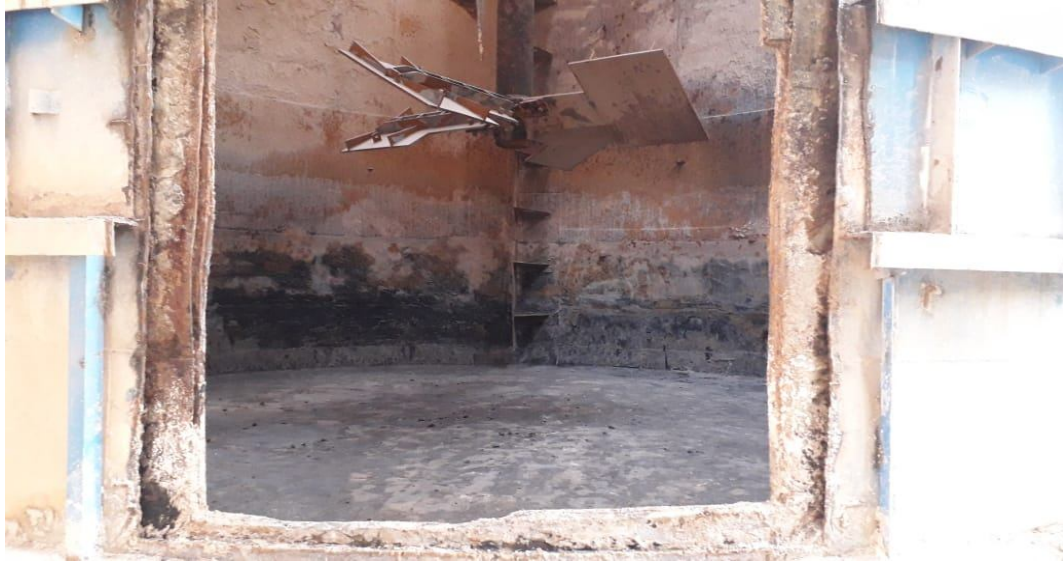
SST after cleaning

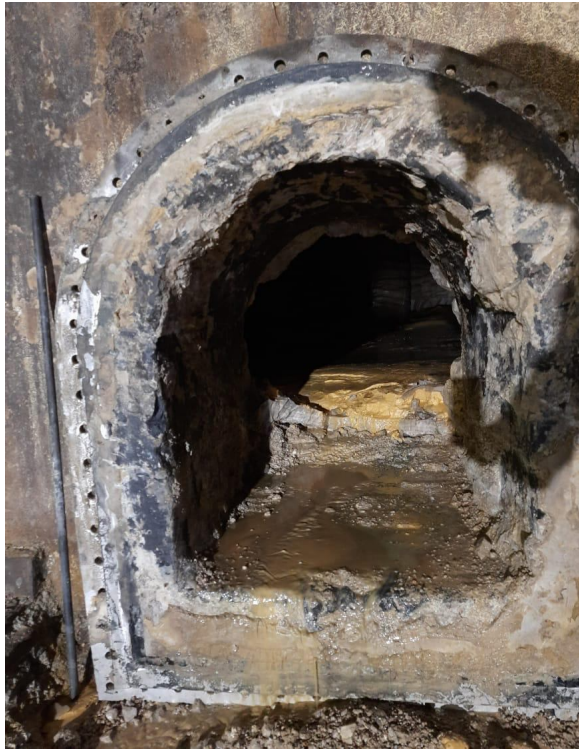
Annular Manway before cleaning

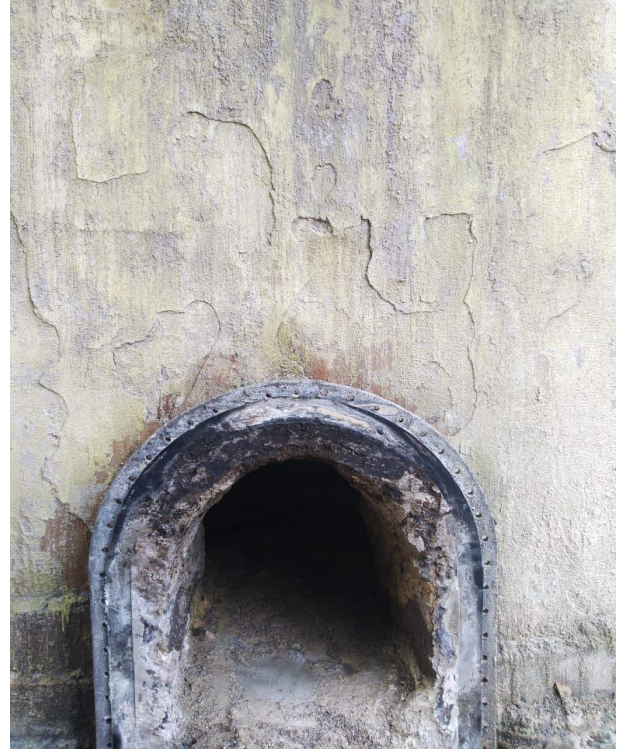
Annular Manway after cleaning

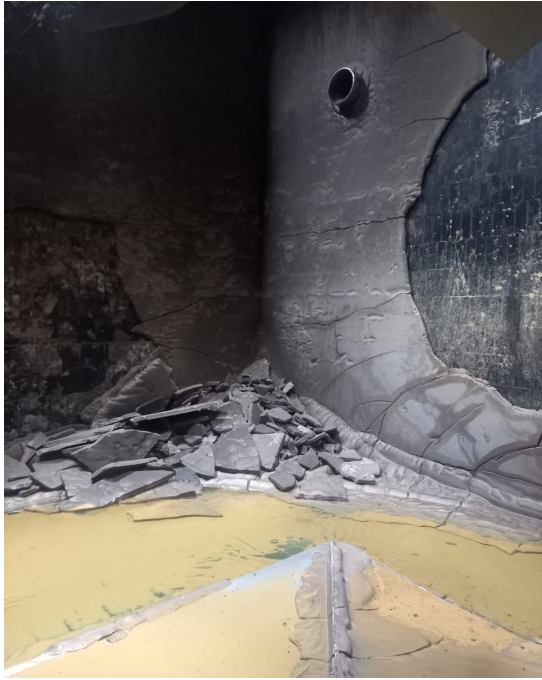
FFT wall before cleaning

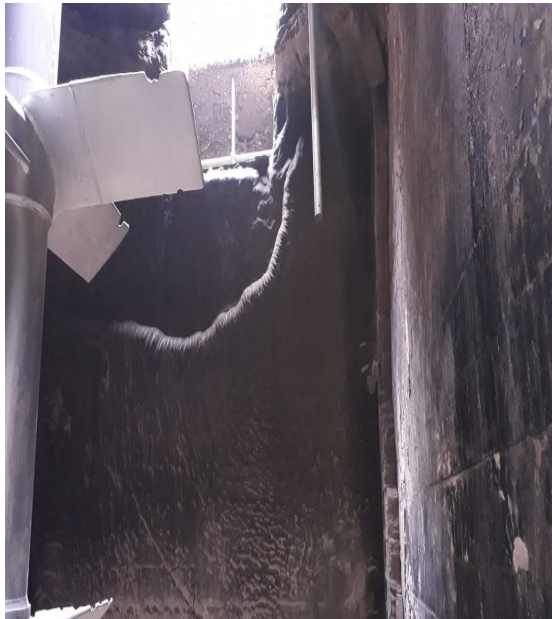
Adjustment tank wall before cleaning

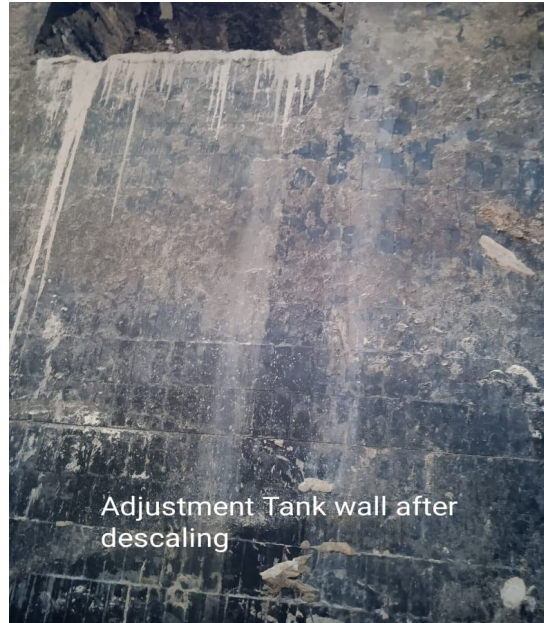
Adjustment tank wall after

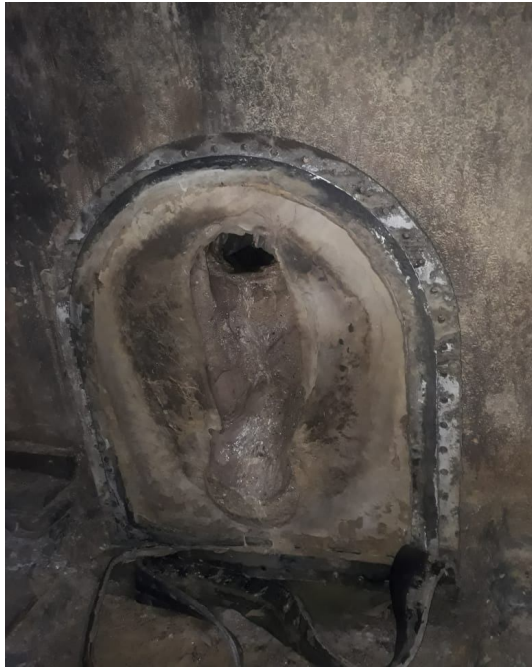
VCST manway before descaling

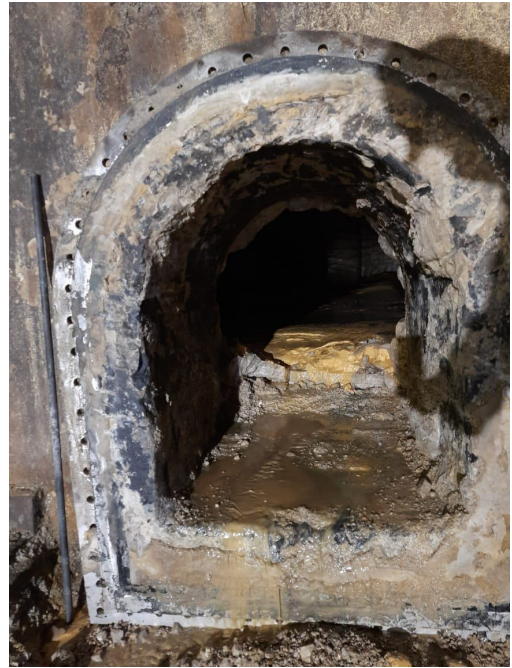
VCST manway after descaling

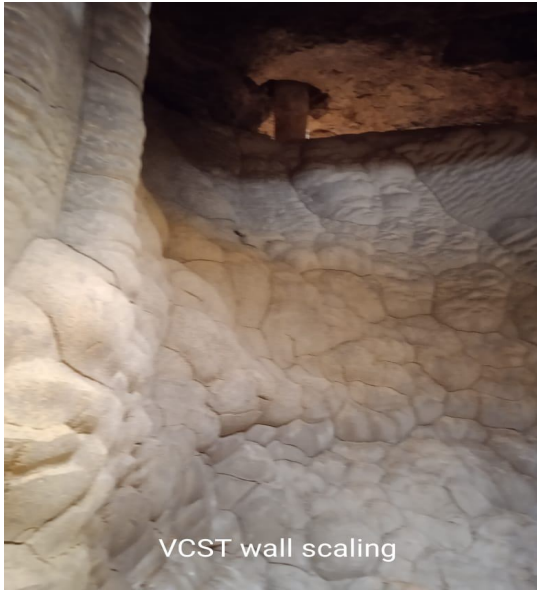
VCST wall before cleaning

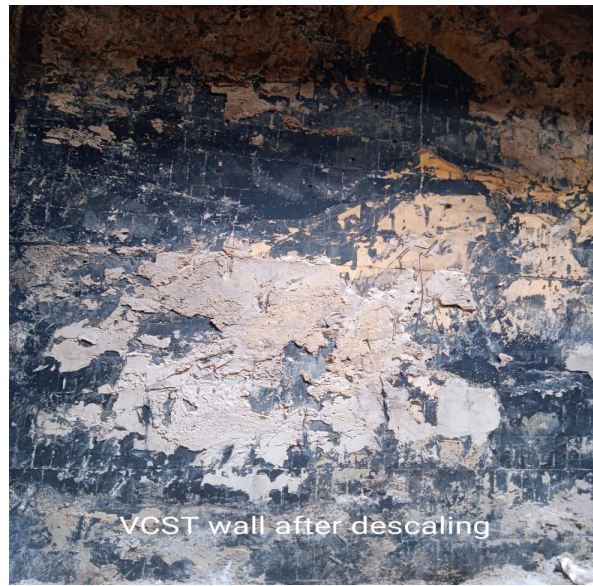
VCST wall after cleaning

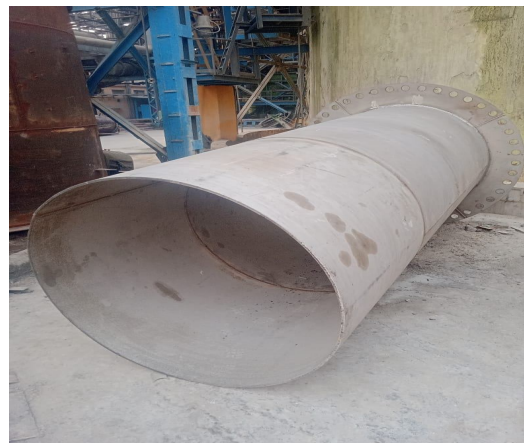
Seal Leg after cleaning

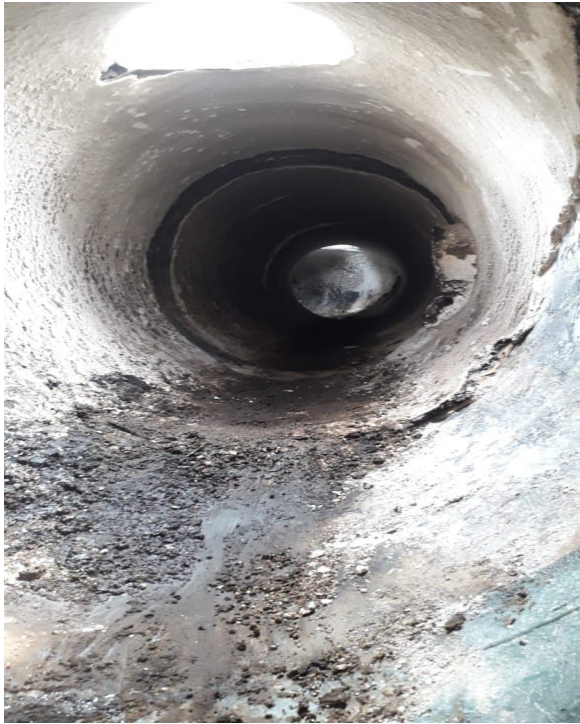
Fumes duct before cleaning

- Fumes scrubber and Pre scrubber:** Fumes duct was cleaned and all leakage points were repaired. Damaged portion of fumes inlet duct inside pre scrubber was also repaired. New vertical gate provided in Fumes duct. Pre scrubber inner shell and its outlet duct to Fumes scrubber completely descaled and cleaned. Deposition over Fumes scrubber inlet duct and entire fumes scrubber chamber cleaned. Fumes scrubber inside bottom damaged plates replaced and joint portion rubber lining done.

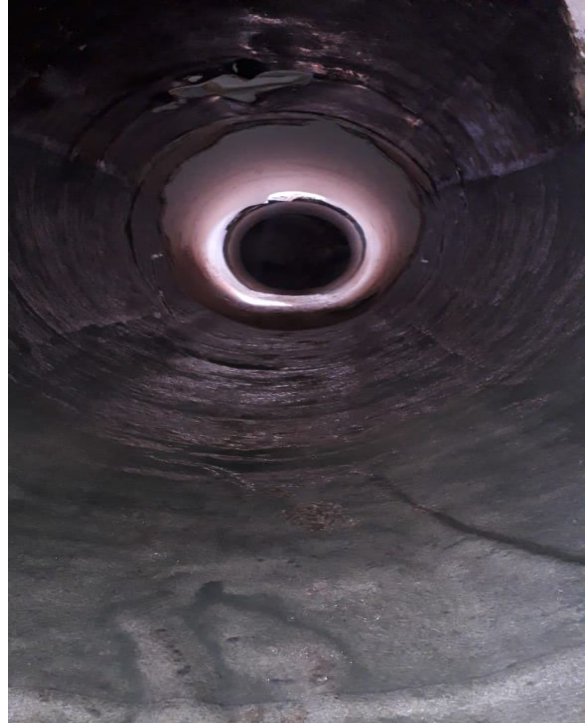
Fumes duct after cleaning

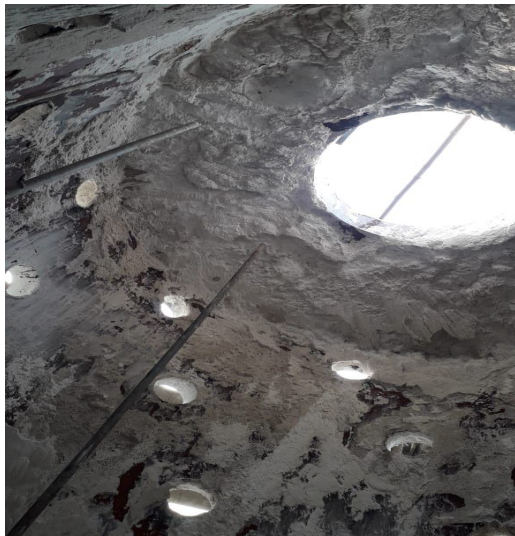
Pre scrubber inner shell before cleaning

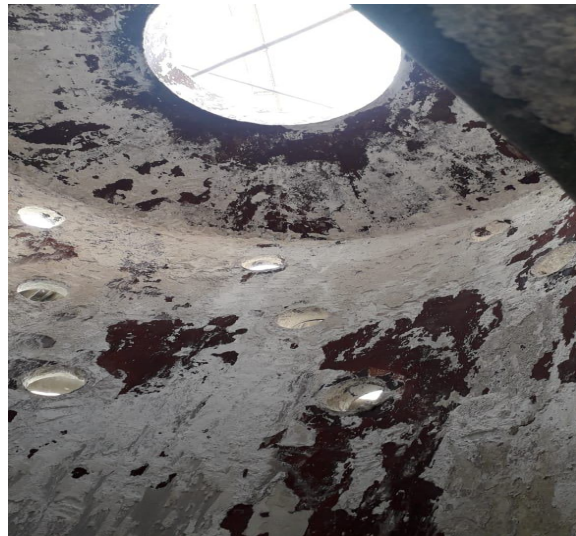
Pre scrubber inner shell after cleaning

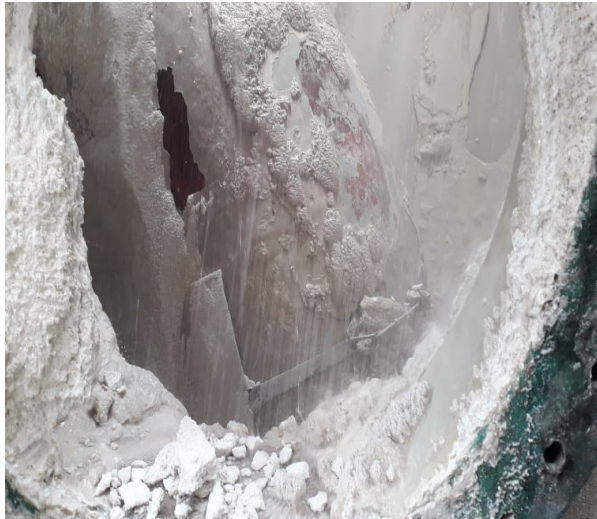
Pre scrubber bottom cone before cleaning

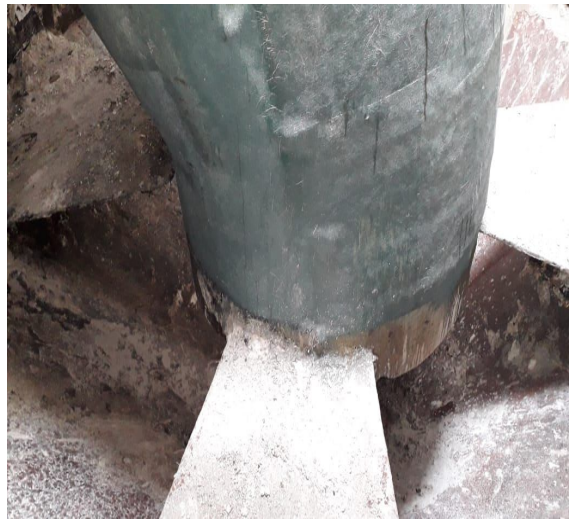
Pre scrubber bottom cone after cleaning

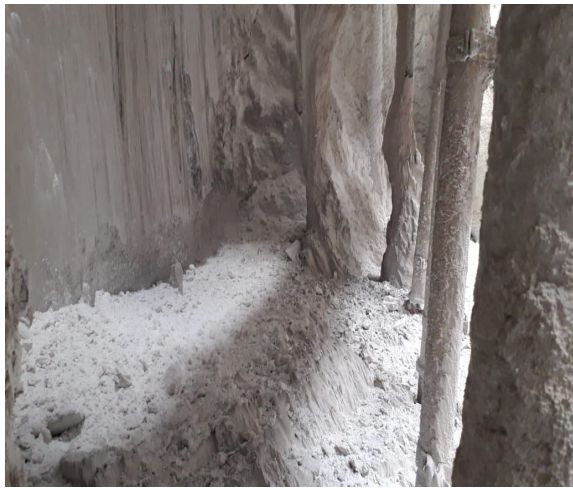
Fumes scrubber chamber before cleaning

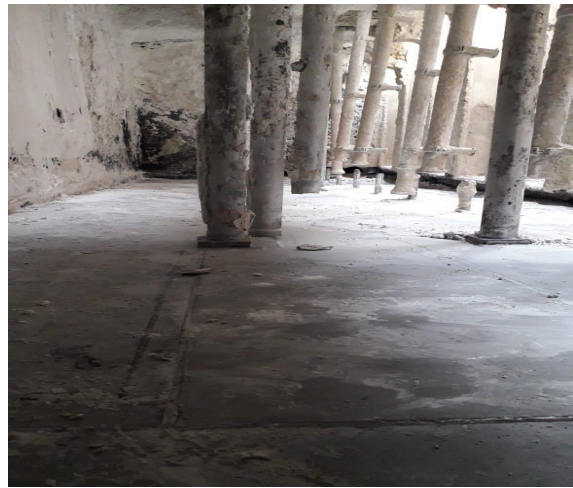
Fumes Scrubber chamber after cleaning

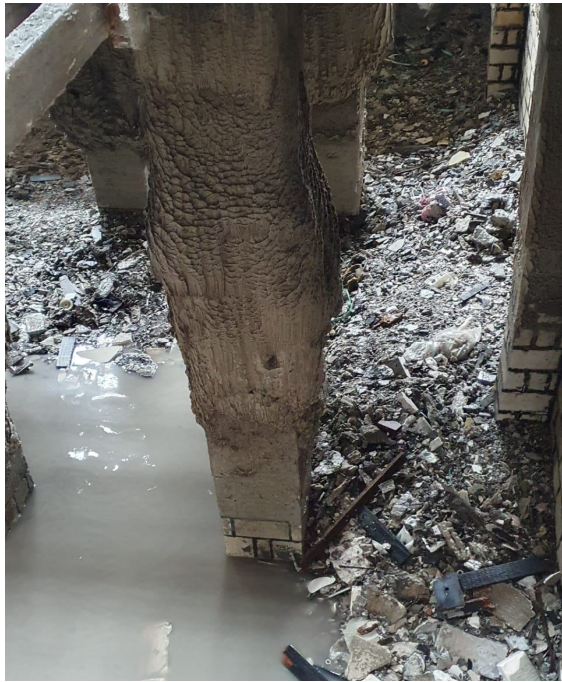
Old Cooling Tower Cell before cleaning

- 4. Old Cooling Tower and New cooling tower:** New cooling tower basins of Cell no. 1, 2 3 & 4 cleaning done. Old cooling tower basins of all Cell cleaned. New Cooling Tower Cell no. 1, 2 & 3 damaged brick lining repaired. Old Cooling Tower Cell no. 2 damaged brick lining repaired. All walls, strainers and deck of both New & Old Cooling Tower was cleaned. Mist eliminators of Cell no- 1 to 8 except Cell no-3 of old Cooling tower cleaned.

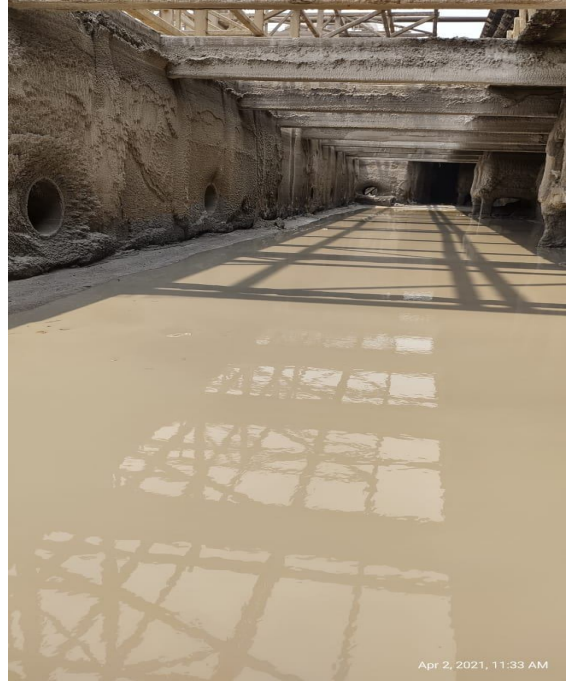
Old Cooling Tower Cell after cleaning

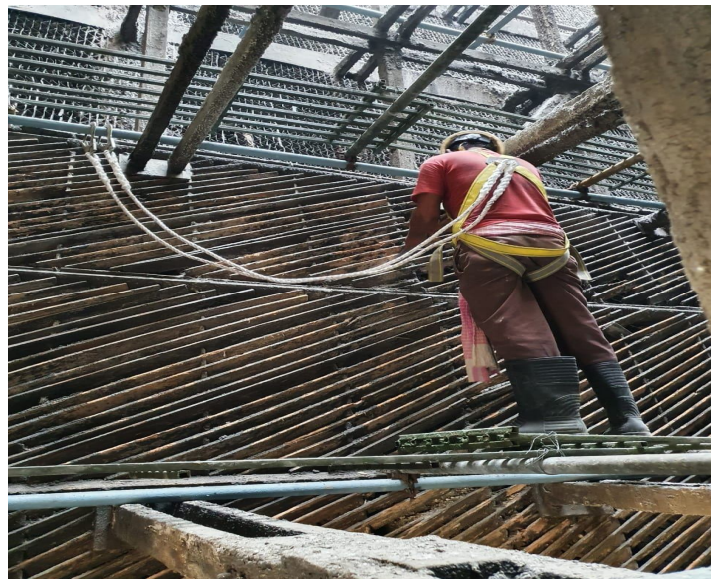
Old Cooling Tower mist eliminator cleaning

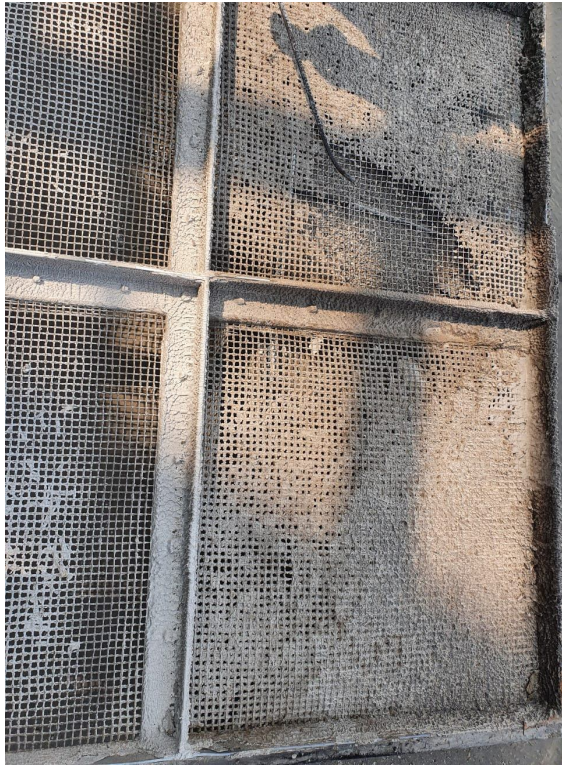
Cooling Tower Strainer before cleaning

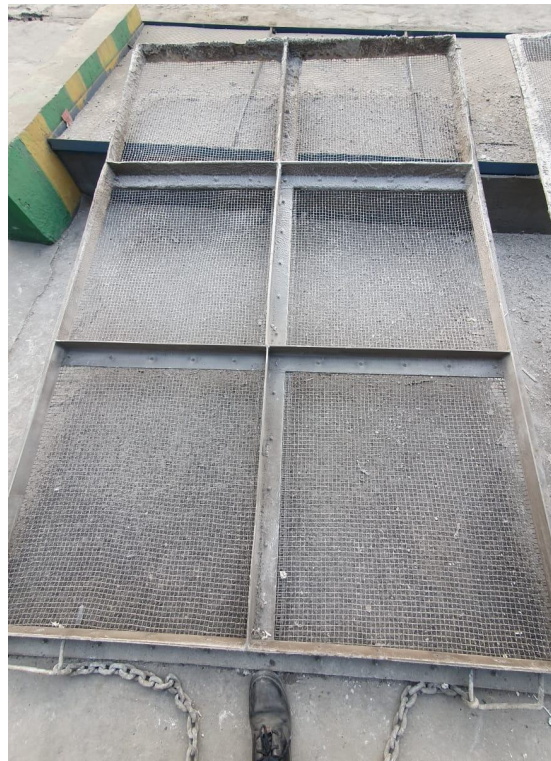
Cooling Tower straner after cleaning

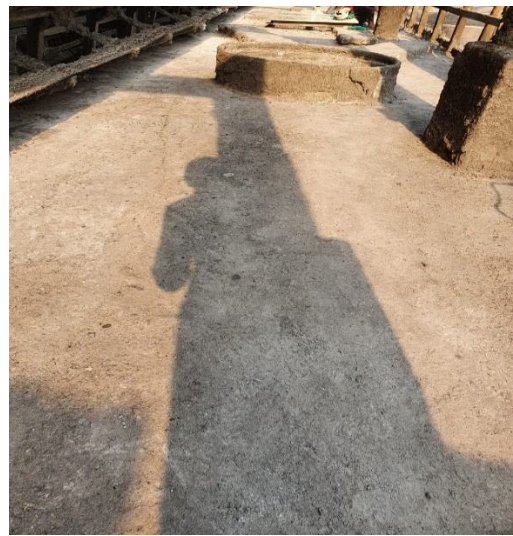
Cooling Tower deck after cleaning

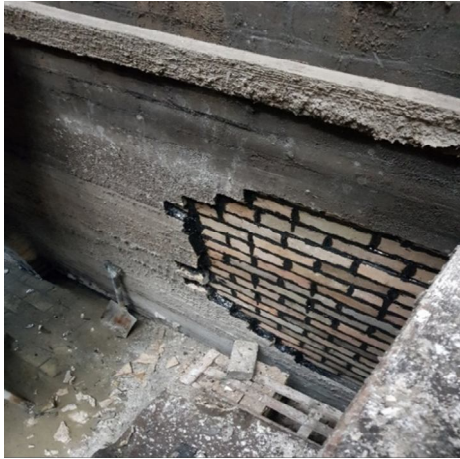
New Cooling Tower cold well cell wall
repairing

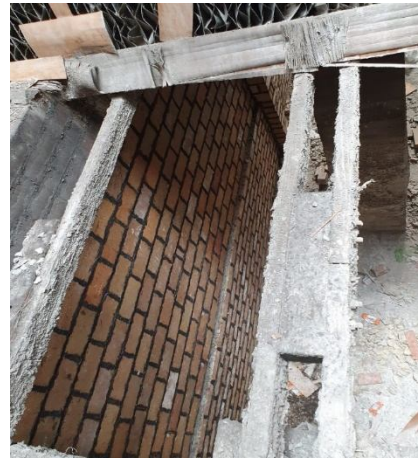
New Cooling Tower cold well cell after
repairing

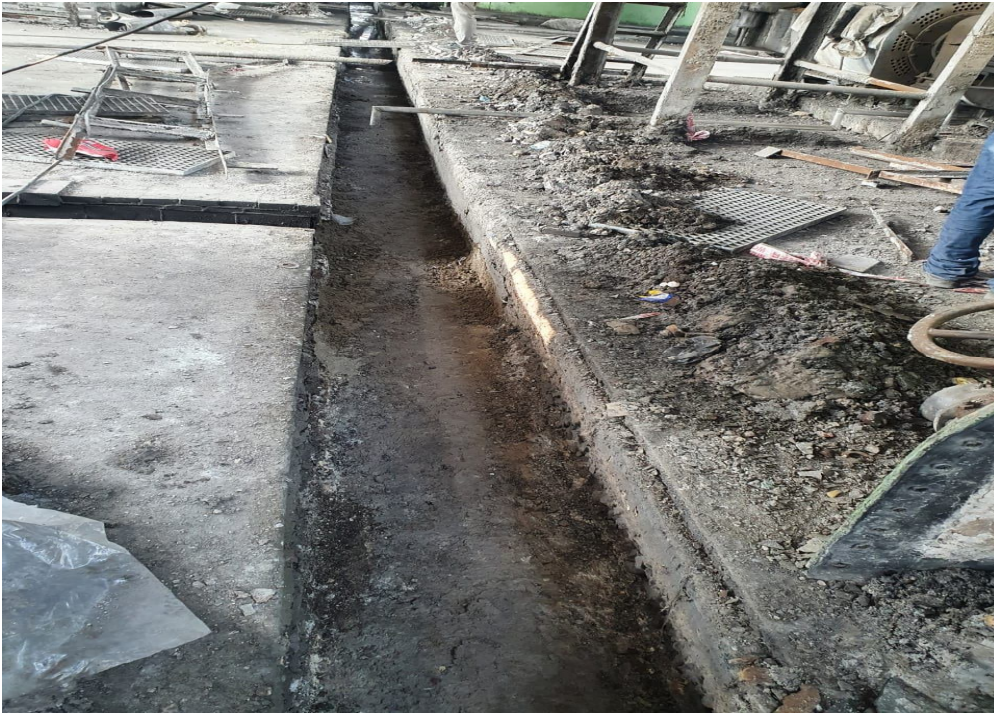
Evaporator area drain cleaning

18. Evaporator area sump cleaning done, civil work done and bottom portion is provided with SS plate.
19. Evaporator area drain brick lining done.
20. Evaporator B to H steam control valve replaced.

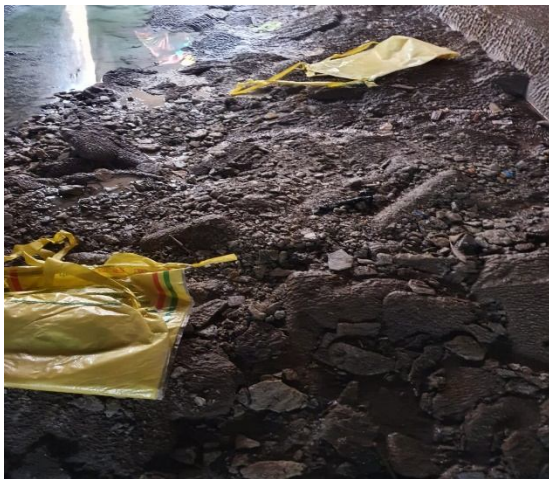
Hot well trench before cleaning

Hot well trench covered roof cutting done at three places and cleaning of the trench done thoroughly up to hot well.

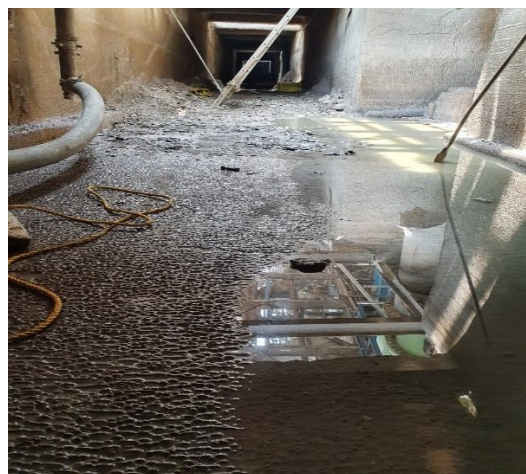
Hot well trench after cleaning

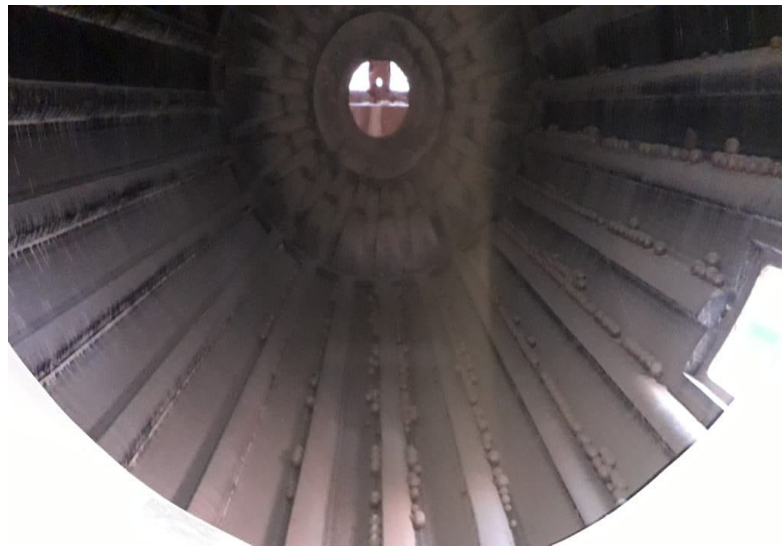
Ball mills water washed

All ball mills water washed and cleaned. Balls were segregated and rejected quantity was topped up with new charge in Ball Mill- C & A. All MST (mill slurry tank) and old SST (slurry surge tank) cleaned.

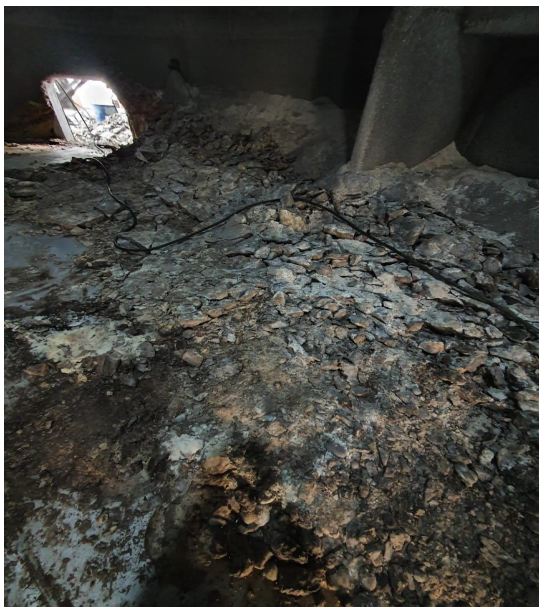
Pump tank manhole was opened during the annual shut down and bottom floor found with hard scale deposit along with gypsum. Tank was cleaned thoroughly.

Pump Tank before cleaning

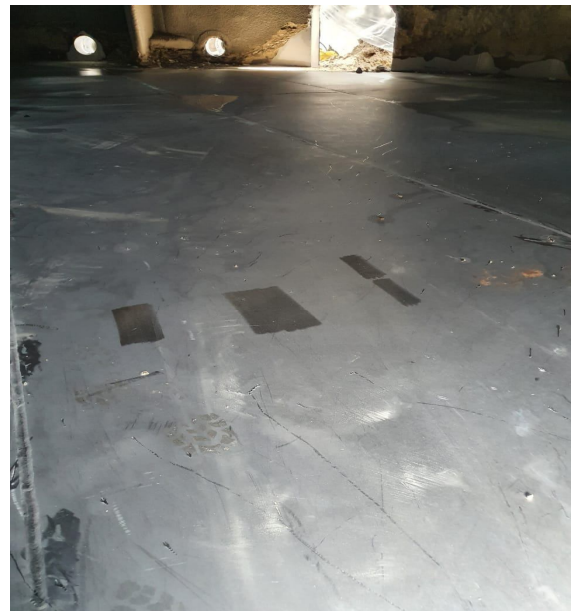
Pump Tank after cleaning

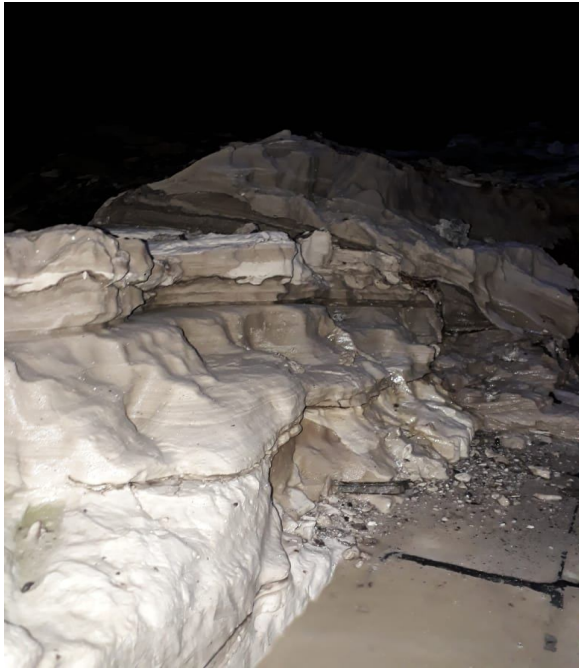
11. New pump tank cleaning: New pump tank manhole was opened during the annual shut down and found to be containing hard gypsum depositions. Tank was cleaned thoroughly.

New pump tank before cleaning

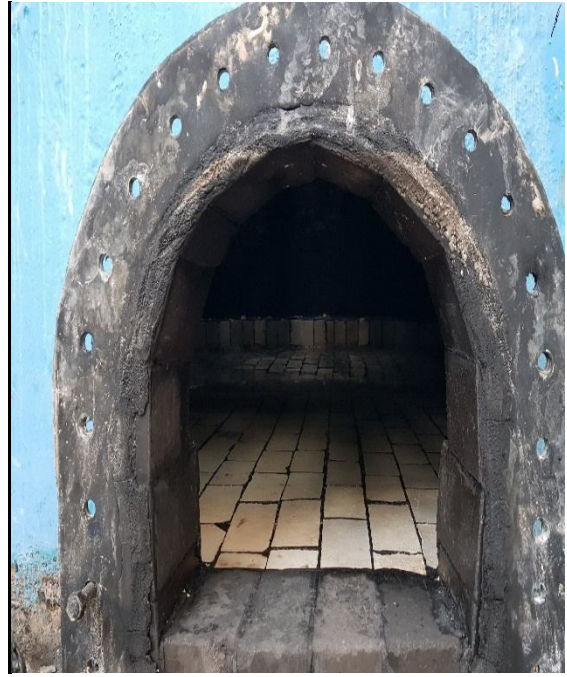
New pump tank after

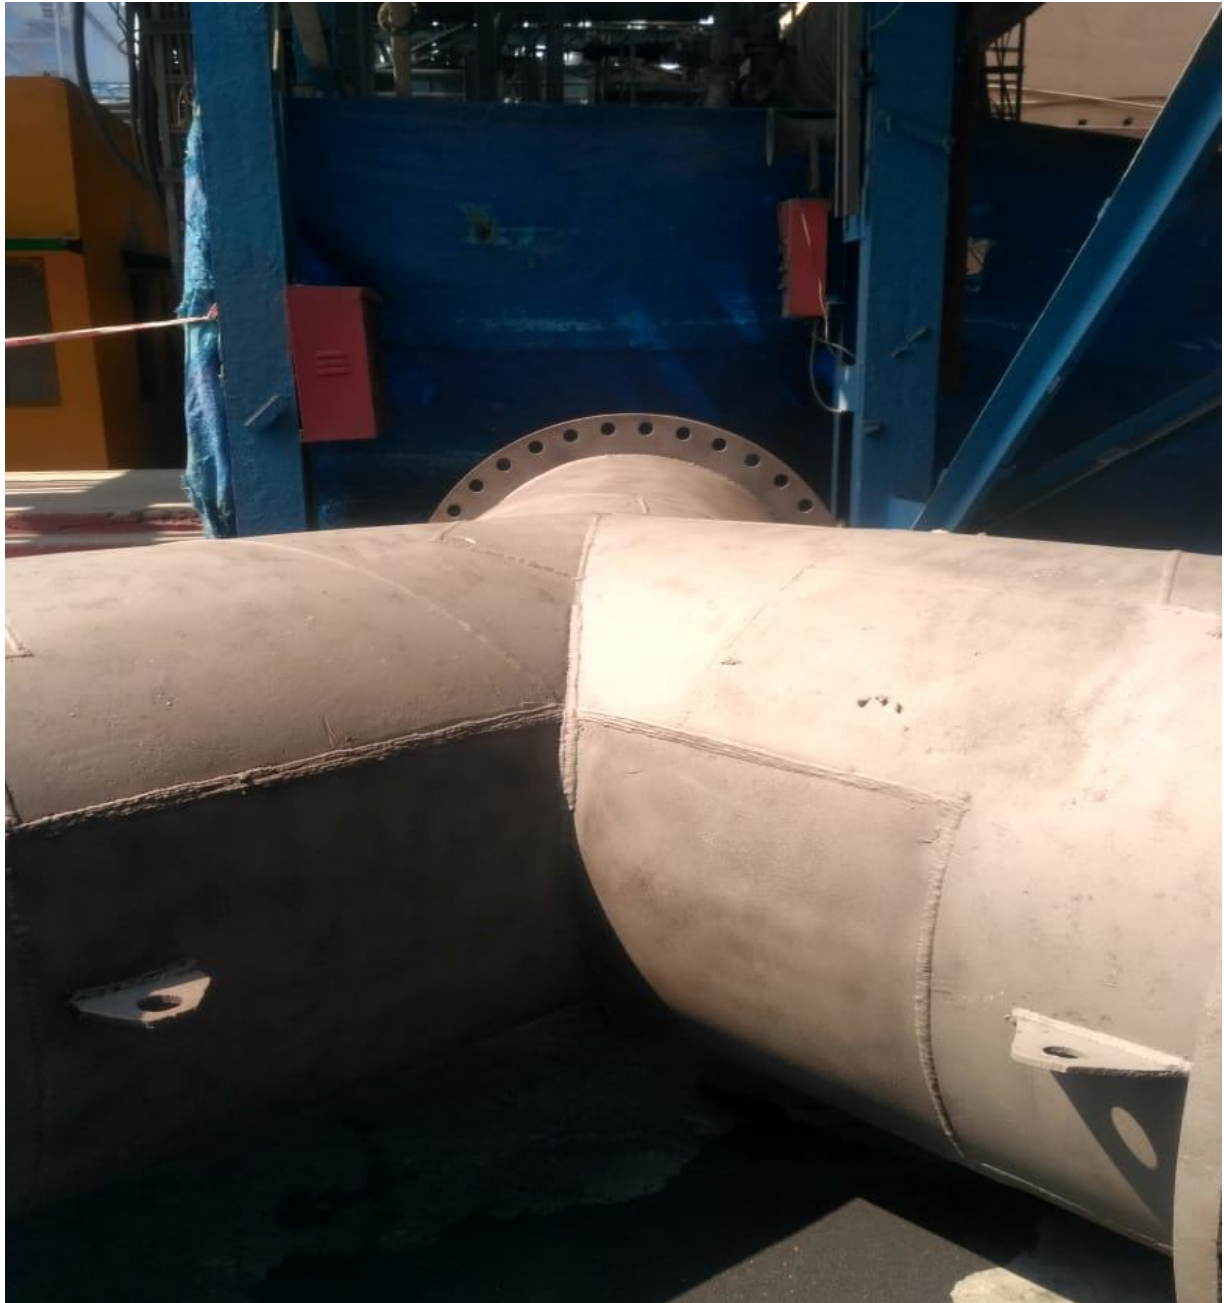
NEW / FABRICATED "Y - PIECE" INSTALLED IN P-113 PUMP DISCHARGE

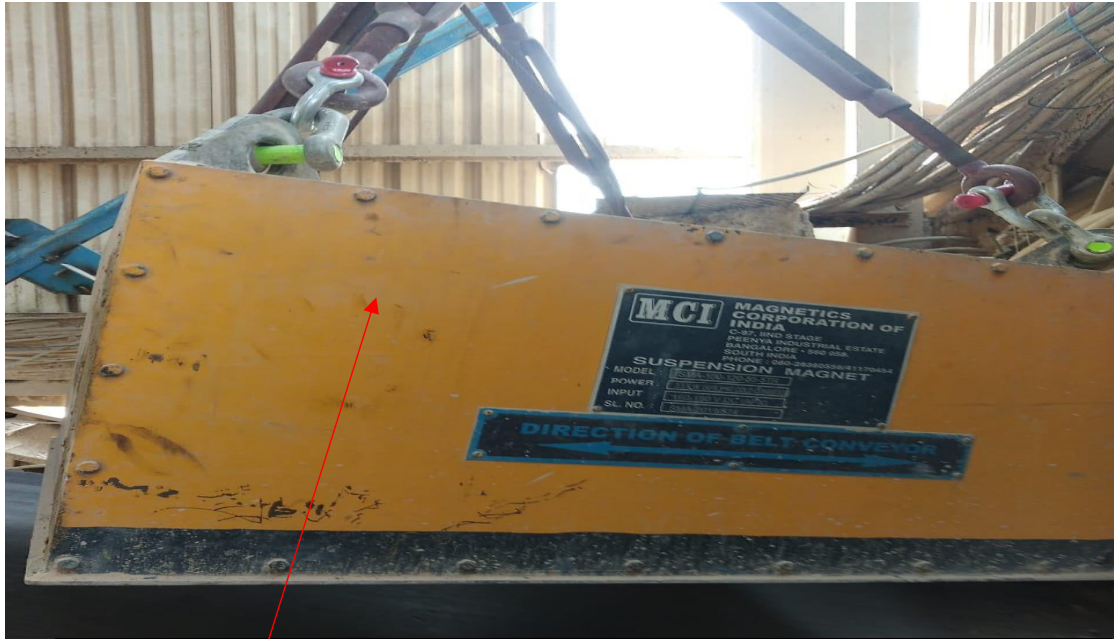
NEW ELECTRO-MAGNET PROVIDED IN THE DRIVE END OF THE CONVEYOR TO REMOVE FOREIGN METALLIC PARTICLES

- Hydraulic oil of fluid coupling was replaced & greasing in gear coupling was done.
- One Electro-magnet was installed in drive end of conveyor to remove the foreign tramp metals from bulk material on the belt conveyor. The magnet shall adheres ferrous contaminants to the belt and it will restrict to passes in to the Ball Mill, MST Pumps etc., which damage shell liner & lifter bar assembly & also damage to the pump.

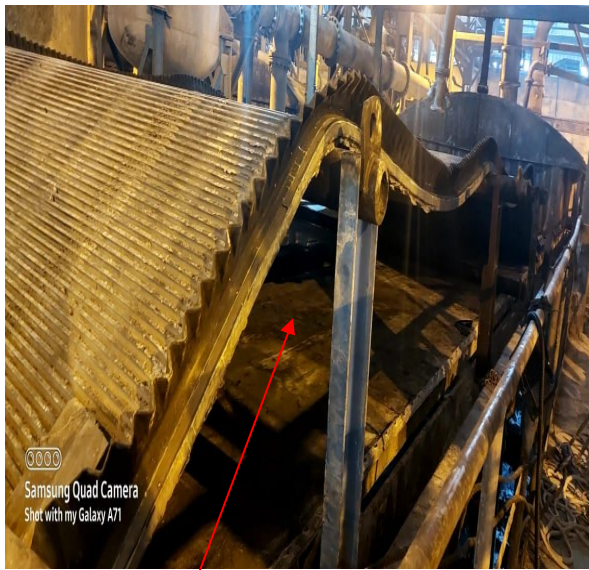
Top Cover replacement job

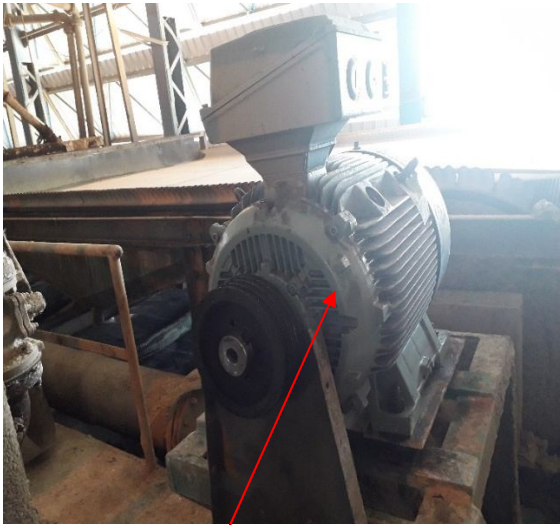
New Motor installation

- Old Motors removed out from position, new motors installed and alignment done.

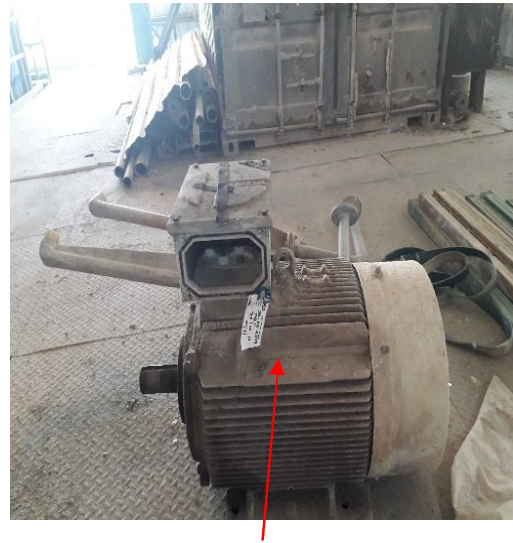
Old Removed out Motor

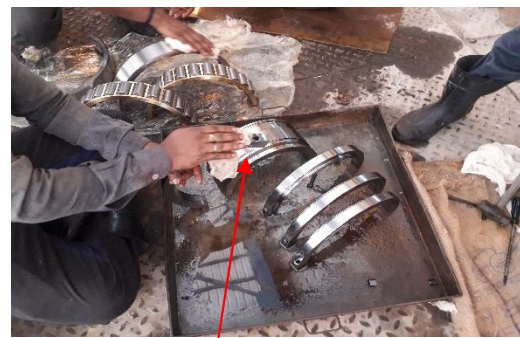
New Bearing ready for installation

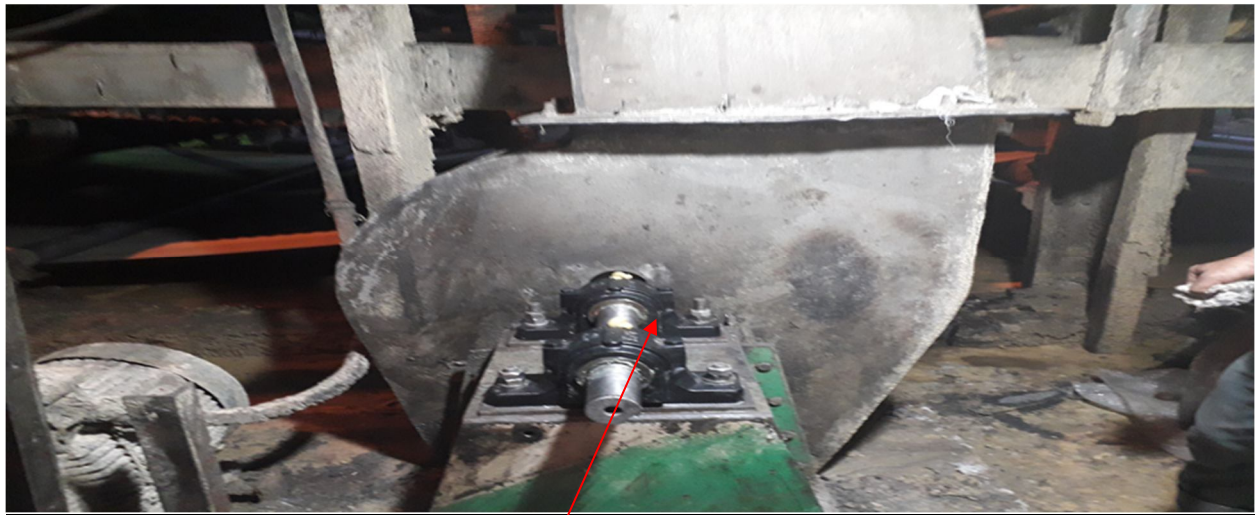
Air Suspension Blower after overhauling

- Bearings of All suspension blowers were inspected.
- Balancing of Rotor of Blower A, B, C, & D was carried out.
- The Rotor of all four fans were balanced.
- Bearings, base bolts, drive belts inspected and corrective measures were taken.
- Finally Blowers were assembled and taken into operation after NDT testing.

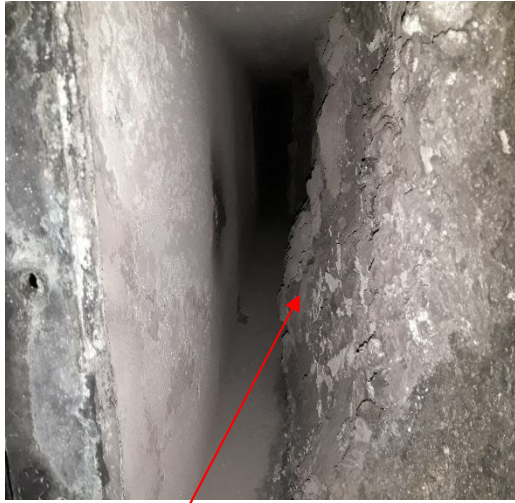
- End dummy of Air Duct opened.
- Heavy sludge deposition observed in Air Ducts.
- Air Ducts cleaned and boxed up.

Chocked Air Duct

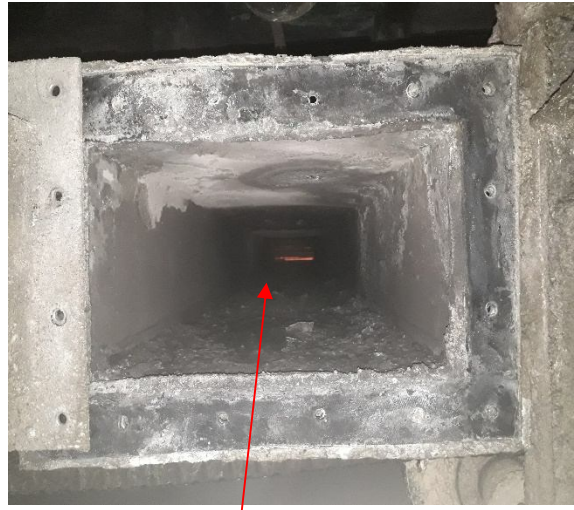
Air Duct after cleaning.

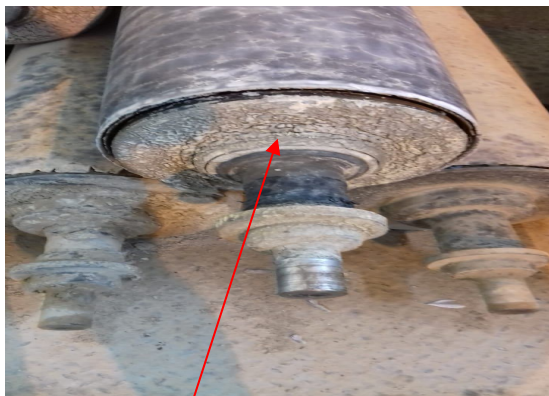
- Belt Return Rollers and Cloth Rollers of all seven filters were inspected.
- It was observed that bearing portion of shaft in some rollers were worn out. Drum of Some Belt Return Rollers were also found corroded due to damaging of rubber lining.
- The damaged rollers were taken out and new rollers were installed.

Damaged taken out Rollers

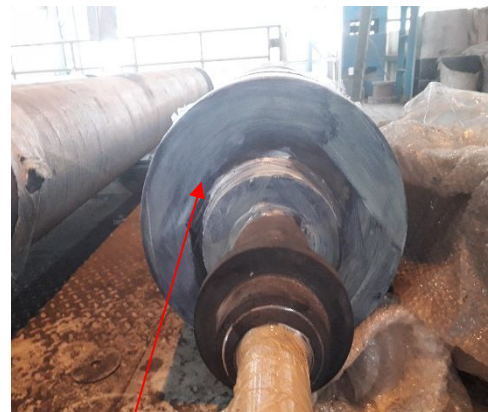
New Rollers ready for installation

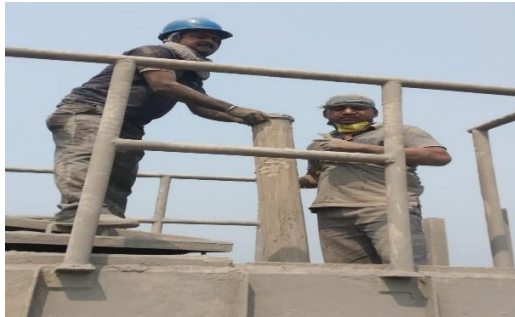
- Maximum number of Bags are in Choked condition & some Bags are found in damaged condition.

- 07 nos of SS cage are found in damaged condition in Old Silo & 05 Nos SS cage are found in damaged condition in New Silo.

OLD BAGS WITH SS CAGE REMOVING WITH CAGE ARE LIFTING

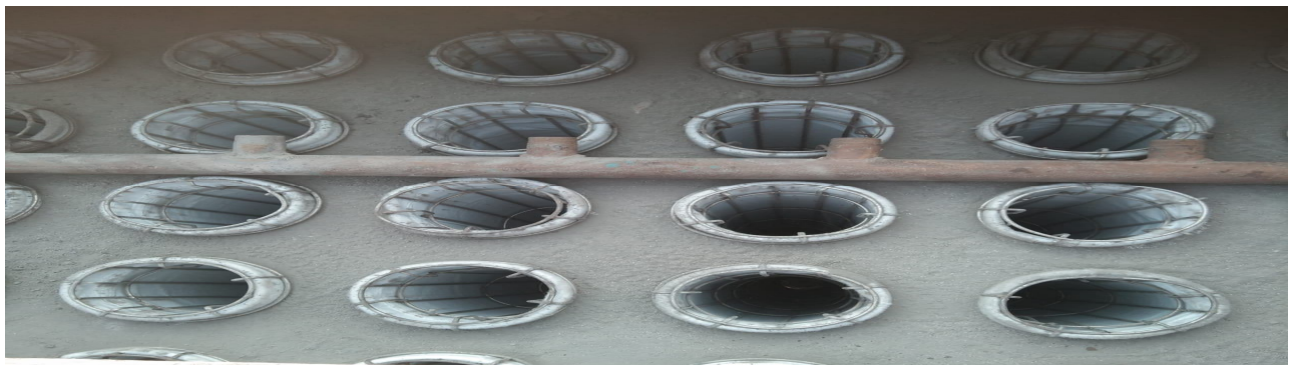
NEW BAGS WITH SS CAGE FITED INSIDE THE VENT FILTER BOX

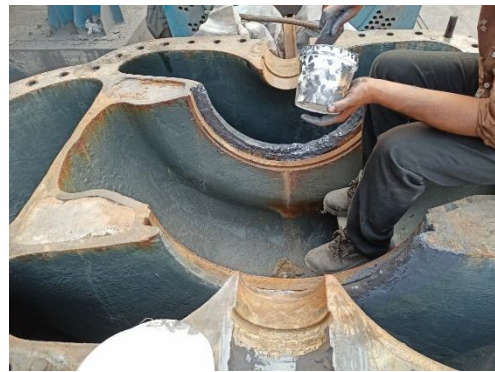
REPAIRING OF CASING

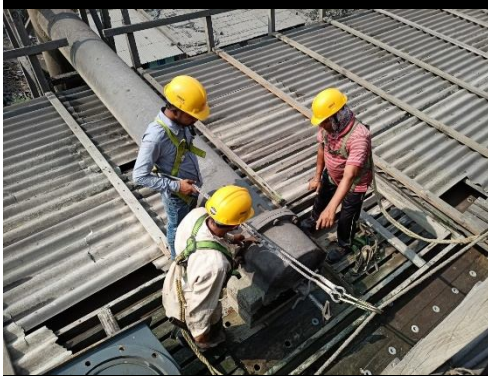
It was observed that cooling tower old flow control valves of cell no 1 & 2 cannot isolate water completely.

Removal of old FCV

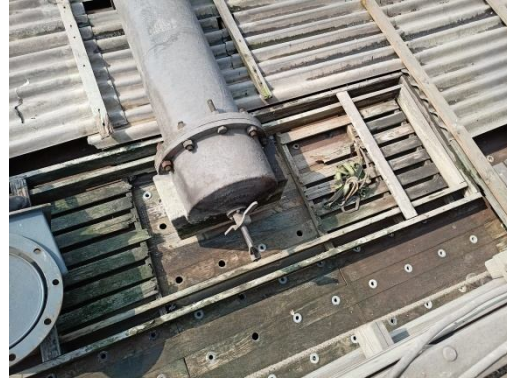
New FCV after installation

It was planned to replace old flow control valves with new flow control valves for upcoming revamping of TG Cooling Tower with pultruded material.

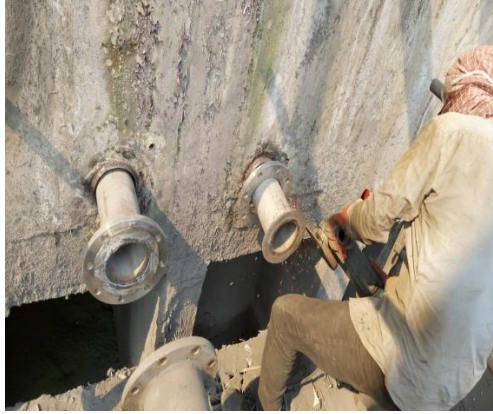
TG Cooling Tower Cell No 7, 8, 9 & 10 blow down line become highly corroded.

S.S. pipe and flange fitting
