ATR REPORT-2021

**INDIAN FARMERS FERTILISERS CO OPERATIVE LTD.
PARADEEP UNIT**

ATR REPORT: 2021

DAP PLANT

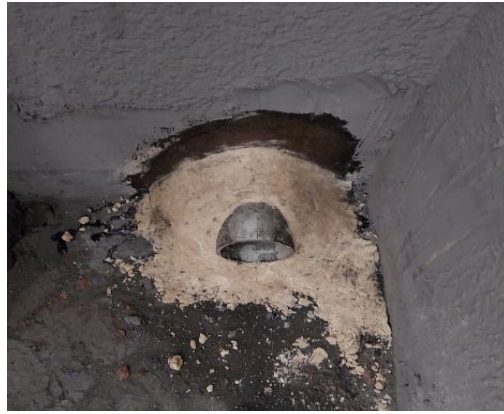
Grouting of S.S. pipe

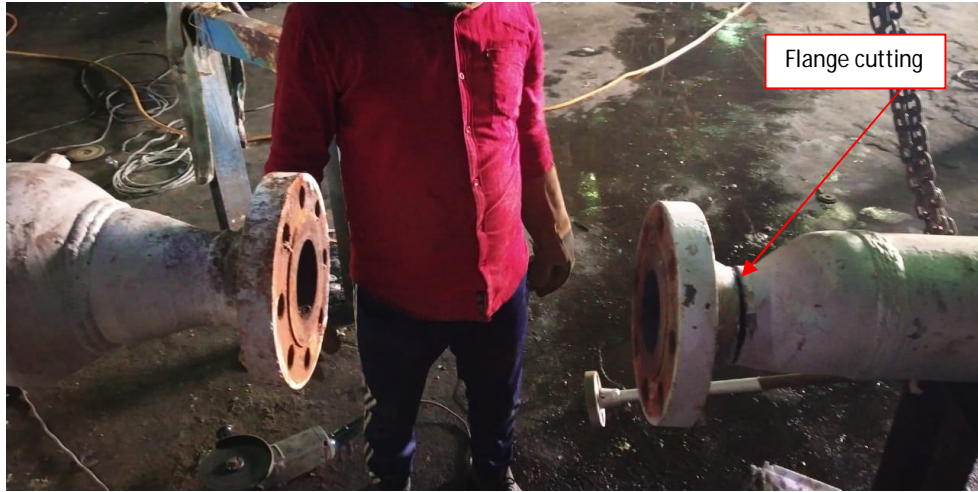
Existing PRDS was not maintaining temperature of steam to the required value. So it is decided to replace present type of PRDS with a new different type of PRDS.

Figure 1: Old PCV removed and flange cutting started

PRDS PCV and TCV are replaced and new nozzle assembly for desuperheating was installed.

Insulation was removed from steam and water headers. Surrounding area was cleaned for maintenance. The steam header was locked and supported to avoid any shifting of header. Old PCV was removed from position by opening bolts from all flanges.

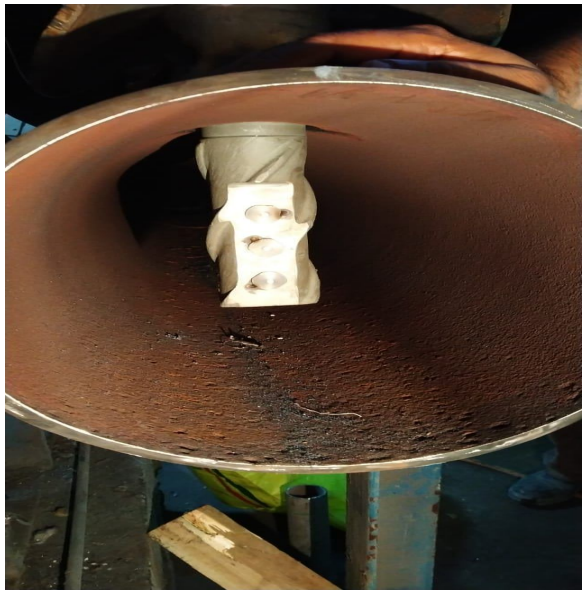
Figure 3: Nozzles for desuperheating

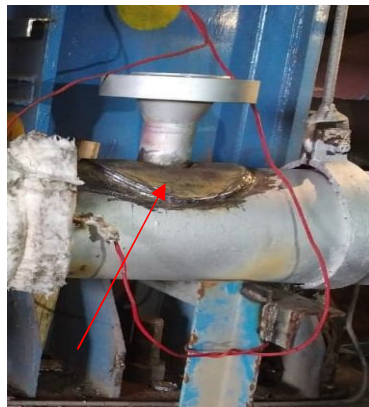
Figure 6: Branch joint pad fitted

This branch joint is padded suitably that are shown in figures below. The cutting of header was done as marked.

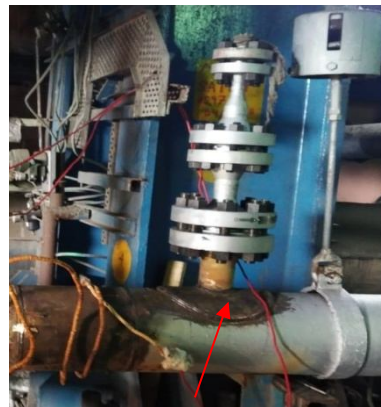
Figure 7: Branch joint pad is welded

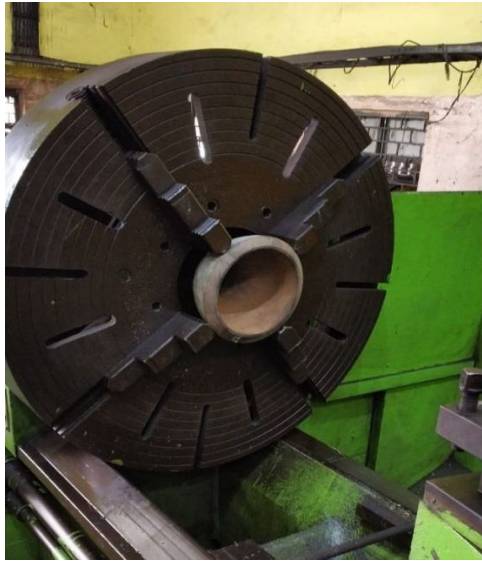
Figure 10: Reducer at workshop for machining

Edge preparation for all joint ends was carried out. Reducer edge was prepared at workshop by machining to match ID with pipe.

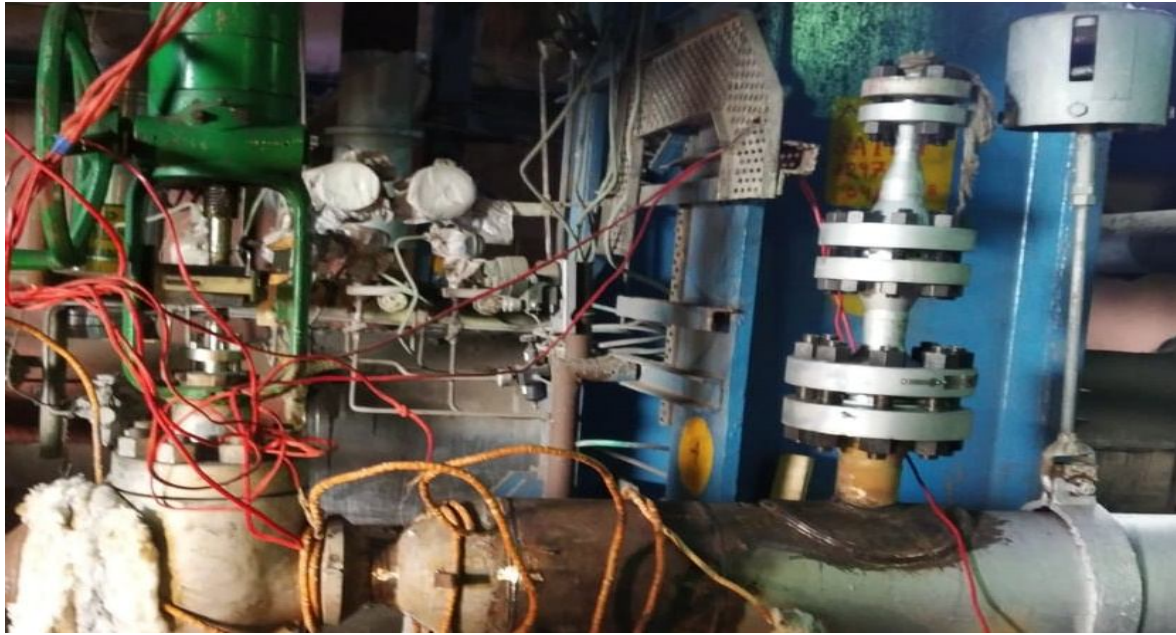
Figure 15: Final welding completed

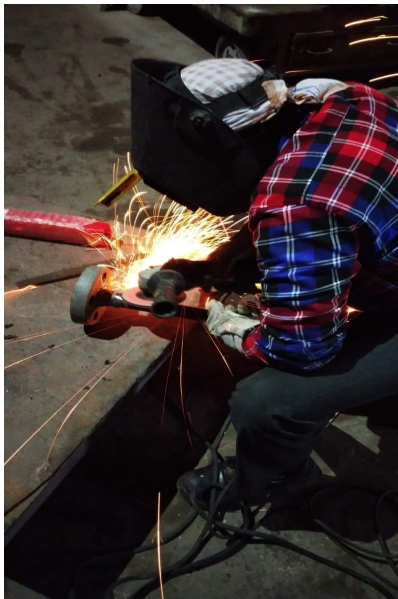
Figure 16: Preparing for TCV positioning

The TCV was positioned and required pipe fabrication was carried out as per scheme. Locking of header was removed. Finally insulation was applied before charging of header.

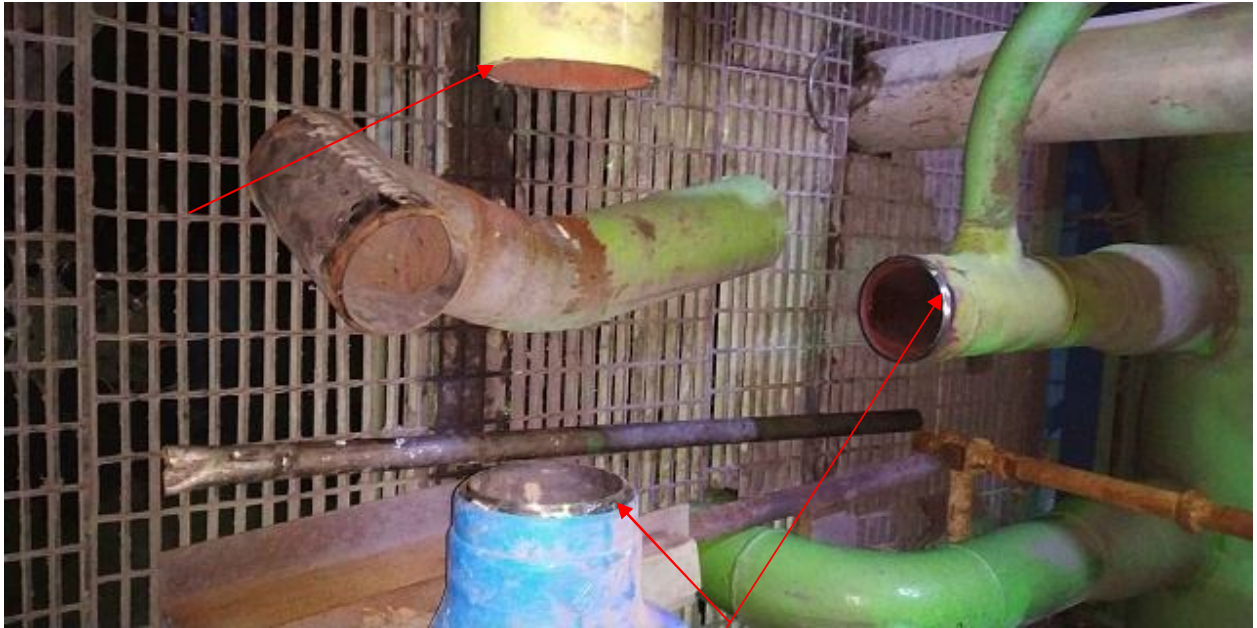
Figure 1: Header cutting done and edge preparation is under progress

Scaffolding work was done prior to start the job. Condensate header was drained and locked to avoid any shifting of header. The positions for cutting the condensate header were marked with precise measurement and alignments. The cutting of headers to hook up was done.

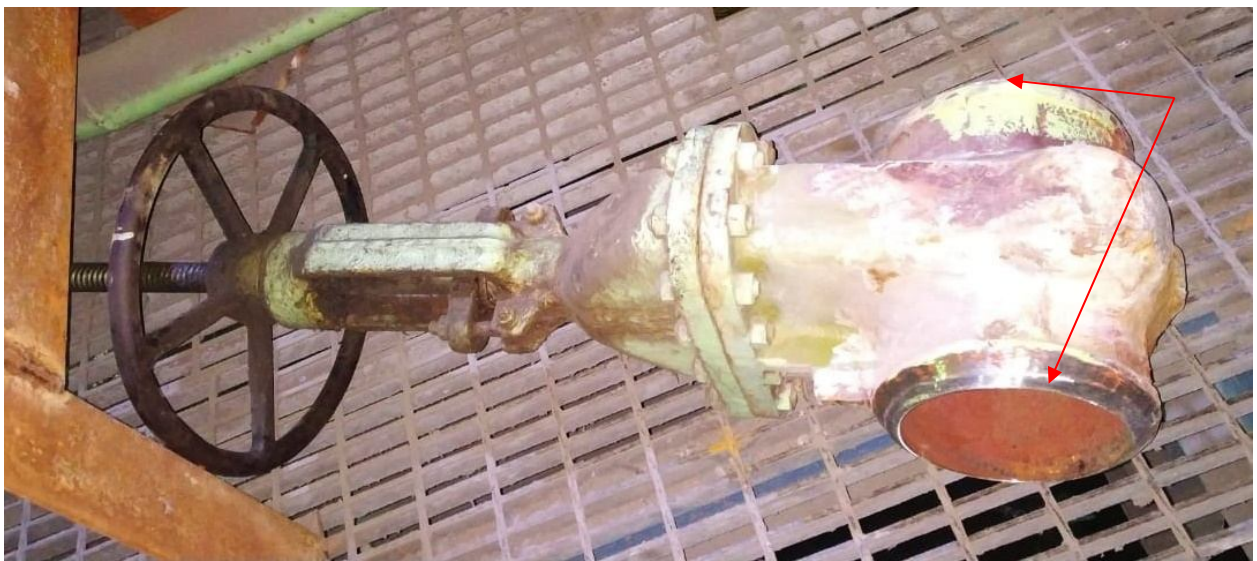
Figure2: Old valve edges are prepared

Edge preparation was carried out both in 150 NB headers & 80 NB pipe line.

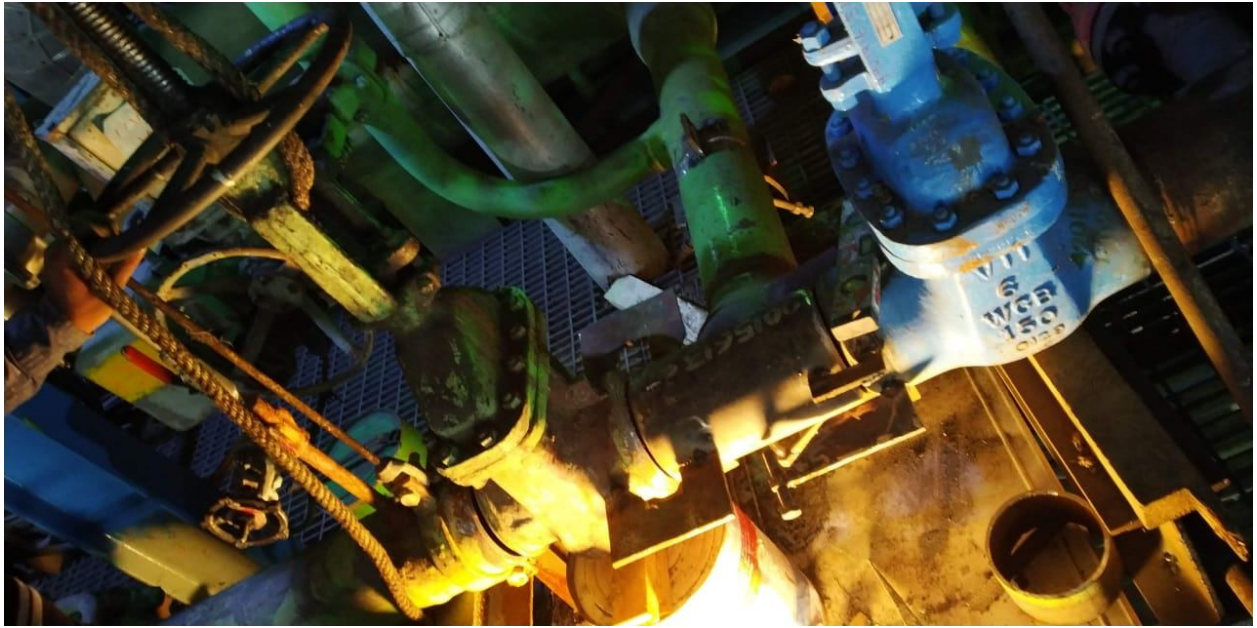
Figure 3: 150 NB joints fit up job is under progress

Fit up of the joints was done & checked for its fitment for welding. Excluding prefabricated job there are eight 150 NB joints and three 80 NB joints.

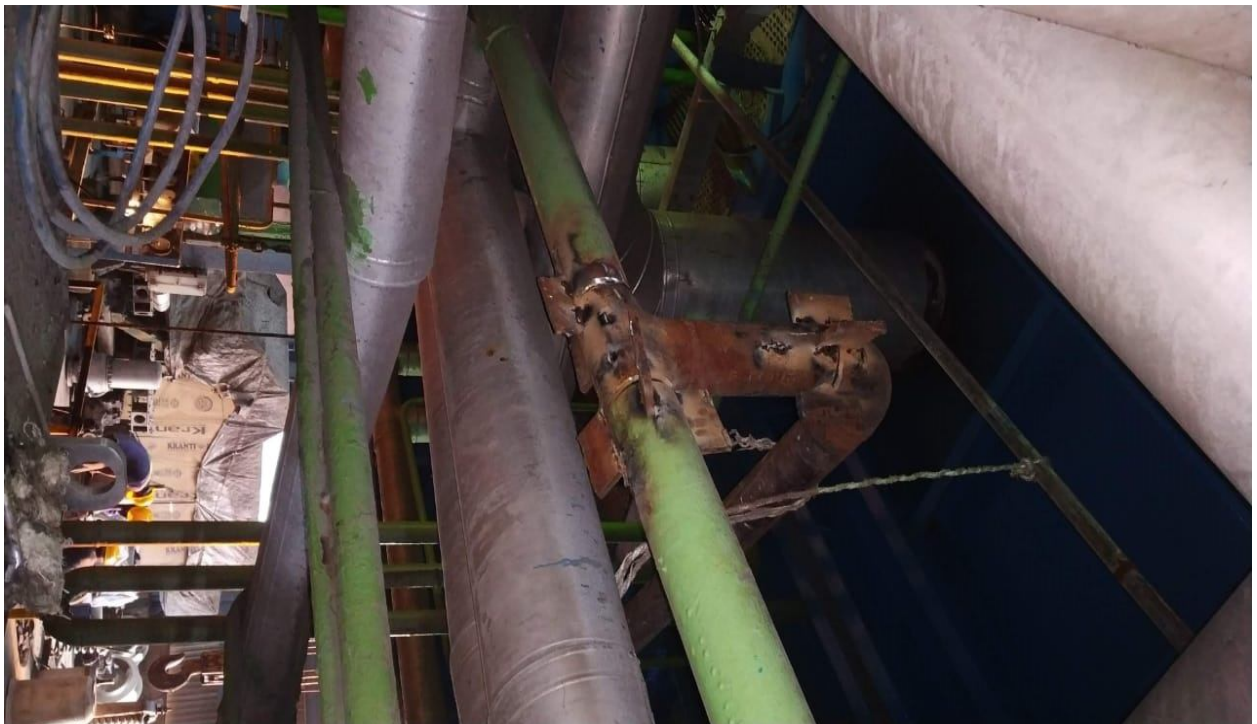
Figure 4: 80 NB pipe fit up completed

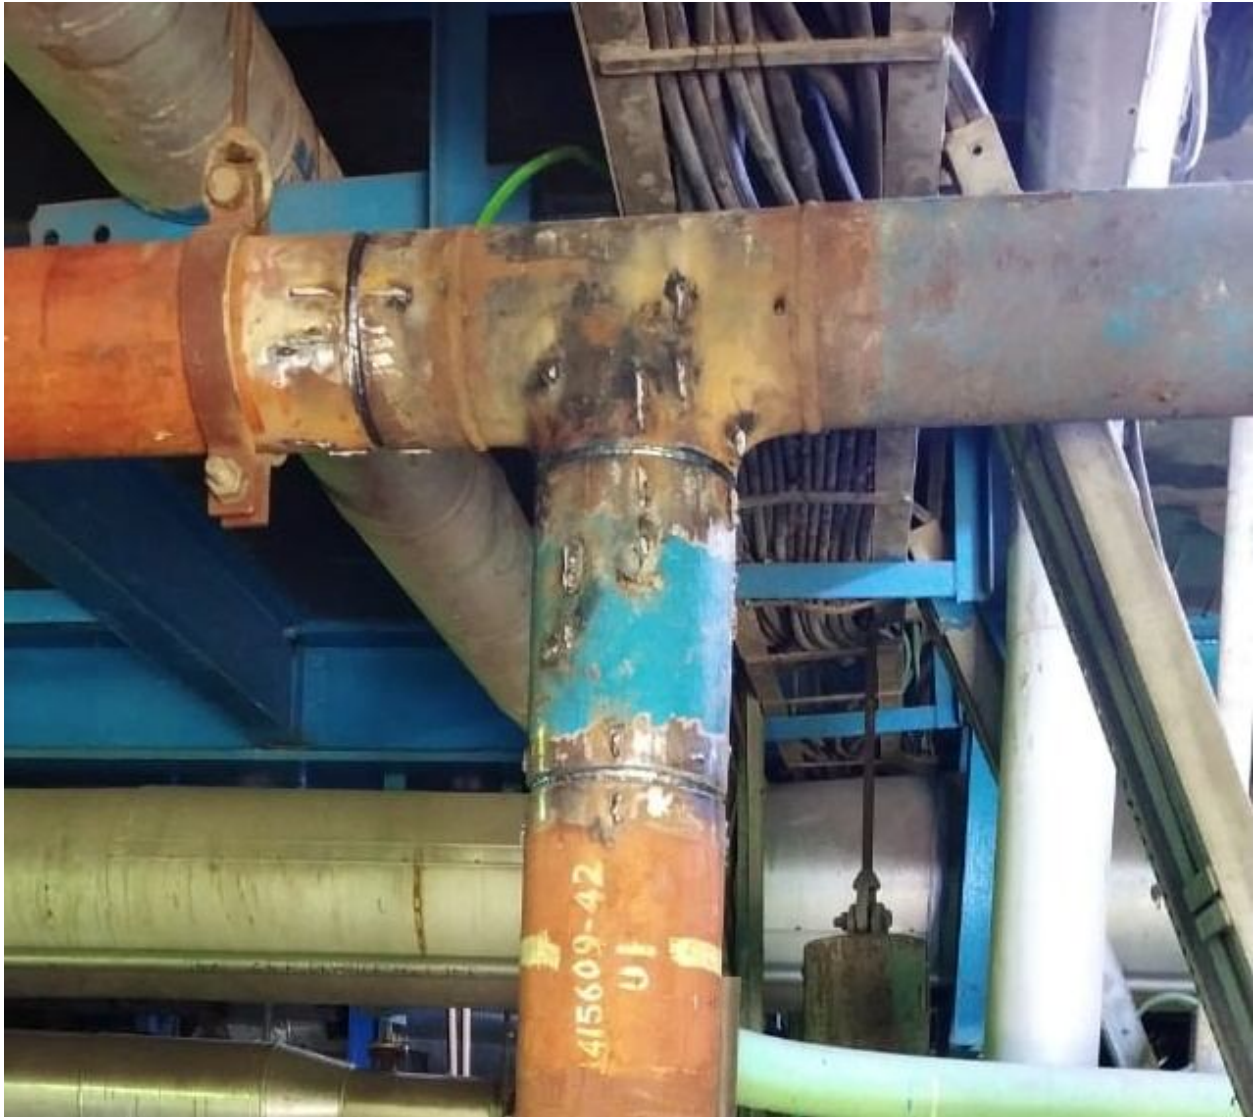
Figure 5: Root welding (TIG) completed

First welding was started with TIG for root joints after that DP test was done.

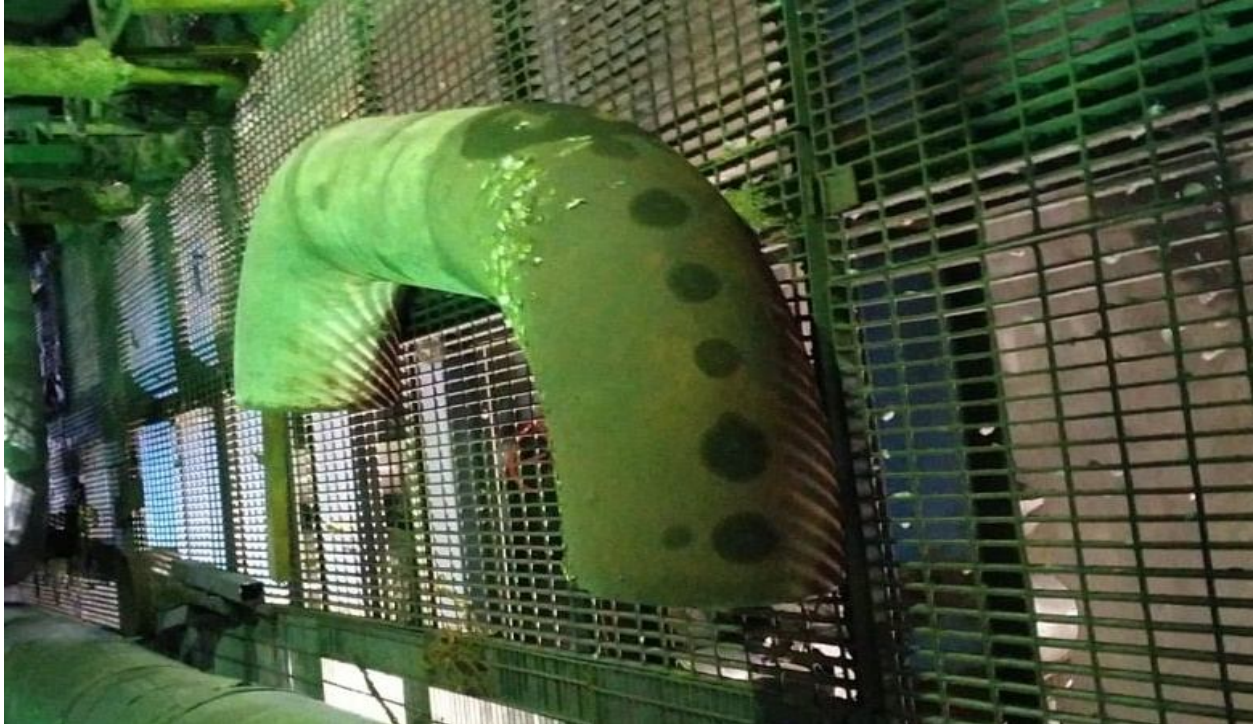
Figure 2: 400 NB LP header portion to be replaced is removed

Insulation was removed from alongside steam headers to provide work front for this job. The surrounding area was cleaned for maintenance. The steam header was locked to avoid any shifting of header. The positions for cutting elbows were marked with precise measurement. Slings & chain blocks were properly placed to hold elbows are to be removed. Cutting of header to replace elbows was started. Old elbows were removed safely.

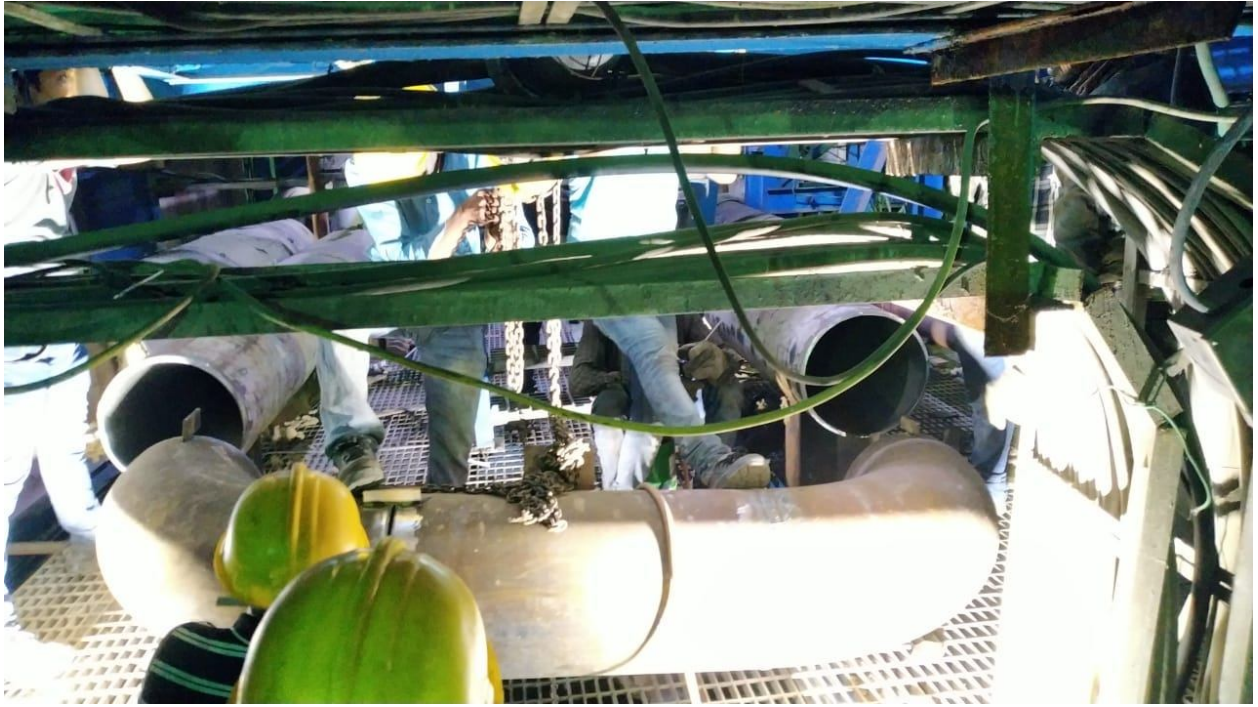
Figure 6: Elbow fit up under progress

Fit up of the elbows were done & checked for its fitment for welding.

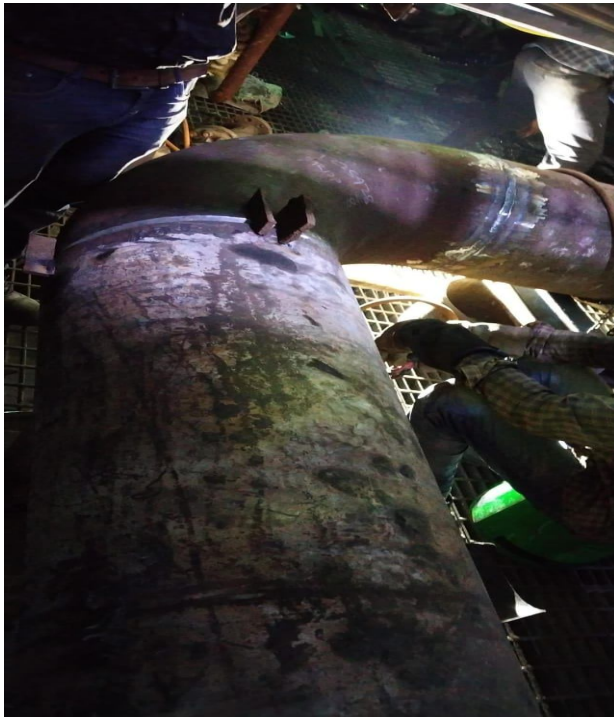
Figure 7 & 8: Both Elbows are fitted and ready for welding

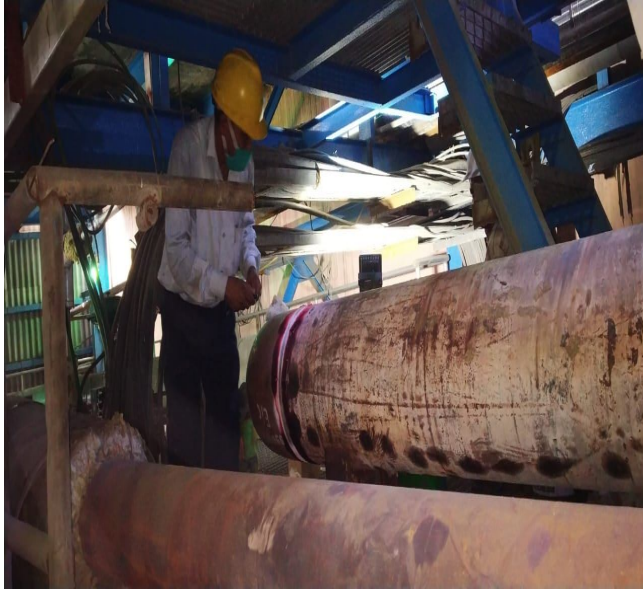
Figure 11: DP test for Joint-2 root welding

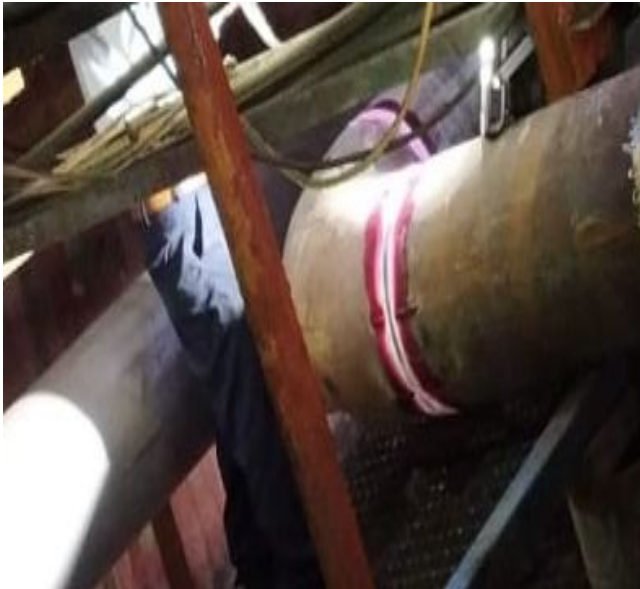
Figure 12: DP test for Joint-3 & 4 roots welding

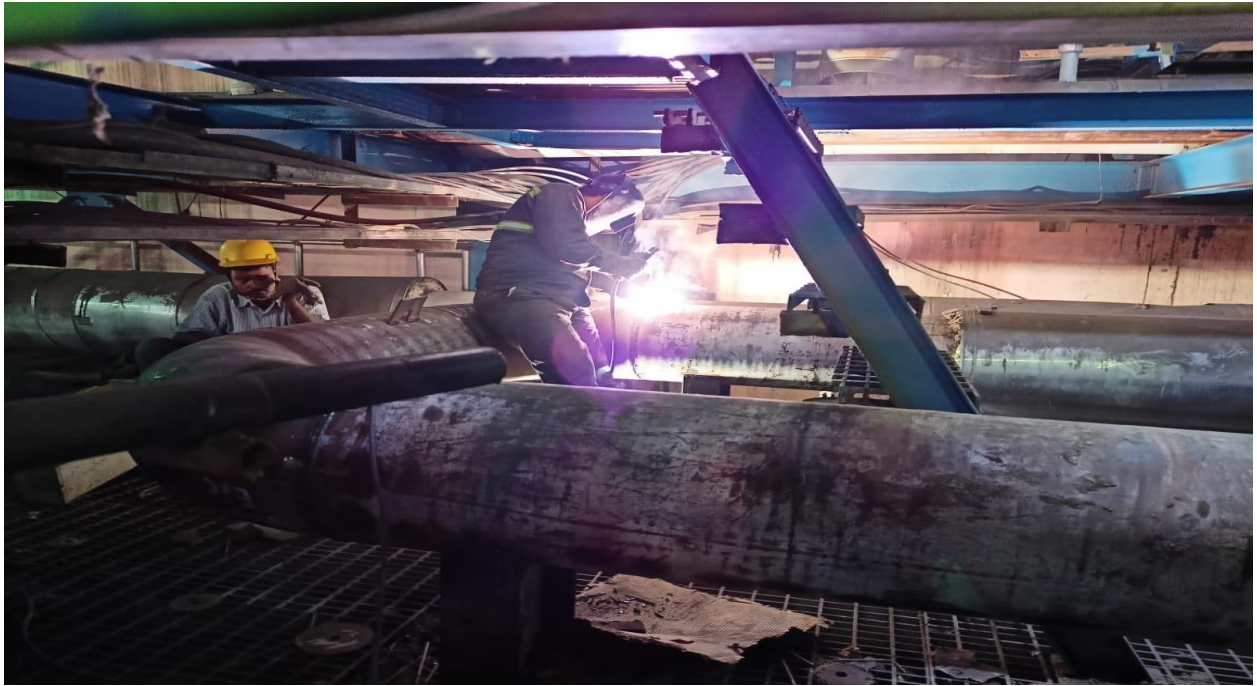
Figure 13: Final welding for joint-4 under progress

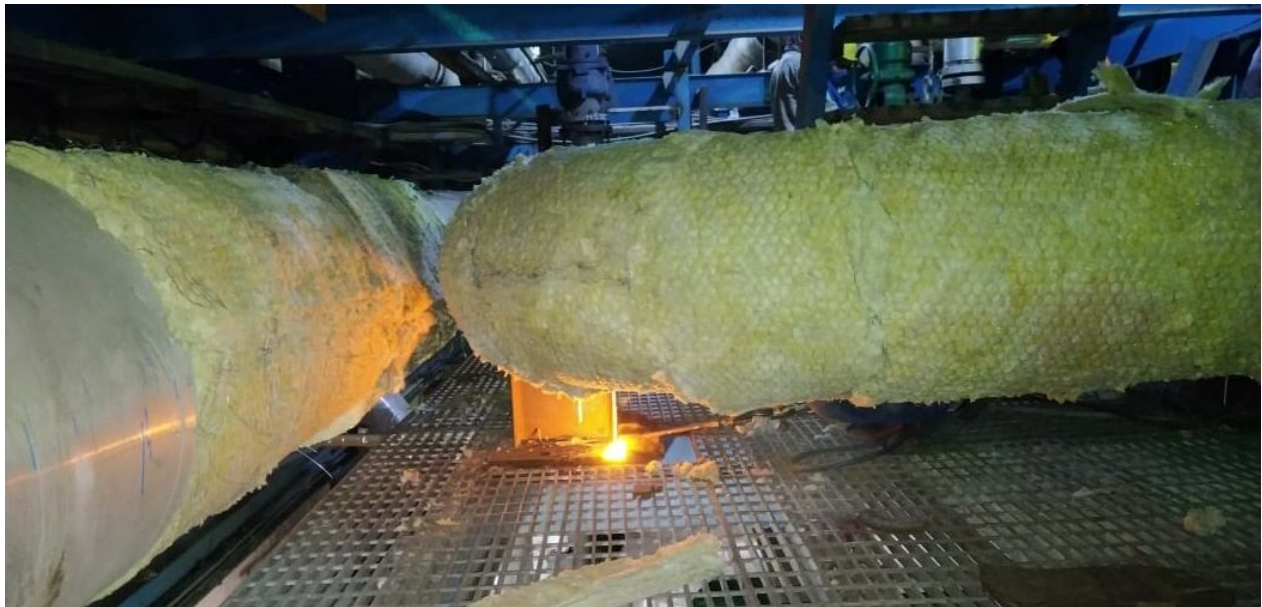
Figure 14: Header locking removal & insulation application

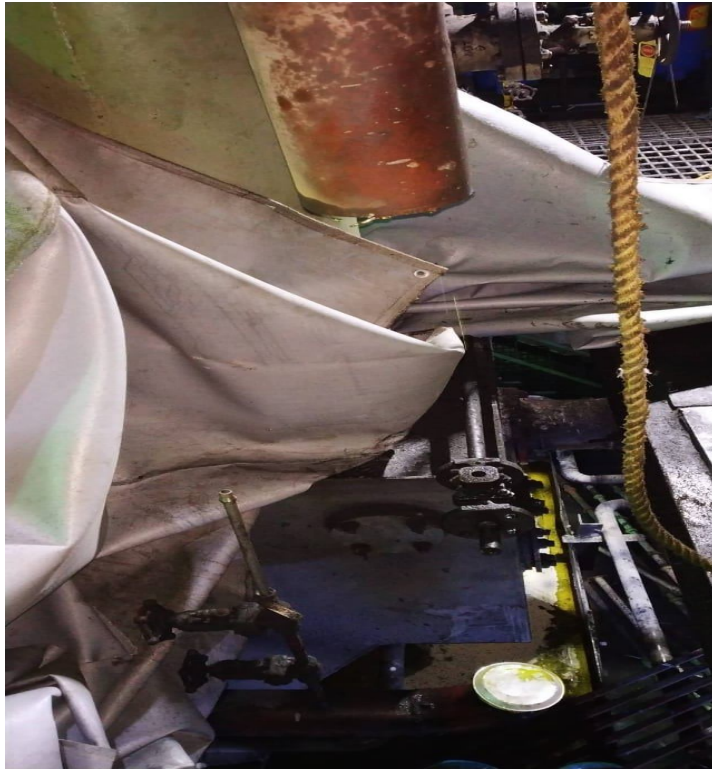
Figure 2: GOP(M) header after cutting NRV & valve

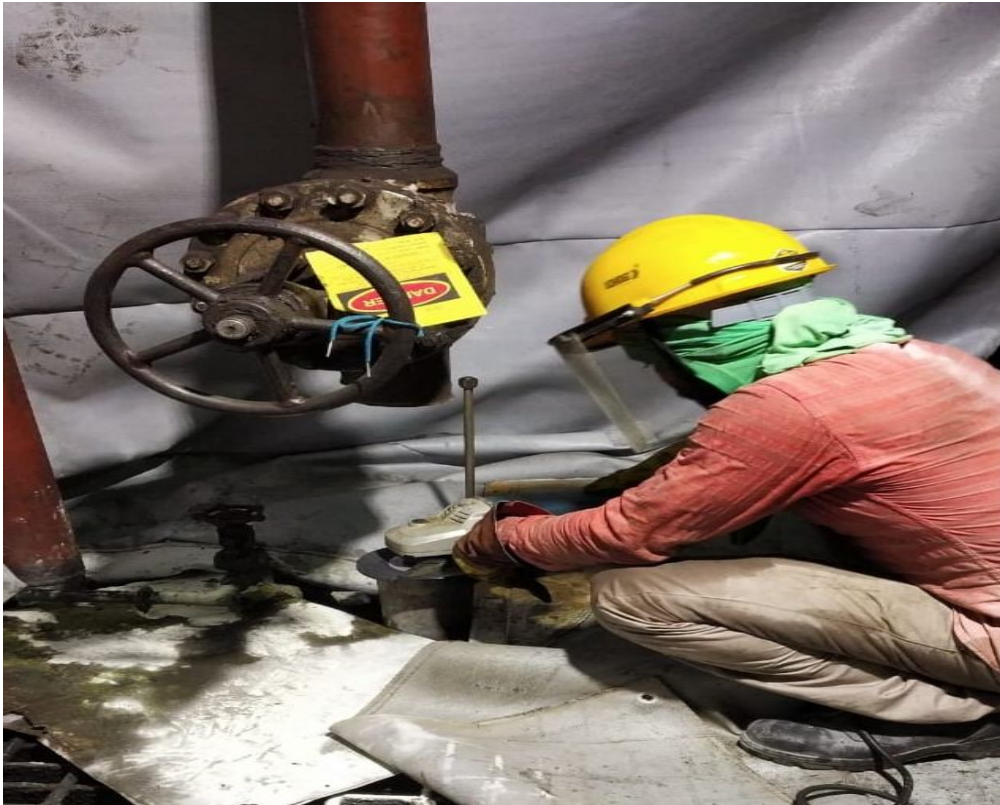
Figure 4: GOP(S) discharge pipe edge preparation is under progress

Edge preparation was carried both in header & items to be replaced. Fit up of new NRV was done & checked its fitment for welding in GOP(S) discharge header. Root welding completed and DP test was done.

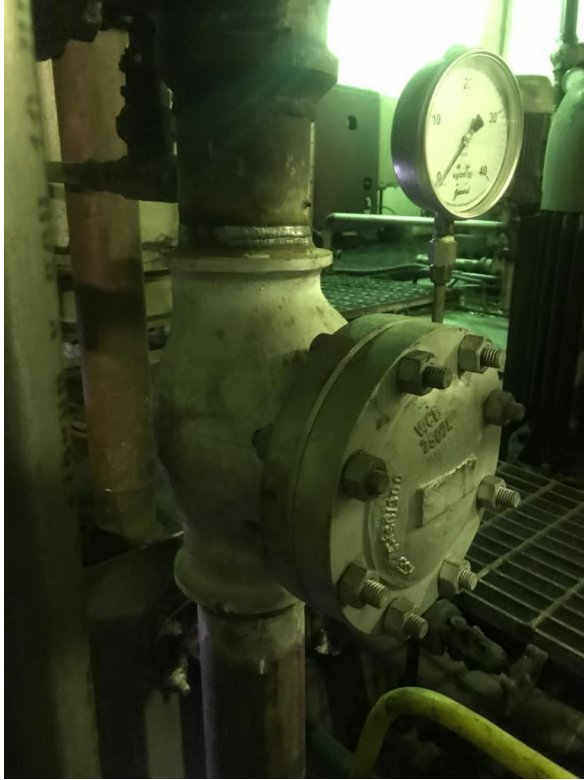
Figure 7: GOP(S) NRV after replacement

Both NRVs are checked for passing and found ok. Now these are in operation.

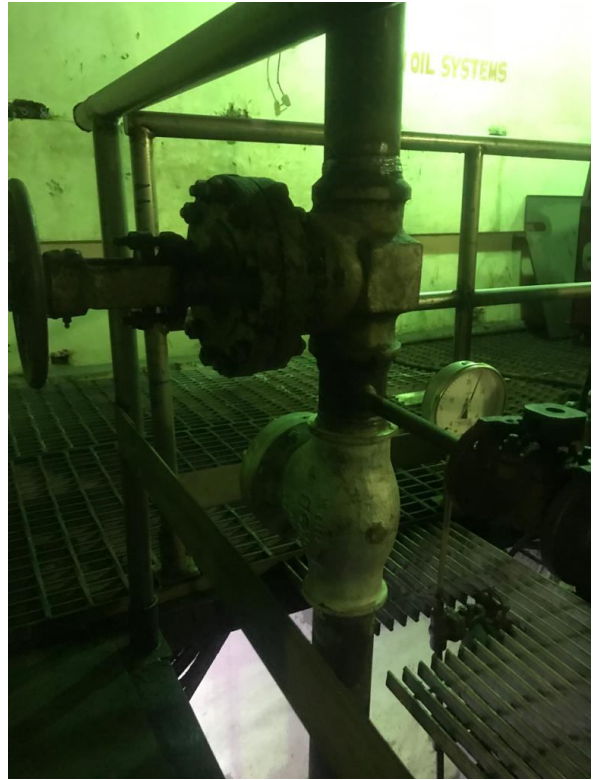
Figure 8: GOP(M) NRV after relocation & replacement

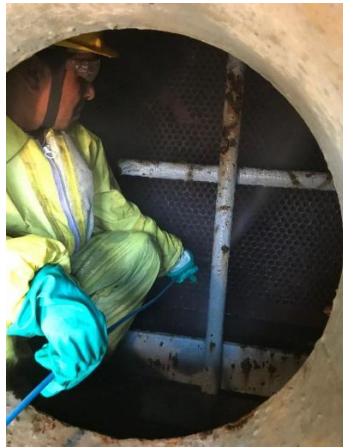
Hydro jet cleaning

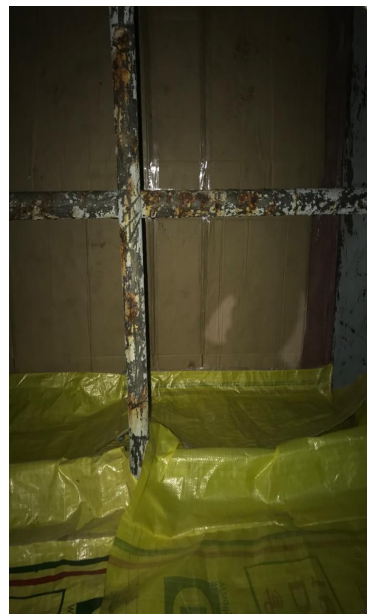
Covering of tubes & header

Action taken: To prevent further rusting of tube sheet area, action was taken and coating work was allotted to M/s Wearrist Technologies against P.O. No.-6600 /252004202619 to carry out the coating job for both condensers.

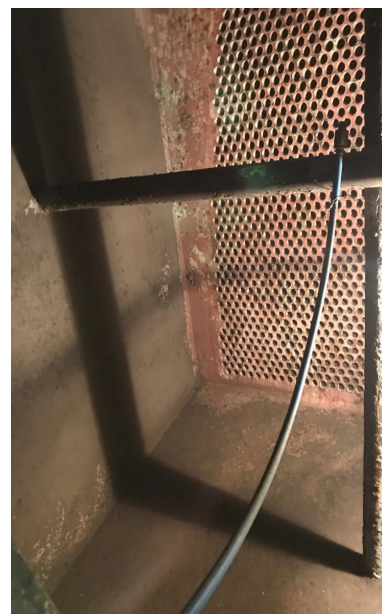
After sand blasting

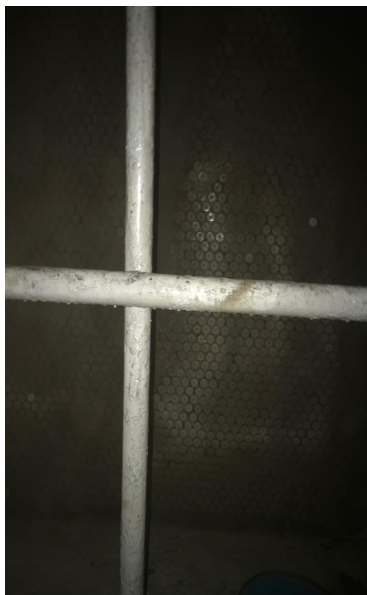
After sand blasting

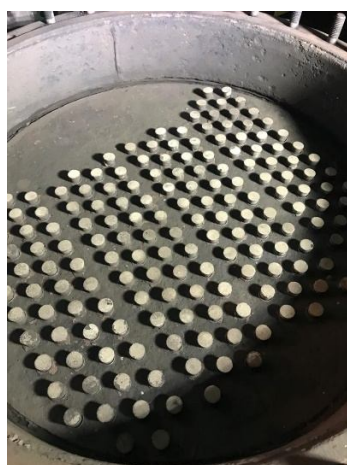
After sand blasting

Job execution: The job of coating for both oil coolers was executed by M/s Wearrist Technologies agencies under the supervision of IFFCO Engineer. Job started on 26/03/2021 and completed on 27/03/2021.

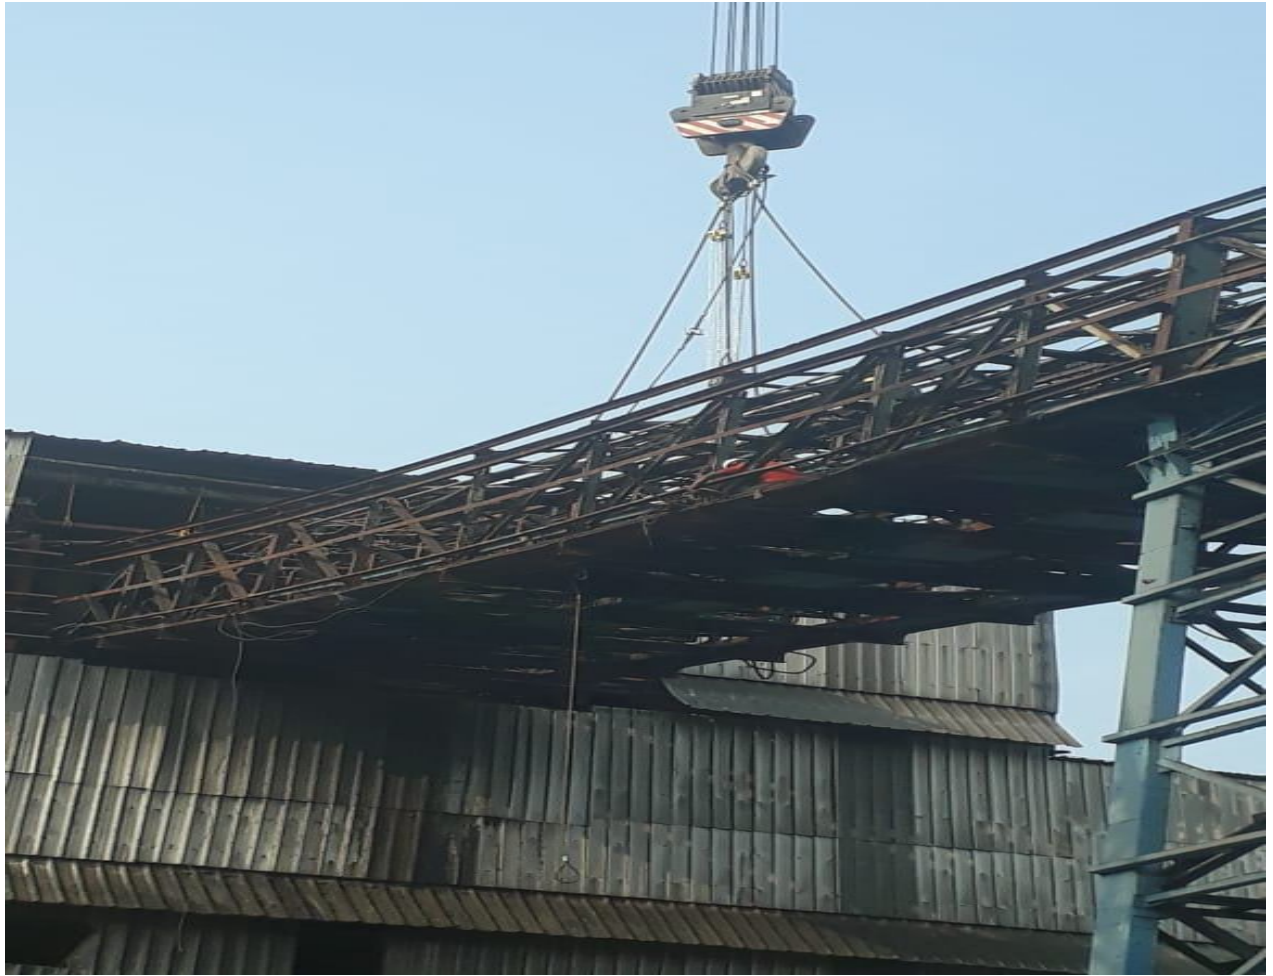
The badly corroded & sagged portion of the BC- 1130 / 132 as shown in the photo snaps were completely replaced with new pre-fabricated structures.

SAGGED PORTION OF GALLERY- BC- 130 /132 – BAGGING PLANT

1. The badly corroded portion (Gallery 1 & 2 -Around 45 Mtrs) of the conveyor gallery BC- 130 / 132 along with its support trestle No- 1 (4 leg support) & take-up structure (2 leg) including its platform had been replaced with complete new pre-fabricated structures during the ATR within a period of 18 days w.e f:16.03.2021. Further, the civil structures **(Total 06 Nos)** were also constructed over which the newly fabricated trestles were placed with base plates having 06 holes instead of 04 holes as earlier. **One no of additional support** structure was also installed near by the take-up structure prior to the cutting of gallery No-2.

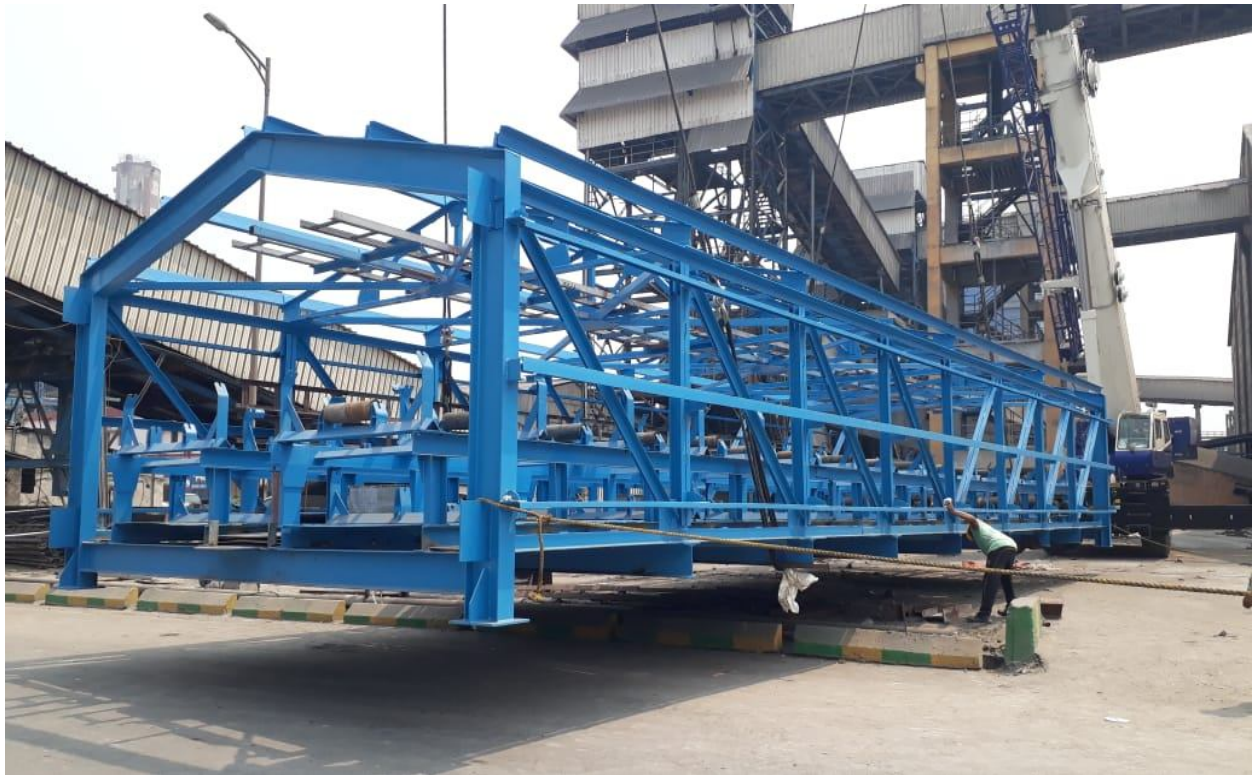
NEW GALLERY FOR ERECTION

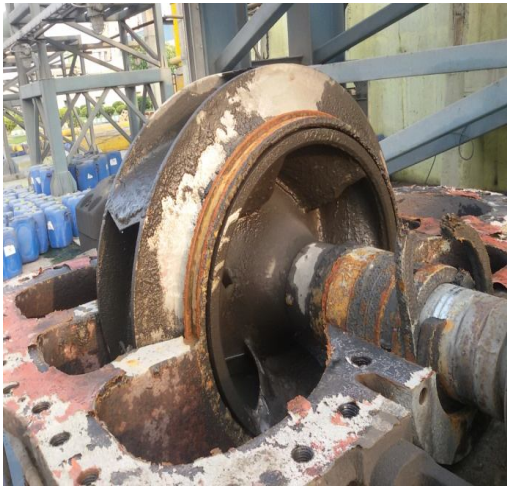
1. Minor Pitting found on both side of suction eye impeller area.
2. Thrust bearing found ok.
3. D.E & NDE side journal bearings found in good condition with little scratching & dents.
4. Gland packing were found severely worn out but Gland sleeves were in good condition.
5. Previously coated antifriction coating in the top and bottom casing found peeled off.

Rotor Assembly Condition after top casing removal

1. A complete rotor assembly (repaired) was made ready for erection.
2. Impeller vane shroud portion that were pitted severely were welded and sent for dynamic mass balancing, balancing report is attached.
3. Both the bearings housing were cleaned with diesel; throat bush sitting position, casing neck ring sitting position were also cleaned properly.
4. Both side journal bearings are replaced with new journal bearings, journal bearings were polished and blue matching was done with an excellent matched area.
5. DE side gland sleeve was replaced with a new gland sleeve.
6. NDE side THRUST Bearing was replaced with a new 6318C3 bearing.
7. New Casing gasket & Hollow core type PTFE gland packing provided.
8. Clearance of both NDE & DE side journal bearing were taken and are 0.11mm & 0.13mm respectively.
9. Finally bearing housing top cover and casing top cover tightened.

10. Top casing and bottom casing pitted portion were built up and applied with ITW coating.

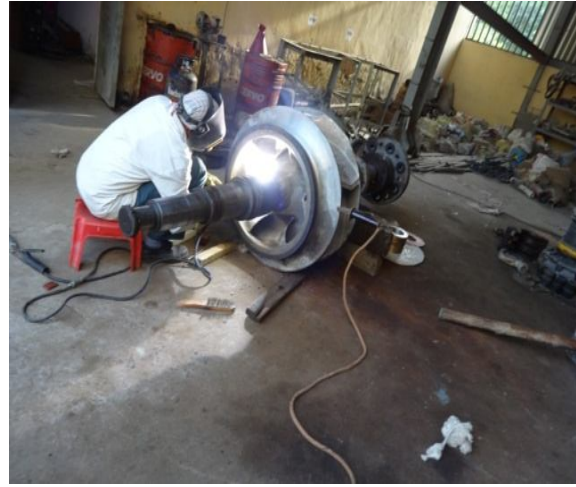
Rotor Assembly Condition after cleaning

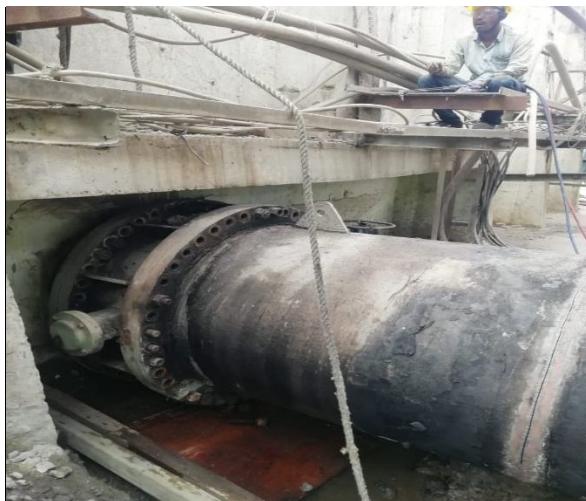
Suction Valve before Replacement

12. Pump Suction valve 1200NB Dia. Replaced.

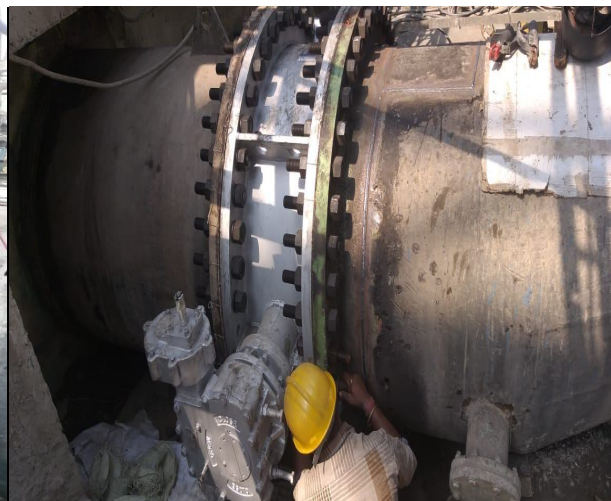
Suction Valve After Replacement

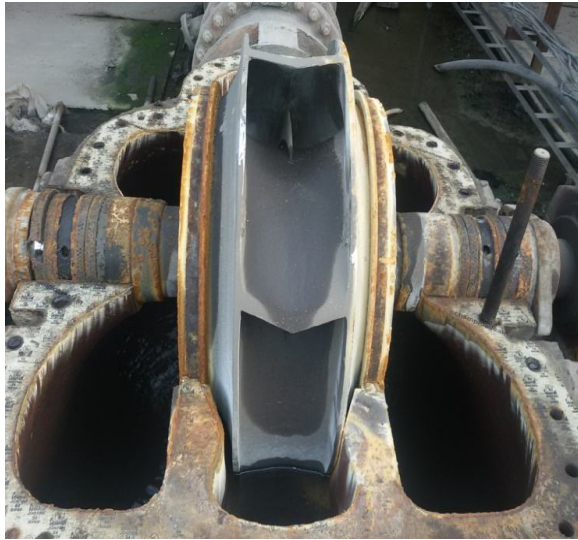
1. Minor Pitting found on both side of suction eye impeller area.
2. Thrust bearing inner race found damaged and distorted.
3. D.E & NDE side journal bearings found in good condition with little scratching & dents.
4. Gland packing were found severely worn out but Gland sleeves were in good condition.
5. Previously coated antifriction coating in the top and bottom casing found peeled off.

Fig: SAP cooling tower Pump B casing rotor condition.

5. Both side journal bearings are replaced with new journal bearings, journal bearings were polished and blue matching was done with an excellent matched area

6. NDE side THRUST Bearing was replaced with a new 6318C3 bearing.
7. Top casing and bottom casing pitted portion were built up and applied with ITW coating.

8. New Casing gasket & Hollow core type PTFE gland packing provided.
9. After fitting of journal bearings, clearance was taken and found within limit (0.11 mm and 0.13mm for DE and NDE Side respectively).

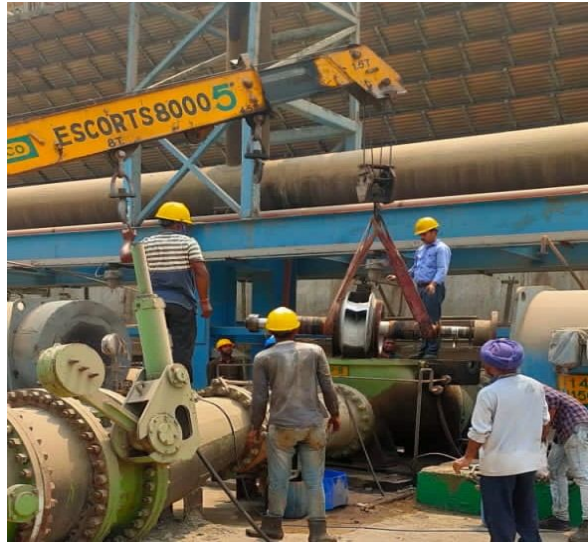
Rotor assembly during erection

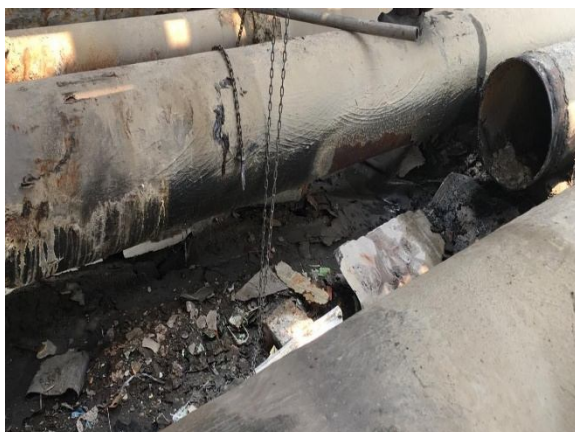
TG Cooling tower line Replacement before

1. Cooling water line to reciprocating and centrifugal air compressor inlet line approximate length 6 mtrs dismantled, fabrication erection and hookup done.
2. Fitment, DP test carried out after root run and final welding done.

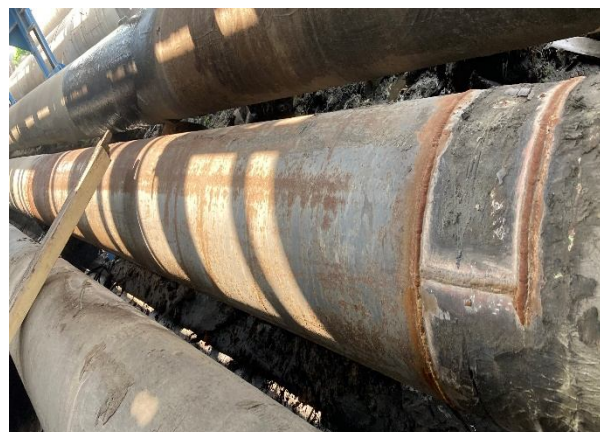
TG Cooling tower line Replacement after

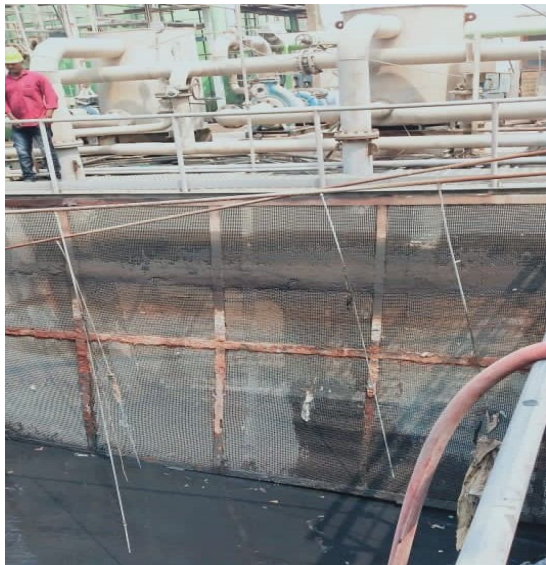
Neutralization Pit Pump Suction strainer before.

D. Neutralization Pit Pump damaged Suction strainer removal, fabrication and erection of new suction strainer of SS 304 jally.

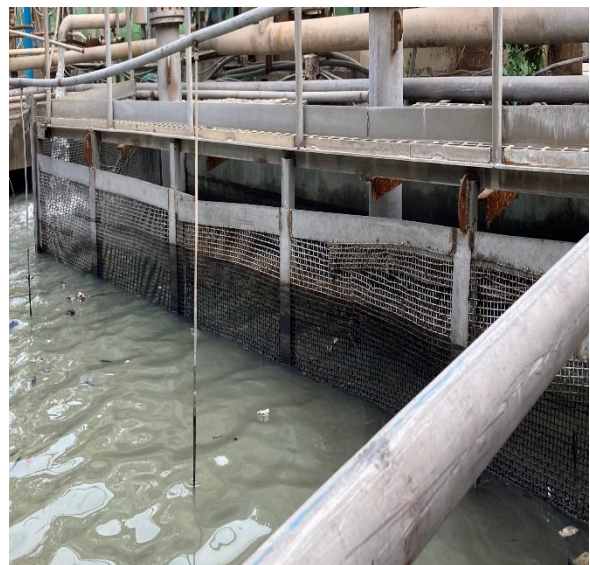
Neutralization pit pump suction strainer after replacement.

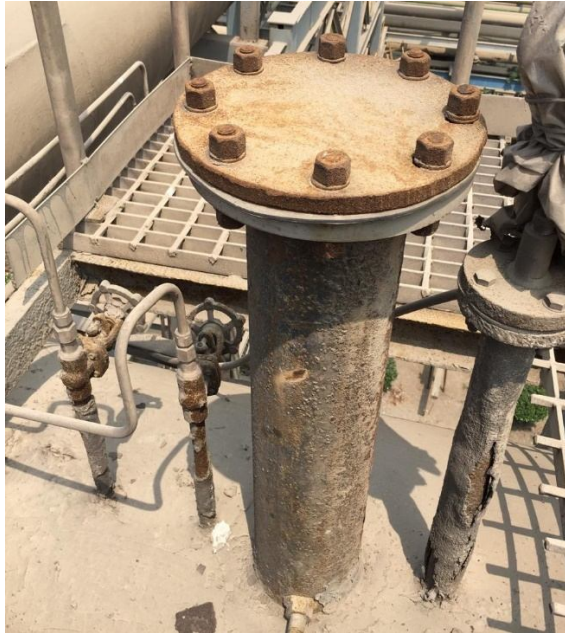
PH and Temperature Nipple before Replacement

F. SAP Cooling Tower Discharge header PH and Temperature meter nipple replacement.
