ATR REPORT-2021

**INDIAN FARMERS FERTILISERS CO OPERATIVE LTD.
PARADEEP UNIT**

ATR REPORT: 2021

DAP PLANT

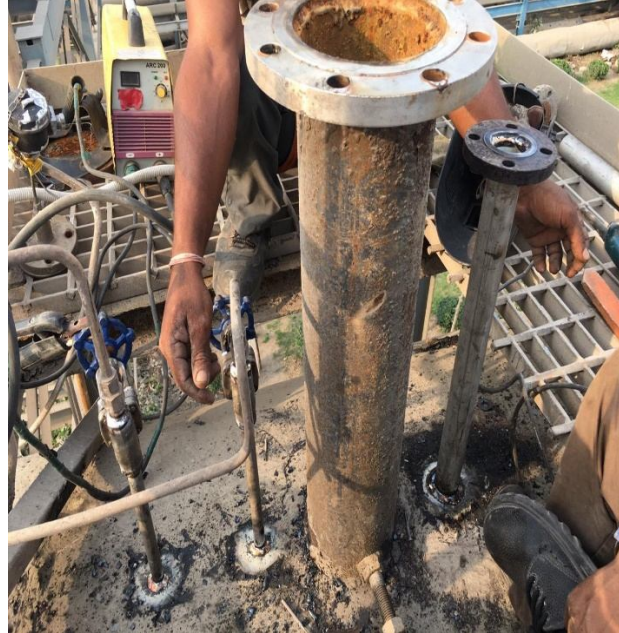
PH and Temperature nipple After Replacement

F. SAP Cooling Tower Discharge header PH and Temperature meter nipple replacement.

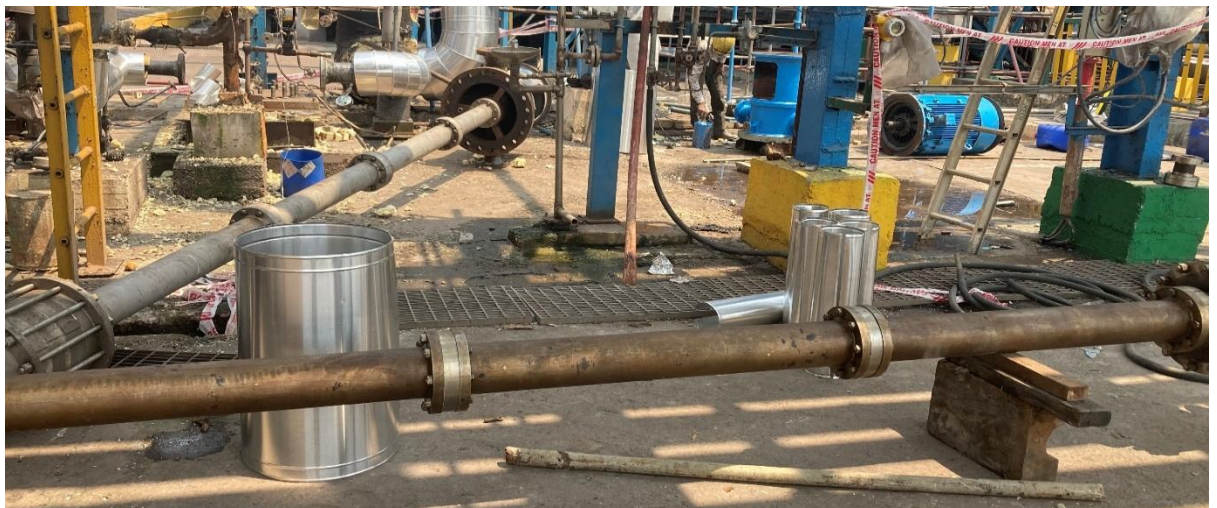
1. Depressuring pipe that is connected with the pump for DP of barrel was found disconnected from the pump and its fitting fallen in the barrel.
2. 2 Nos.Stage bush were found worn out and damaged.
3. Column pipe carrier bush and sleeve found in good condition.

4. O-rings used in the suction casing and stage casing were found damaged.
5. All the 3 Nos of impeller and sleeves were found in good condition.
6. Conical couplings for the column shaft were found in good condition.
7. Motor stool piece found corroded and pitted.

Ammonia Transfer pump-A Ready or Erection.

1. After completion of visual inspection all the spares were cleaned thoroughly.
2. The runout and straightness of the shaft were checked and found within the tolerance limit.

3. Assembly of the stage casing and impellers were done, 2 Nos. of new stage bush were used.
4. While assembling of impeller and stage casing clearance of impeller and stage casing were measured and found within the limit

5. All the stage gasket and suction casing gasket and orings were replaced with new Gasket and orings.
6. After complete assembly of impellers, stage casing and column pipes the pump is ready for erection.

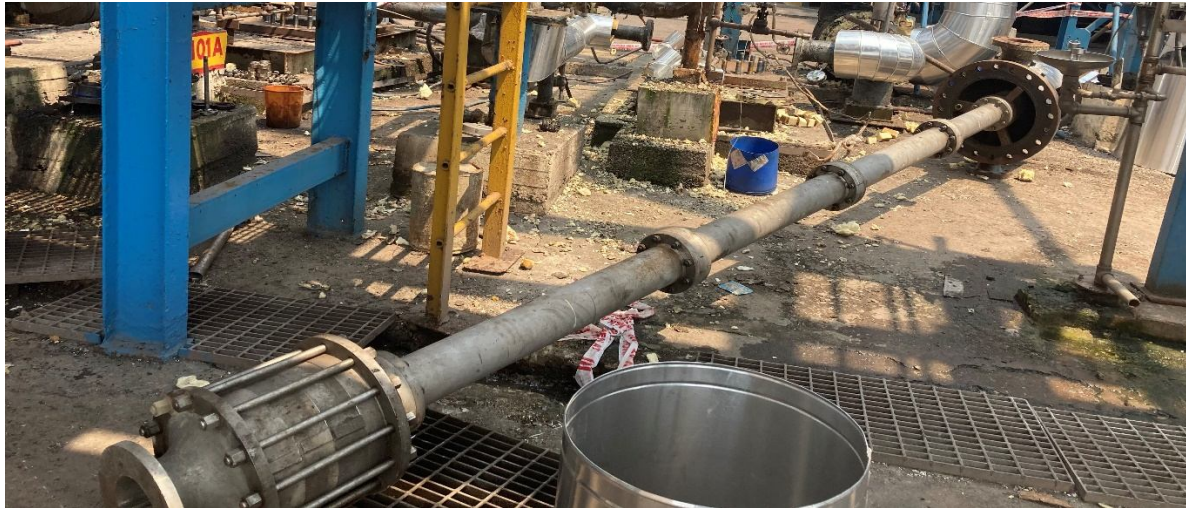
Ammonia transfer pump B ready for erection.

1. The runout and straightness of the shaft were checked and found within the tolerance limit.
2. Assembly of the stage casing and impellers 3 in Nos were done, new stage bush were used.

3. While assembling of impeller and stage casing clearance of impeller and stage casing were measured and found within the limit
4. All the stage gasket and suction casing gasket and orings were replaced with new Gasket and orings.

10. The existing Dry type Mechanical seal is replaced with a new Wet type methanol based mechanical seal and all the associated pipings for the mechanical seal were connected.

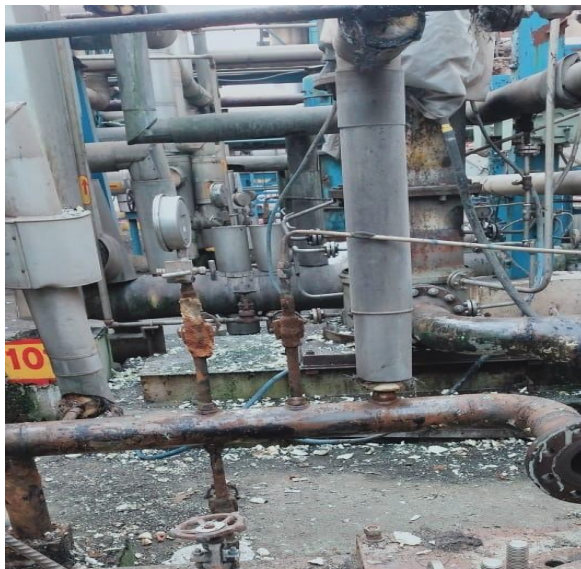
Ammonia Tr pump.drain line pressure gauge nipple welding

1. Ammonia Transfer Pump 'A' Suction Drain Line Replacement done.
2. Ammonia Transfer pump 'A' Suction Pressure gauge Nipple Replaced.
3. Ammonia transfer Pump 'A' Discharge Line nipple replaced.
4. Ammonia transfer Pump 'A' Discharge Line pressure gauge Nipple replaced.
5. 18 Nos of Ammonia drain line nozzle weldment DP and thickness measurement done, no porosity and thickness reduction found.

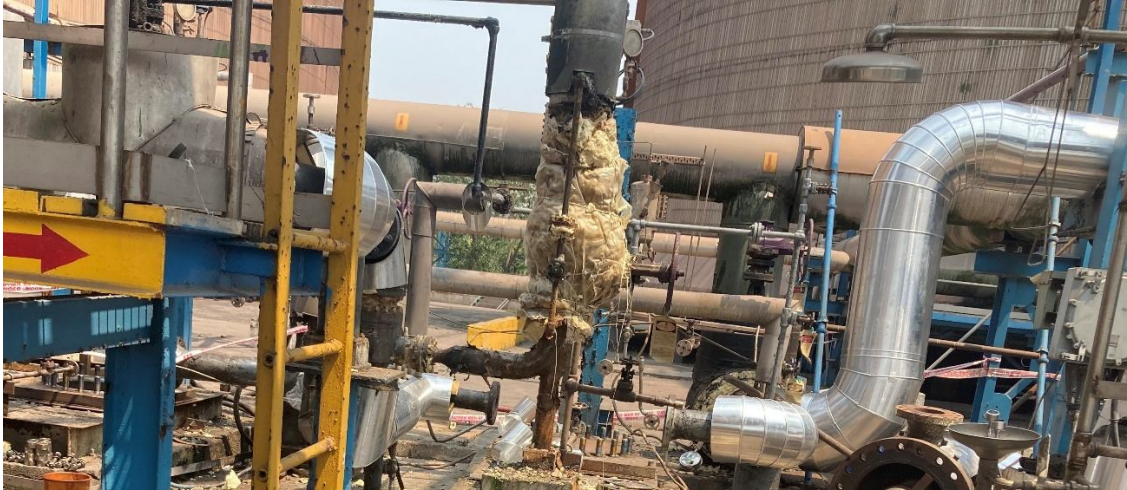
Insulation of 12" Ammonia suction and discharge line

6. Ammonia storage tank 'A' Pilot valve vapour inlet line support welding done.
7. 8" Ammonia transfer line safety relief valve replaced with a new SRV with set pressure 22.5 Kg/Cm².
8. 8 Mtrs lengths of 12" ammonia suction line cold insulation near transfer pump A replaced with insitu foam cold insulation.

9. 30 Mtrs lengths of 8" ammonia transfer line cold insulation replaced with insitu foam cold insulation.
10. All the discharge line up to ARC valve cold insulation removed and new insitu foam insulation done.
11. 8" Ammonia transfer line old damaged insulation near T8 area and SAP CT front area was replaced with new insulation Approx. length 150 Mtrs.

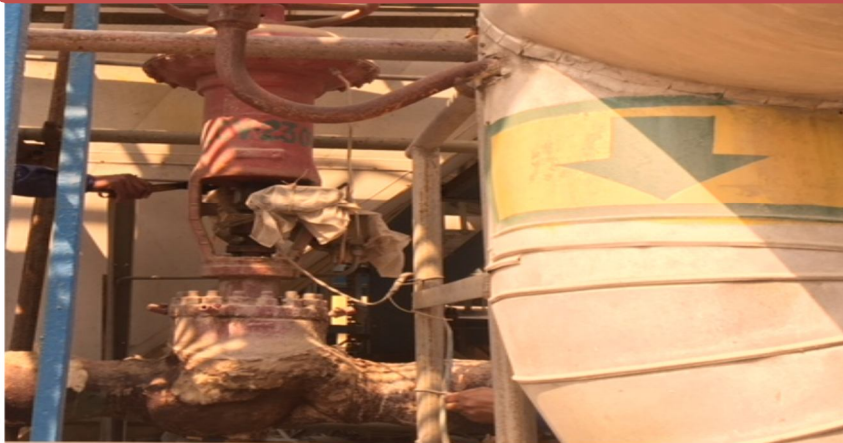
Old 10LCV1301 before Replacement

- Old & Obsolete Boiler drum level control valve of SAP-1 (10LCV1301) was replaced with new Dresser make control valve.

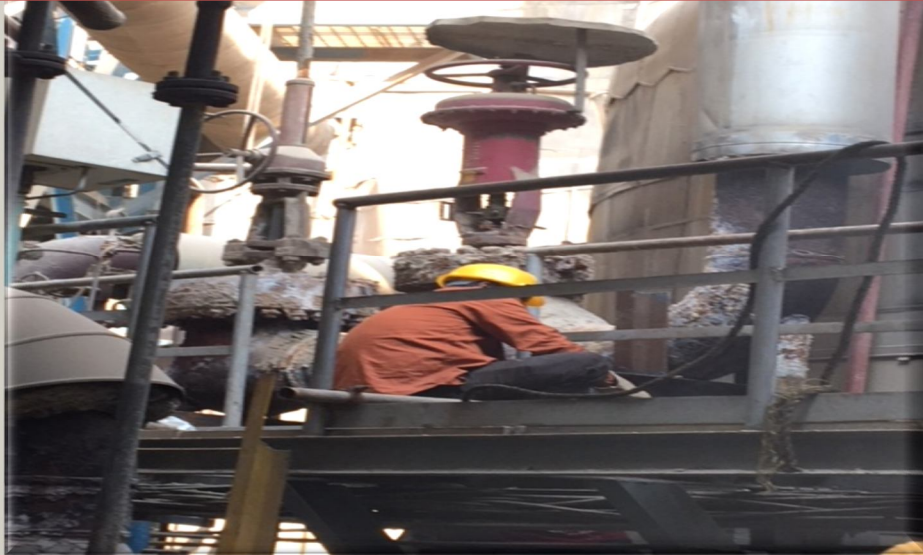
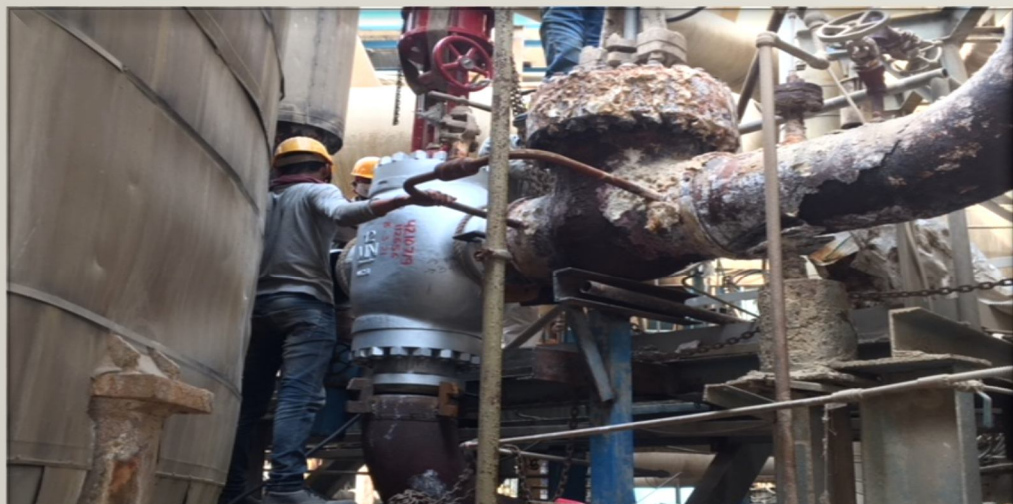
Old 3-Way 10TCV1506 before Replacement

- Old & Obsolete 3-Way temperature control valve of Super-heater-1 (10TCV-1506) was replaced with new Dresser make control valve in SAP-1.

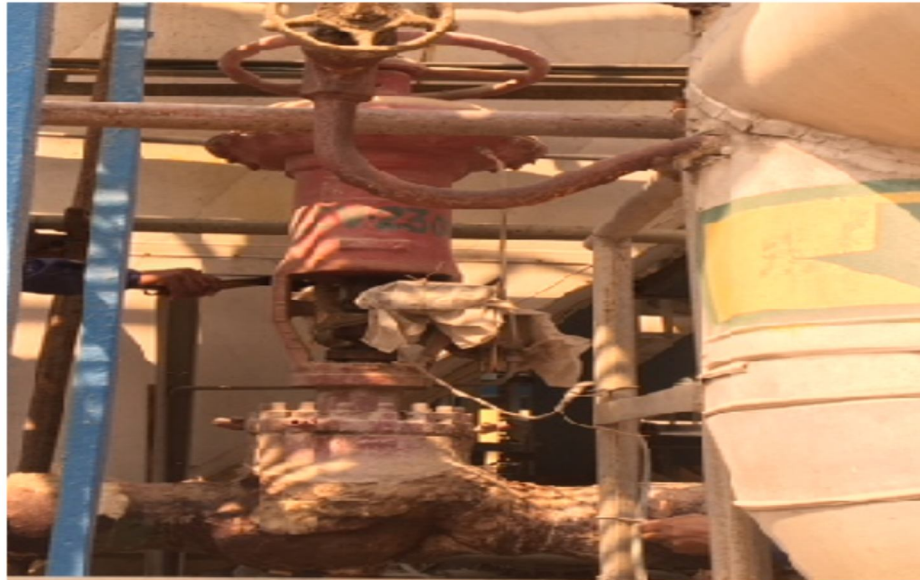
OLD Drum level Control Valve Tag 10LCV2301

- Old & Obsolete Boiler drum level control valve of SAP-2 (10LCV2301) was replaced with new KSB MIL make control valve.

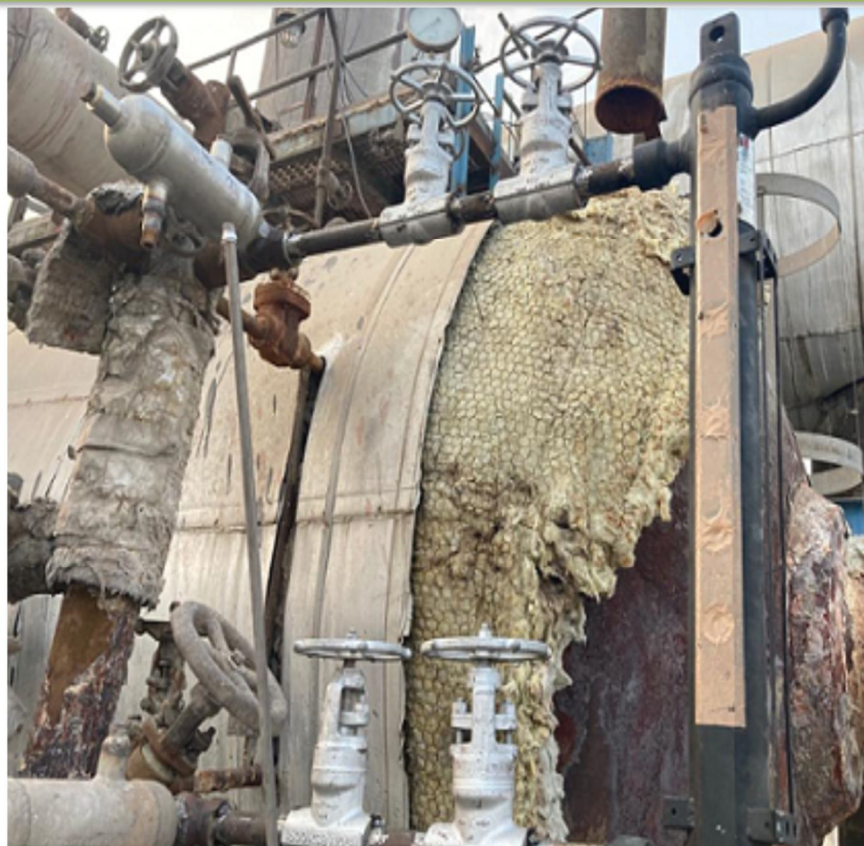
HYDRASTEP INSTALLATION IN SAP-2 BOILER

Delta Mobrey make electronic level indicator was Installed & Commissioned in boiler drum of SAP-2 with remote display unit installed in control room for direct level indication.

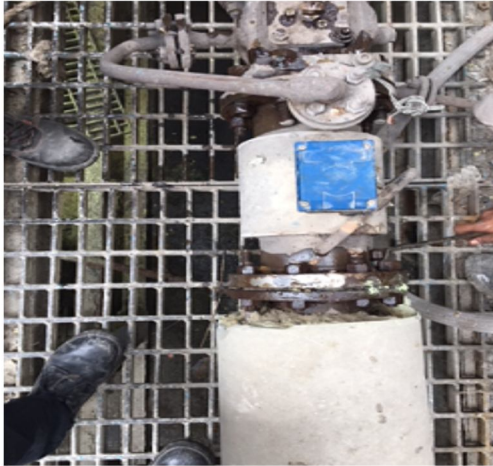
OLD Sulphur Flow meter

- Old damaged molten sulphur flow head along with transmitter was replaced with a new ones in SAP-2 (10FT2206).

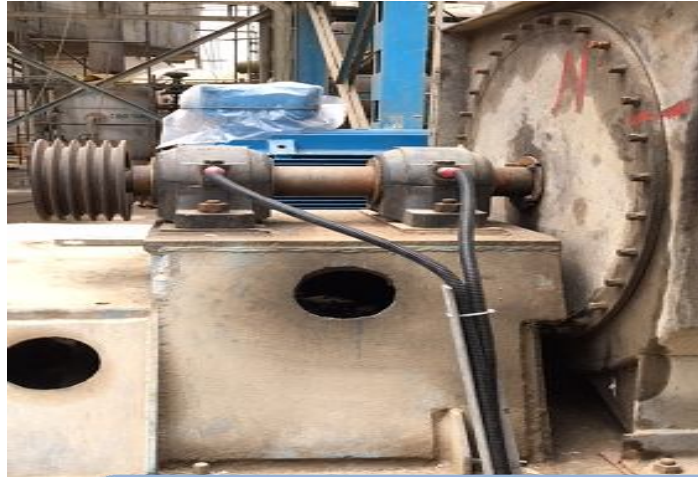
Vibration Probe installation In PA Fan

- New vibration probes were installed both PA fans of SAP-1 & 2.
- All control valves were cleaned, calibrated & stroke checking was carried out in both trains.

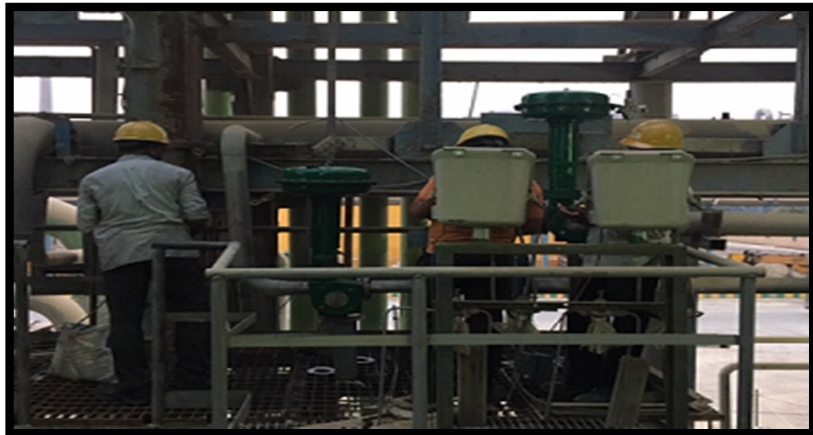
- 10AV2450 & 10LV2440 control valves were replaced due to gland leakage & damaged actuators.

Control Valve replaced for 10AV2450, 10LV2440

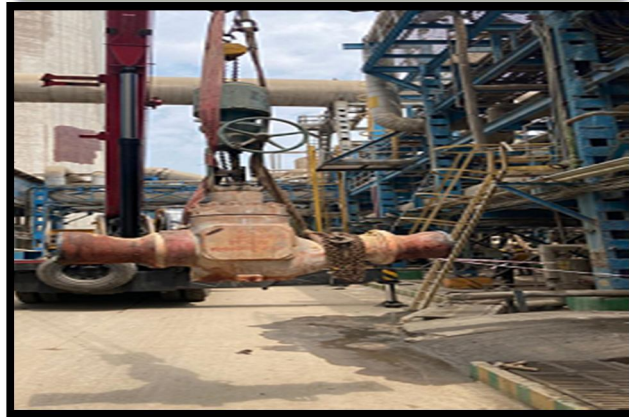
- Old & damaged Pressure control valve of LPS-1 (10PCV1555) was replaced with new Dresser make control valve.

Old PCV-1555 Control Valve

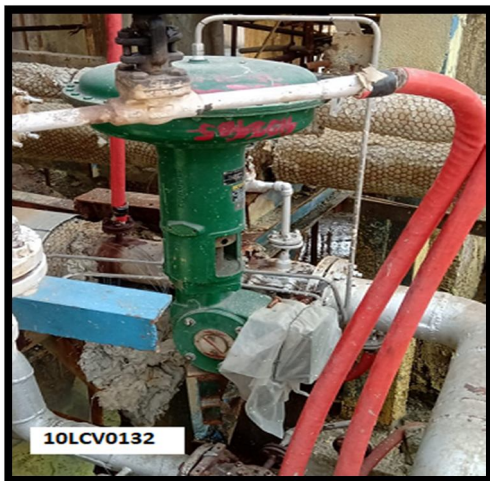
Control valve before relocation

Control valve after Re-location

- Melter-132 VPT re-circulating control valve 10LCV0132 was relocated for ease of maintenance.

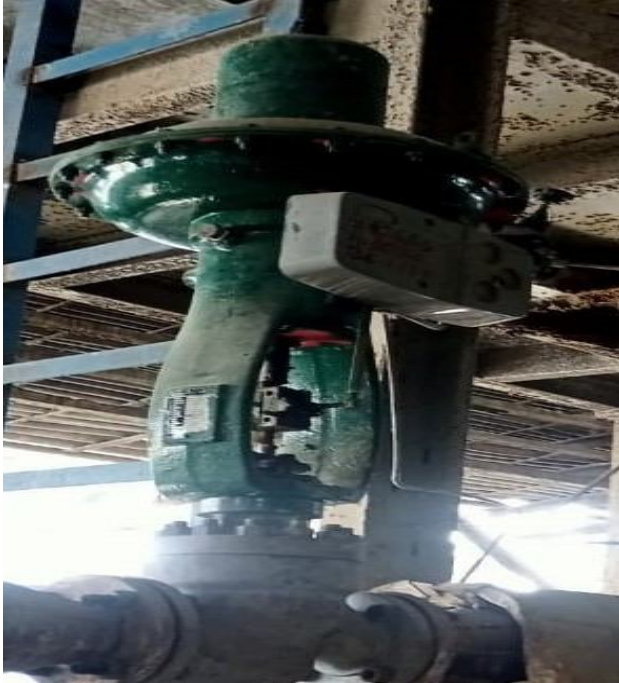
New M/s MIL make Control Valves in Filtration A & E.

1. Filtration area all control valves (3rd wash, 4th wash & cake wash) were removed from line for maintenance. Damaged control valves are replaced with new valves. Stroke checking & calibration of all the control valves are done.
2. Filtration area all seal tank dip tubes cleaning, maintenance done. Level transmitters proper mounting and calibration also done.
3. All magnetic flow heads of Filtration section are removed from line for cleaning, checking and maintenance. Faulty flow heads and flow converters are replaced.
4. Modification of SS tubing, damaged SS tubes & fittings replacement job done for selected control valves in Filtration area except G.
5. Filtration A & E cake wash steam control valves have been replaced with new valves.

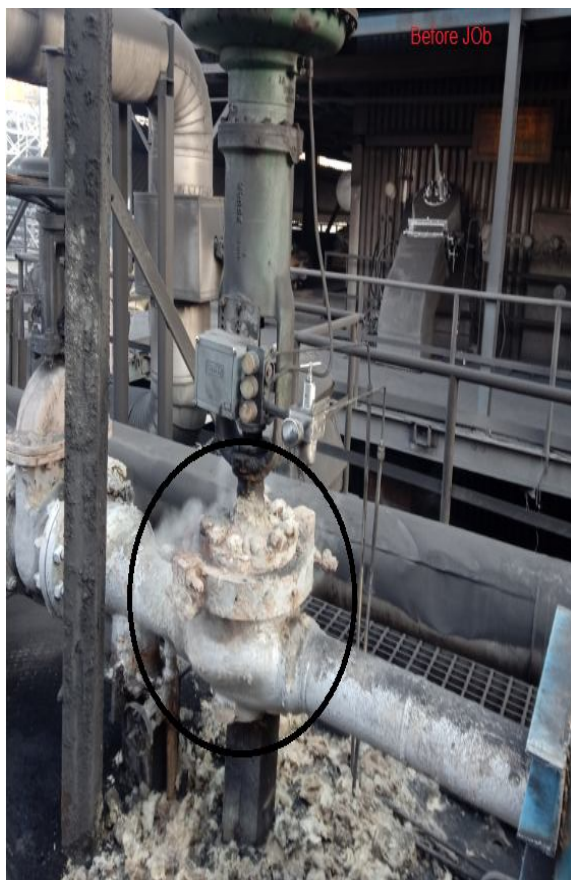
Old Control Valve

- Leakage from its bonnet

- Control valve replaced with new one
- Control Valve Stroke Calibration done
- Control valve SS Tubing done

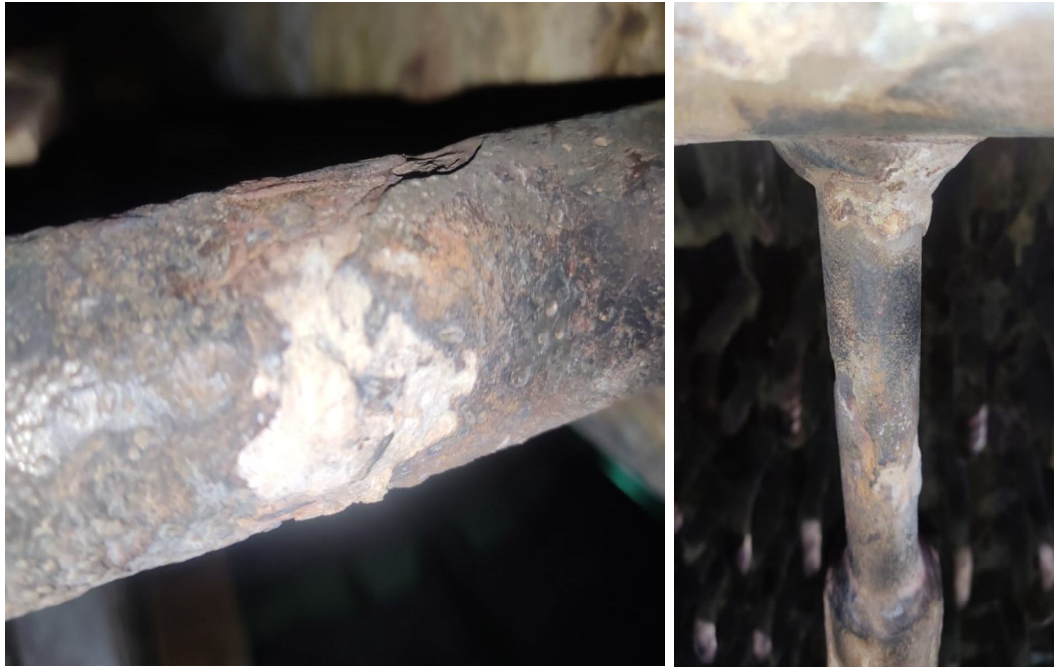
- DP test of header to straight tube joints, tube to tube sheet joints were also carried out. Repairs were marked and repaired. Drain line was found corroded. It was also replaced.

Header drain line was found corroded and was replaced
