**INDIAN FARMERS FERTILISER
COOPERATIVE
LTD, PARADEEP, ORISSA**

March- 2013

Health survey of the existing plant structures at IFFCO
Paradeep Unit.

INSPECTION REPORT
For
Condition Assessment
For
“BOILER HOUSE”
Of
A F B C BOILER PLANT
At
Paradeep, Orissa.

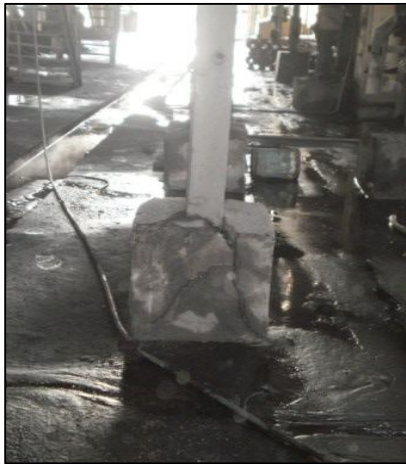
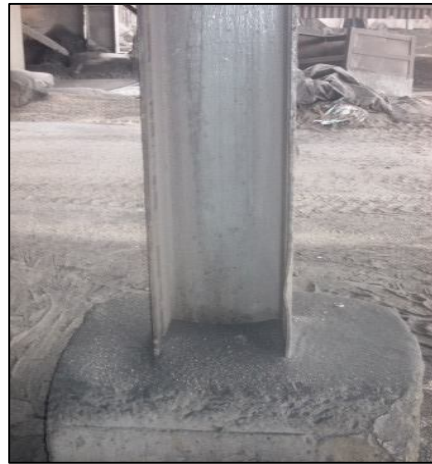
5. East and west side structures are in the form of shade used to store raw material. Columns of the shade have been constructed with new RCC pedestals. Some steel columns noted bent due to hit of vehicles.

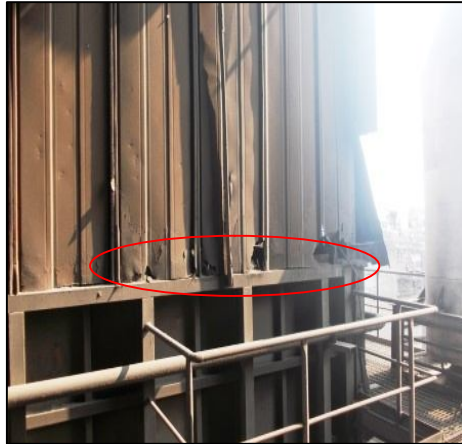
At 33.68 level

- Roofing structural supporting members noted with severe corrosion and bent at some location.
