INDIAN FARMERS FERTILISER COOPERATIVE

Health survey of the existing plant structures at IFFCO
Paradeep Unit.

INSPECTION REPORT

“AFBC Boiler”

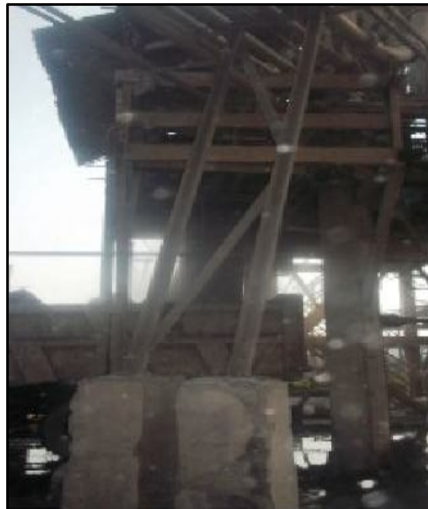
The structure under reference i.e. "Ash pipe rack-I" situated in Boiler Plant at Indian Farmers Fertilizers Cooperative Ltd. (IFFCO) Paradeep unit, Orissa. The structure has been constructed with structural steel framing system and suitably rest on RCC foundations. However, it is not visible since the area is further encased with RCC for the area above.

- RCC pedestals noted with honey combing and localized damaged edges.

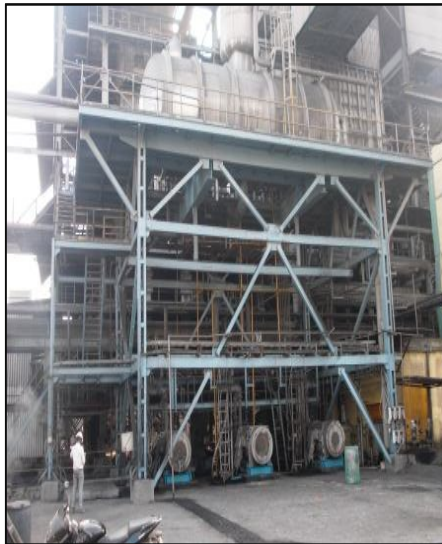
Deriator/ESP structure is fabricated in structural framing system. Tie beam and cross bracing have been provided as seen in the photographs. Since the structure has recently painted visual distress are covered. Staircase has been provided on east side.

- As a matter of critical observation; huge steel tank noted rest on steel beams as seen in the photograph below. However, the said steel beams (supporting the said tank) connected with comparatively small / undersized main beams. The system needs cross verification with fresh design and accordingly to re-done.

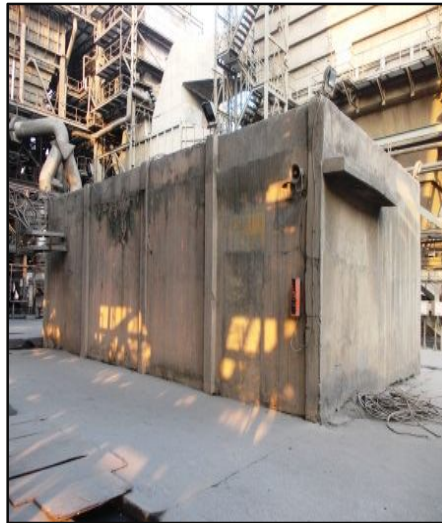
ESP control room is a RCC framed structure of ground floor having brick masonry walls.

- Peeling of external paint, localized damaged plaster, separation crack at the junction of roof beam and masonry wall, leakage/seepage resulted in moss growth etc. noted. Please refer photographs below.

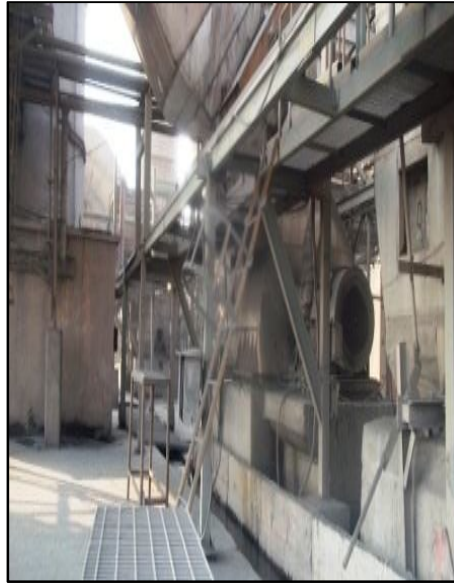
WATER PIPE RACK is a steel framing structure suitably installed over the RCC foundation. The said RCC foundation area further encased with RCC for the area above as seen in the photographs below.

- The structure noted with distresses like exposed steel/dowel bars, minor corrosion in the steel elements, localized missing of cleat and seat angles as a matter of inadequate connections and improper / incomplete welding at localized areas etc. Please refer photographs below.

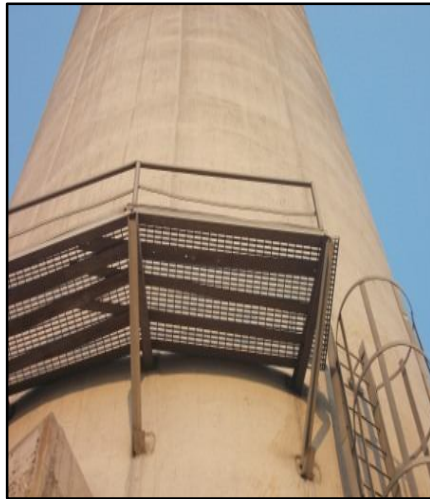
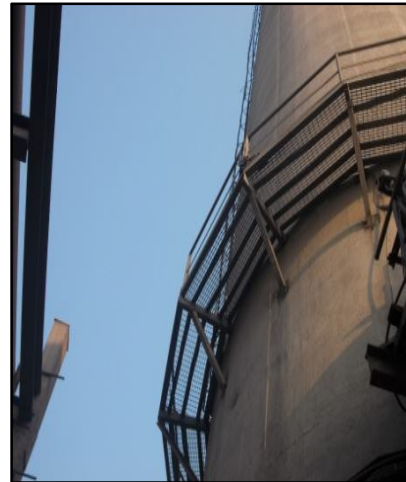
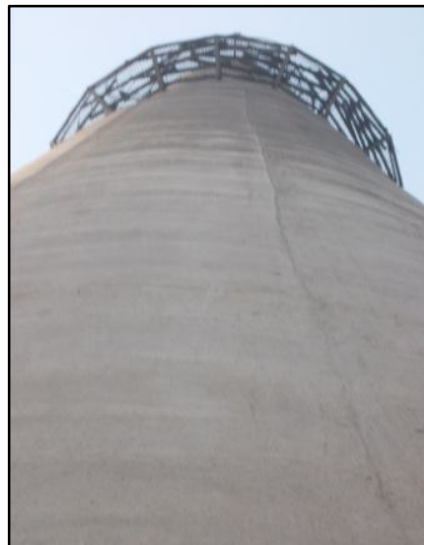
- The structure under reference i.e. RCC chimney is located at AFBC boiler area. This is a RCC conical shaped structure constructed with 900 mm thick wall.
- Suitable steel platforms/walkways are provided to the structure as per requirement.

- Several horizontal cracks at subsequent concrete pours of slip form lifts, localized hollow sound in RCC wall and separation crack noted between the RCC and door frame at of entrance area; as shown in the photographs below.
