INSPECTION REPORT
For
Health Survey of Structures
Of
Ammonia Plant
At
IFFCO, Paradeep
Orissa

**INDIAN FARMERS FERTILISER COOPERATIVE
LTD, PARADEEP, ORISSA**

March - 2013

INSPECTION REPORT
For
Condition Assessment
For
Ammonia Plants structures
At
Utility and offsites plant
Of
Paradeep, Orissa.

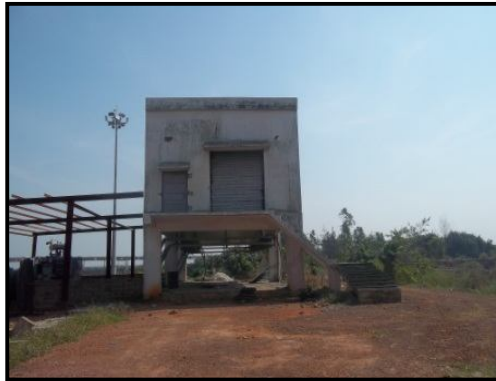
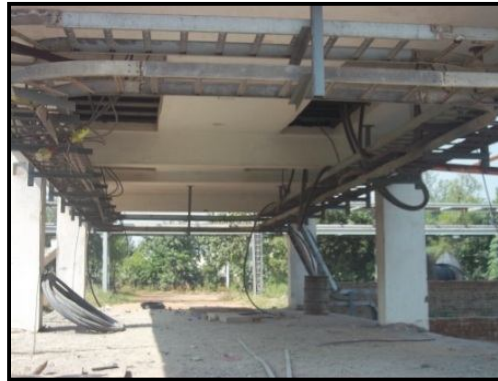
- This structure noted with distresses like damaged RCC chajja, weathered surface, leakage / seepage marks & delamination of cover concrete at staircase area and cracks in external plaster etc. as shown in the photographs below.

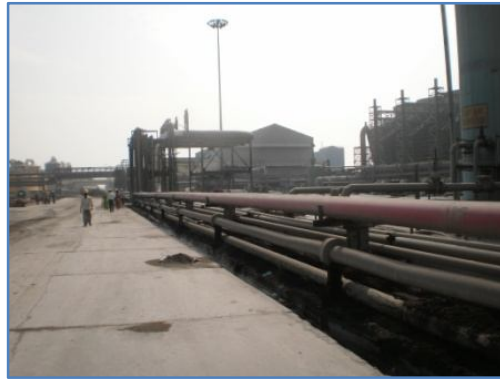
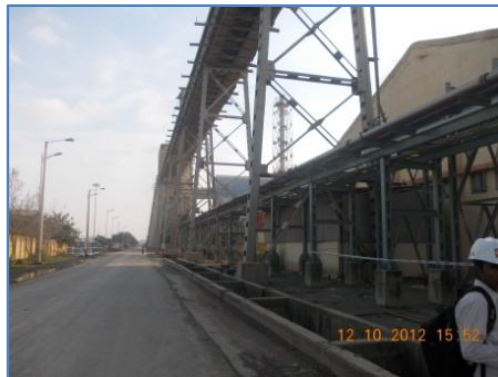
OSBL Pipe structure starts from AFBC boiler to DM Plant & continues till the end of Ammonia plant.

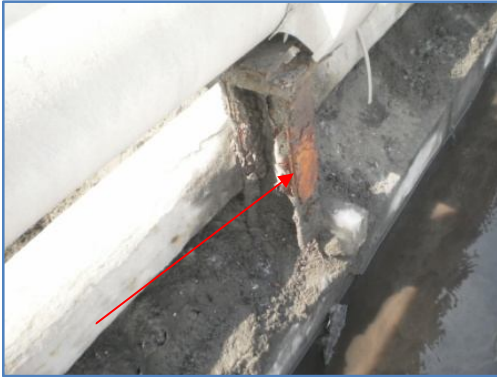
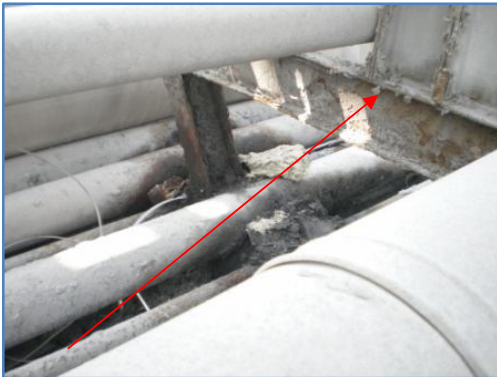
- Deteriorated condition of steel elements due to severe corrosion noted at many locations near the AFBC boiler house as shown in the typical photographs below.

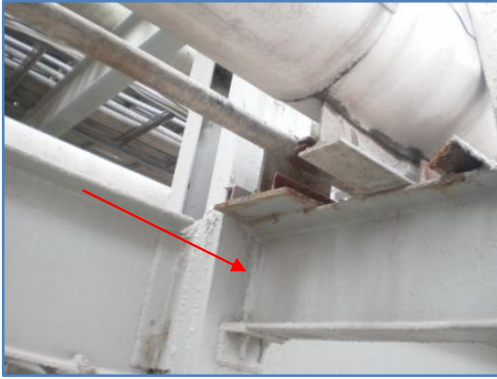
- Inadequate connections in the form of cleat angle missing on one side noted at many locations in the entire framing system as shown in the typical photographs below.

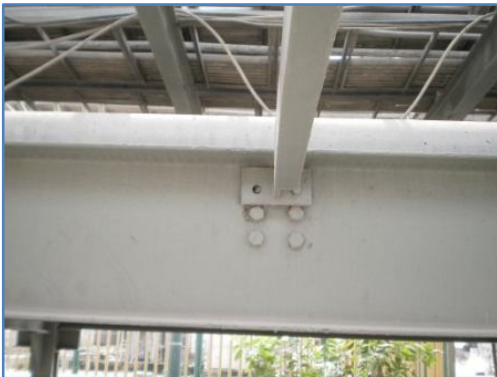
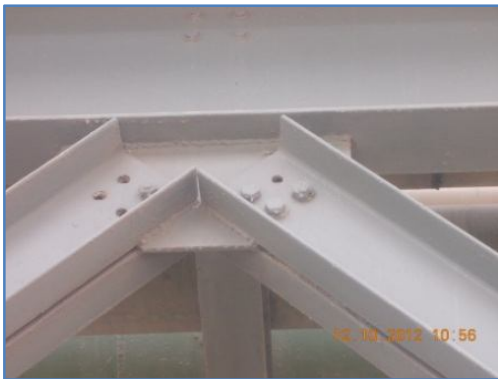
- Localized missing of nut bolts noted at many locations on longitudinal members, horizontal members and cross bracing as shown in the typical photographs below.

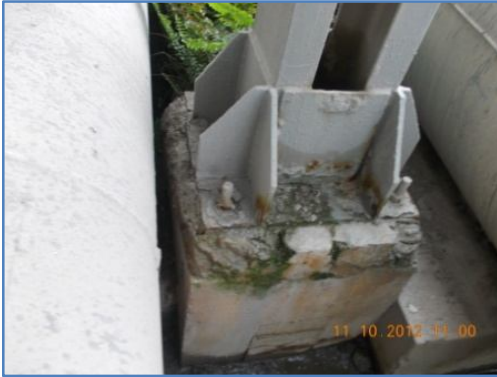
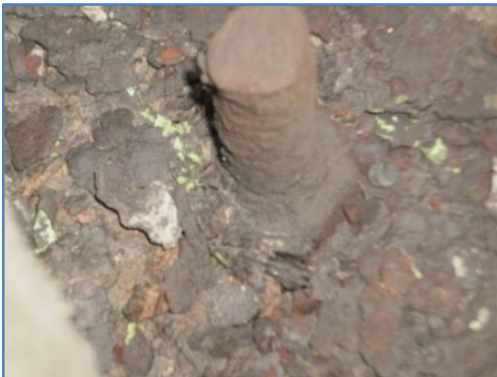
- Foundation nut bolts, base plate, side gusset plate and bottom section of the steel column noted with scaling, corrosion and pitting etc. Also RCC pedestal edges are damaged at many locations. Please refer typical photographs below.

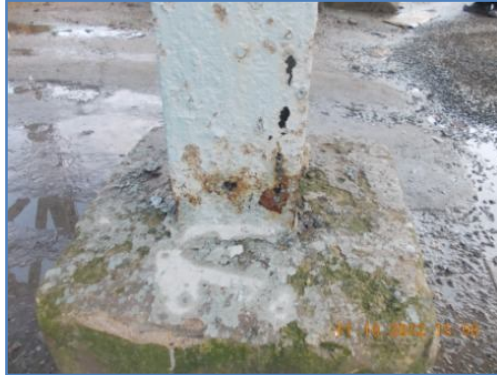
- Steel columns noted with severe corrosion might be due to the continuous presence of water around as shown in the typical photograph below.

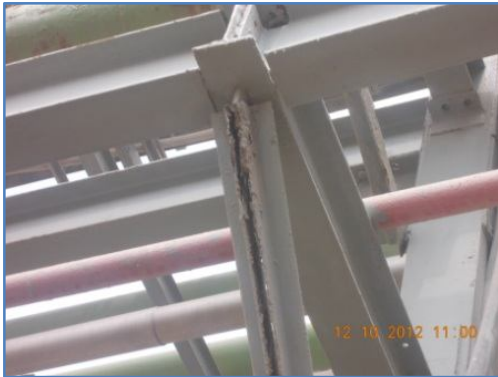
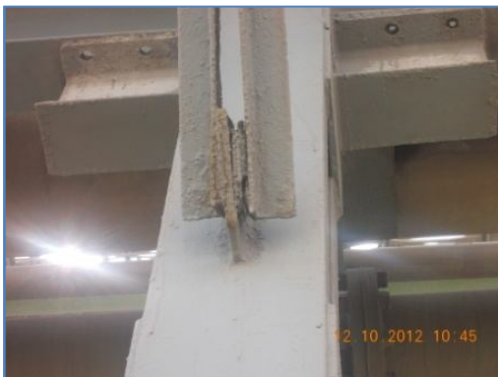
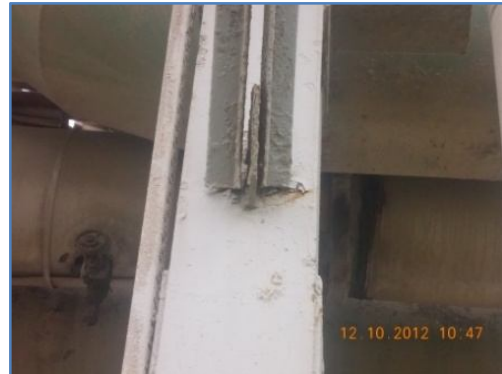
- Framing system of cantilever brackets noted with weld joints opened out due to severe corrosion and scaling at many locations as shown typical photographs below.

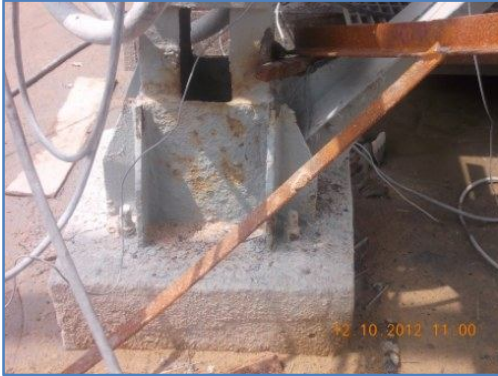
- Steel elements of connections noted with corrosion. Please refer typical photographs below.

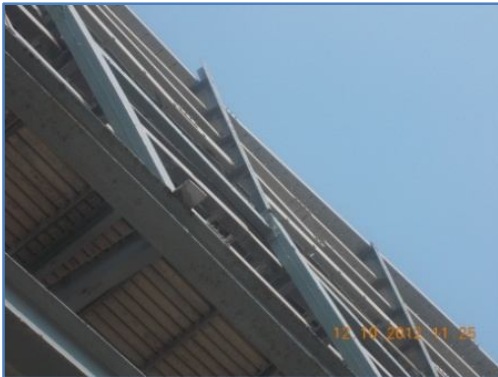
- Vertical members as seen in the photographs below noted with deflection in the alignment; might be due to the original construction deficiency. Also noted tack welding done instead of full welding. Localized missing of nut bolts at every connection also noted. Please refer typical photographs below.

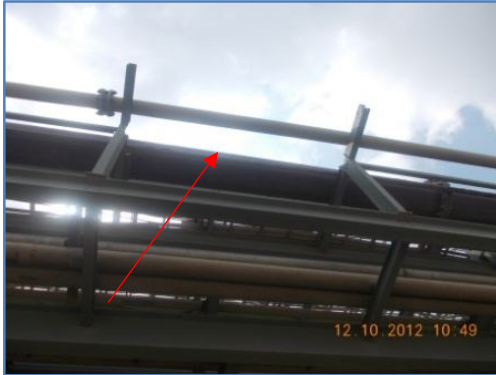
- Localized missing of longitudinal members noted as shown in the typical photograph below.

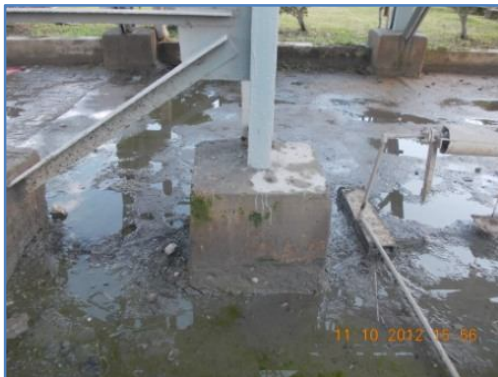
- Moss growth noted on the RCC pedestals at some locations. Also sever corrosion and scaling on vertical members & side gusset plates noted as shown in the typical photographs below.

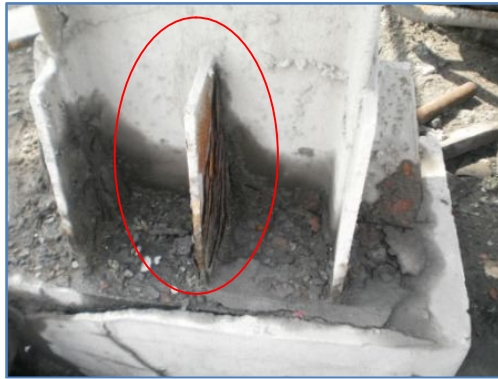
Severe corrosion and scaling

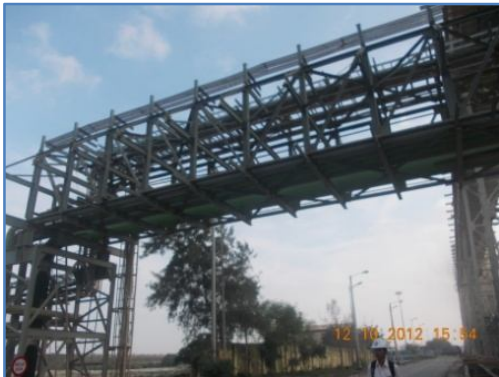
- Structural steel framing system of elevated pipe rack support system noted with localized corrosion in longitudinal members, horizontal members, cross bracings, nut bolts, vertical members, localized missing of nut bolts & cross bracings, peeling of existing paint etc. Please refer photographs below.

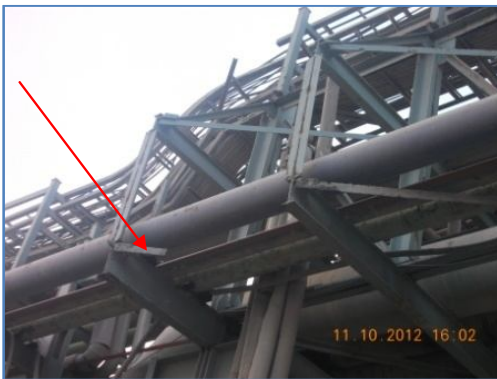
Corrosion, scaling and cut/slotted cross bracing

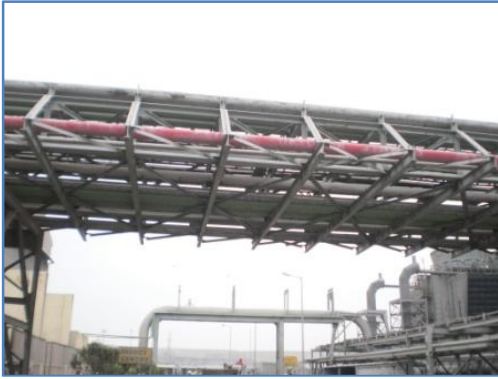
Inadequately welded connections

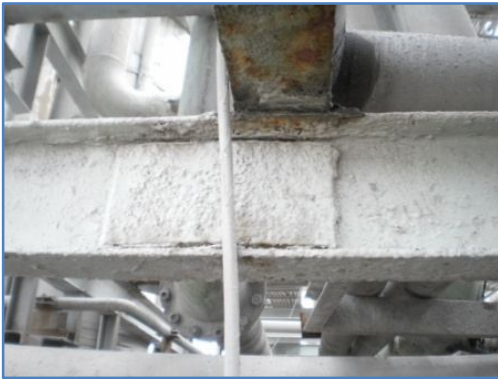
Severe corrosion

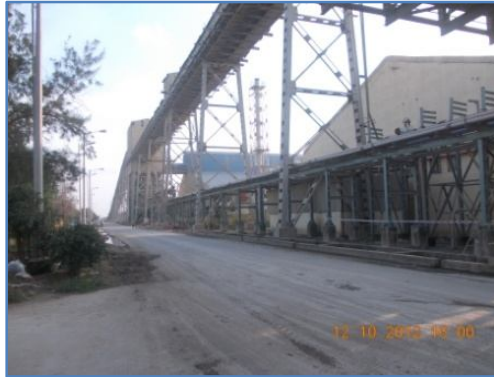
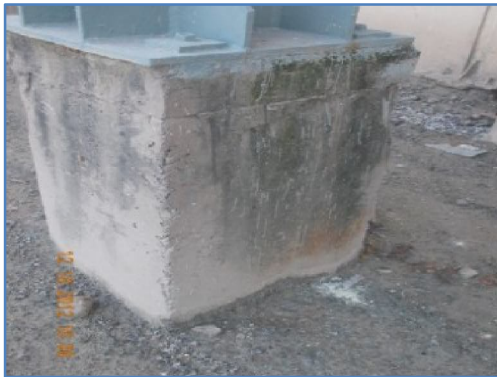
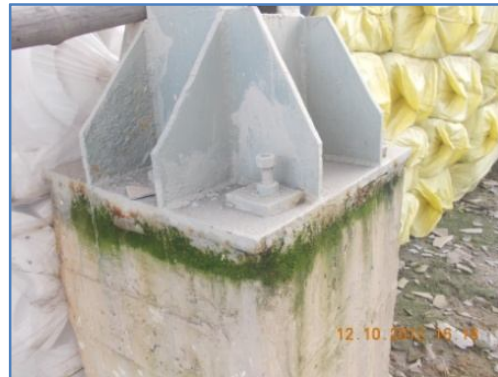
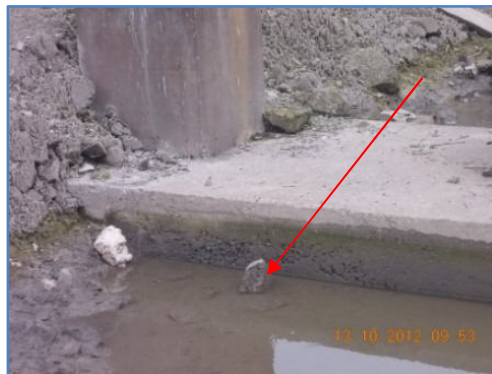
- Honey combing, moss growth, gap between base plate and RCC pedestal, corrosion and scaling on base plate, side gusset plate and foundation nut bolts and vegetation growth noted as shown in the typical photographs below.

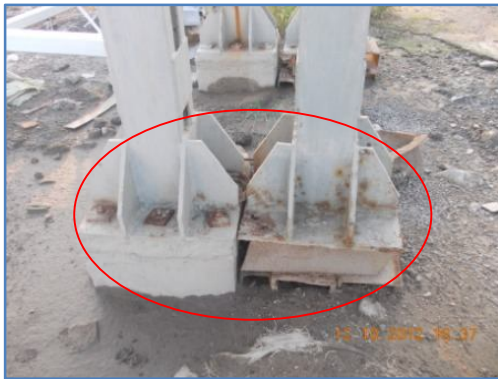
Scaling, corrosion on base plate and gusset plate also vegetation growth and honey combing

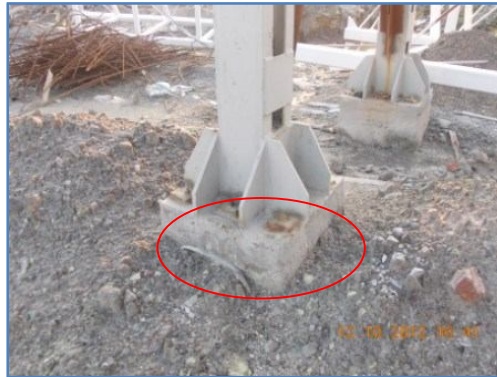
- Localized exposed reinforcement (actually it is original construction deficiency i.e. reinforcement laid without sufficient cover concrete), delamination of cover concrete of RCC pedestals etc. noted at many locations as shown in the photographs below.

- Follow methodology to treat exposed reinforcement as per recommendation mentioned in corrosion cracks in R.C.C members with replacement of snapped steel with new steel reinforcement of similar diameter, as per requirement as per existing design.

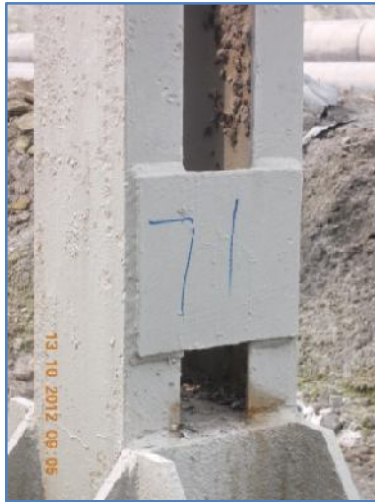
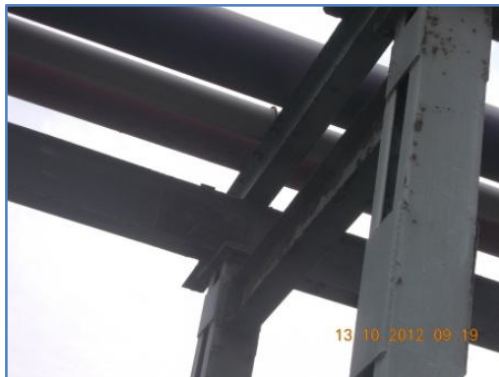
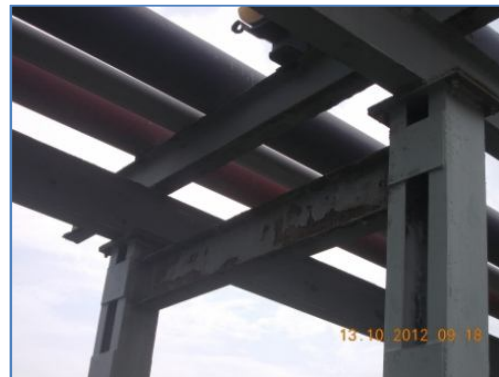
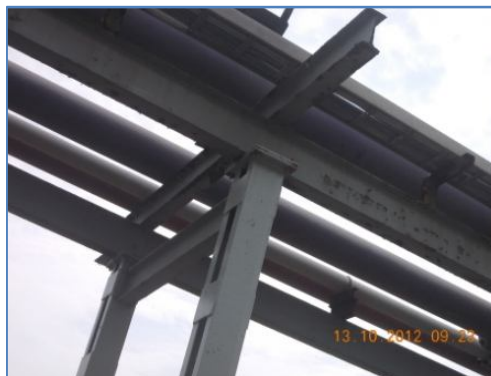
- Vertical members of the framing system noted with corrosion & pitting at many locations at many locations as shown in the typical photographs below.

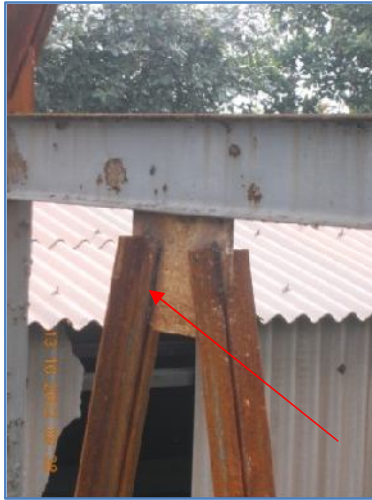
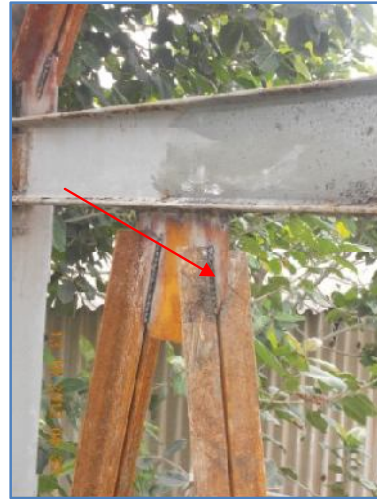
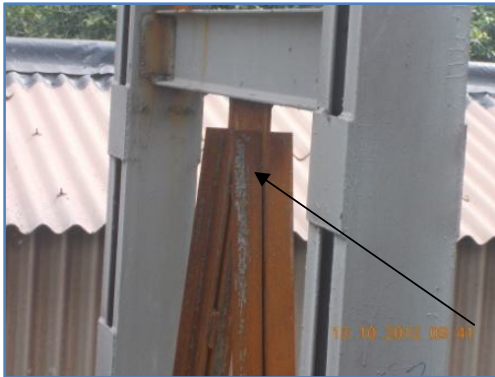
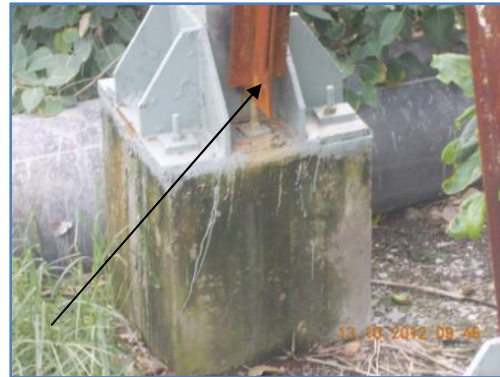
- Few structural elements noted without protective paints as shown in the typical photographs below.

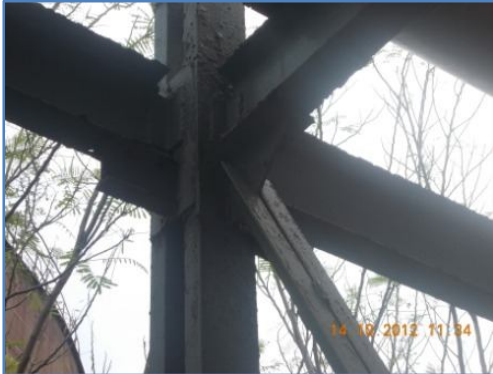
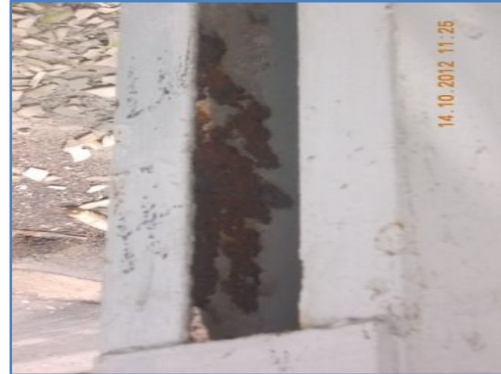
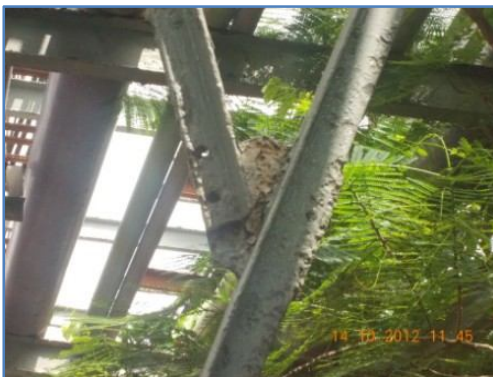
- Severe corrosion, scaling, pitting and peeling of paint noted on vertical steel member, side gusset plate, seat and cleat angle of longitudinal and horizontal steel members at some locations as shown in the typical photographs below.

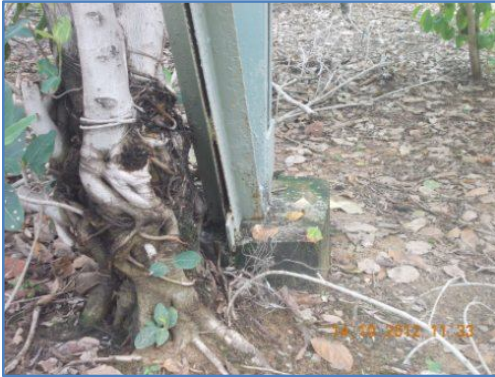
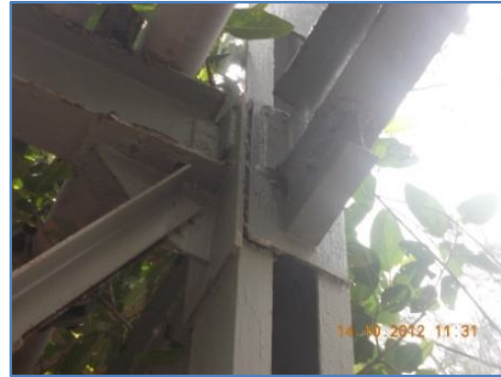
- Vegetation growth, moss growth and localized nut bolt missing noted at some locations as shown in the typical photographs below.

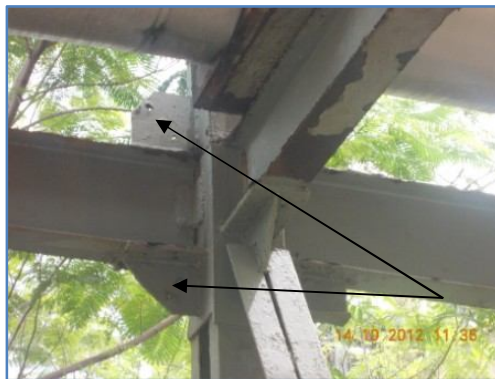
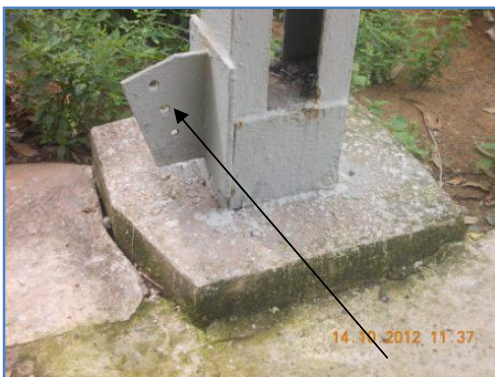
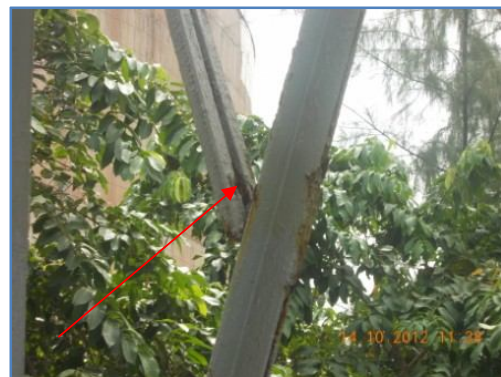
- Localized missing/slotted cross bracings as also weld connections opened out noted at some locations as shown in the typical photographs below.

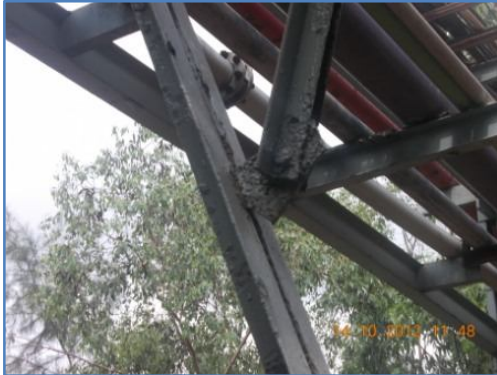
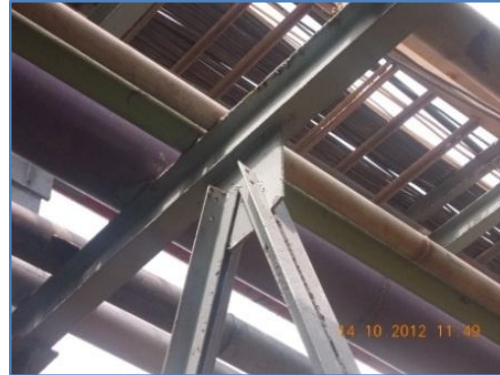
- Scaling, corrosion on nut bolts, gusset plates and also in weld connections noted at many locations as shown in the photographs below.

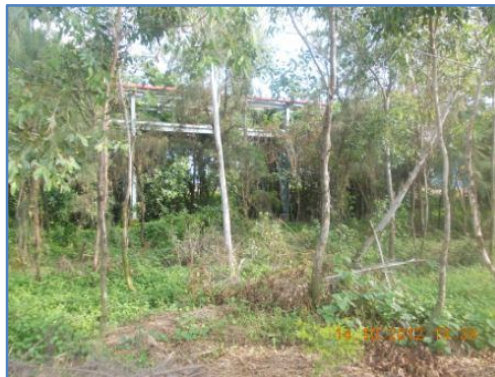
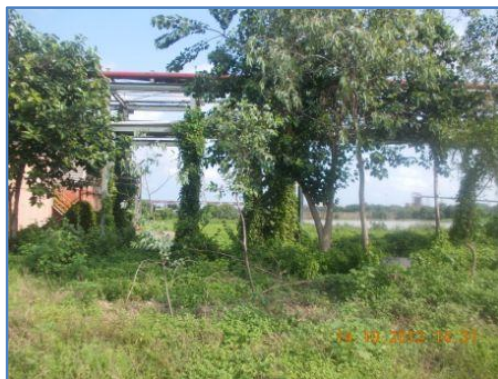
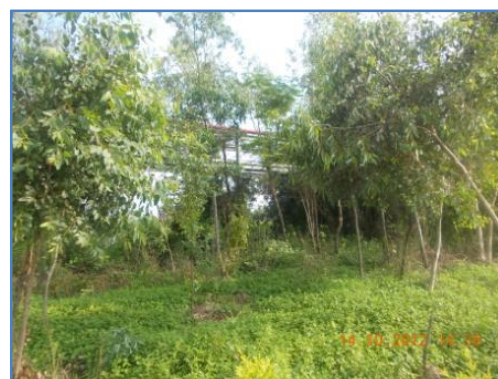
- Inspection of the few areas especially area of OSBL from Ammonia cooling tower to end of the SAP and PAP steel tanks could not be possible; locally; due to unavailability of proper access and profuse vegetation as seen in the photographs below.
