INSPECTION REPORT

**Health Survey of Existing Structure at
Ammonia Plant**

**Of
IFFCO, Paradeep
Orissa**

**INDIAN FARMERS FERTILISER COOPERATIVE
LTD, PARADEEP, ORISSA**

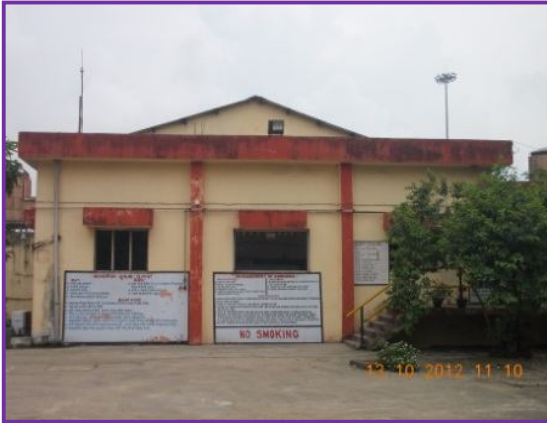
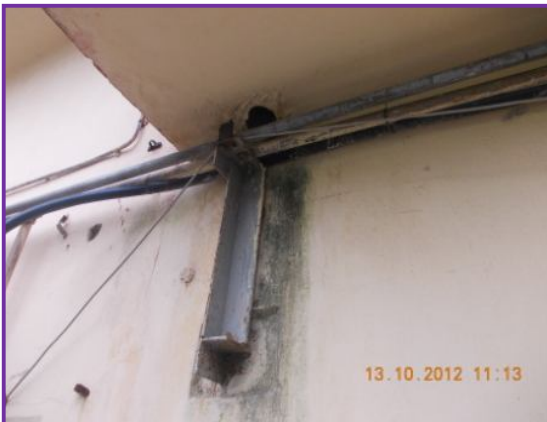
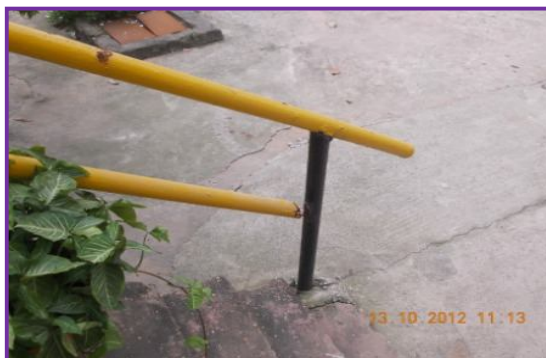
South side external observations:-

- This area reveal distresses like leakage / seepage marks & moss growth due to damaged/missing rain water pipes, localized spalling of cover concrete thereby exposed reinforcement at the soffit of RCC chajja etc.

- Expose the cracked / spalled elements completely. Use long sharp chisels of about 16-20 mm diameter and hammers upto 2 lbs weight. Remove the complete corrosion of reinforcement with wire brushes (preferably mechanical type). Remove all the loose and damaged concrete particles till sound concrete of uniform texture is visible. Apply rust removers like 'Rusticide SS' or equivalent to the reinforcement to remove the traces of rust. Clean the reinforcement once again with the wire brush. Wash the complete concrete surface including the reinforcement to remove the traces of rust remover. Apply a coat of rust passivator like 'Polyalk Fixoprime and cement' or equivalent as per the recommendations of the manufacturers. The concrete surface treated for corrosion shall be patch repaired with Polymer Modified Mortar like 'Polyalk EP' or any other equivalent as per the manufacturer's recommendations.

- Wherever the moss growth has been observed check that area for any hollow sound in the plaster.
- Remove and redo the damaged plaster and protect the surface with good quality paint.

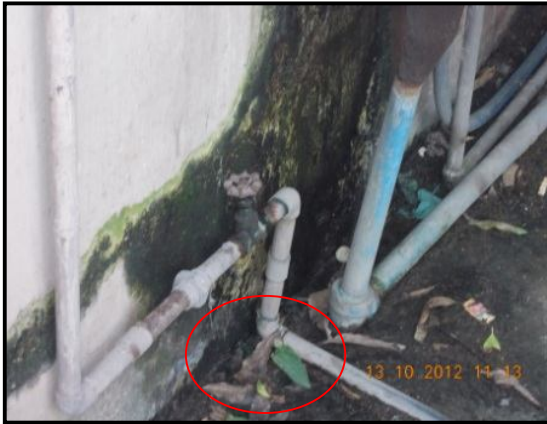
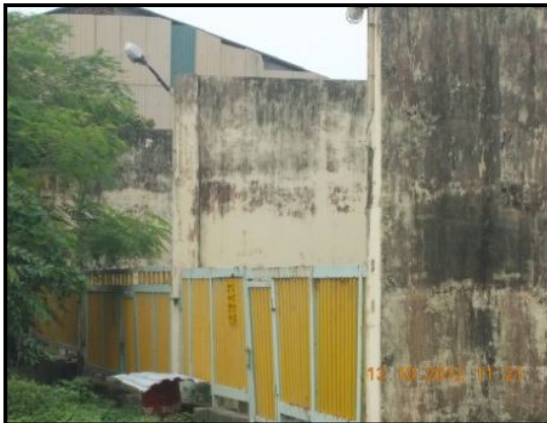
East side external observations:-

- This are reveal with distresses like vegetation growth, moss growth due to leakage/seepage, discoloration of paint and weathered surfaces etc.

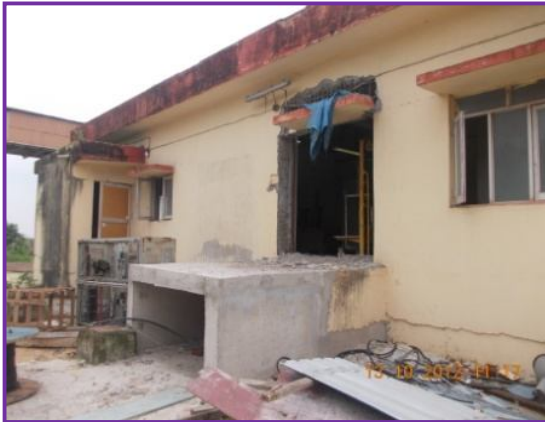
West side external observations:-

- Damaged and broken RCC beam and chajja noted on West side due to new opening arrangements made, as per requirement. However, the area left without any treatment is a cause of concern. Also, Separation crack noted at the junction of RCC and masonry wall.

- Open the separation cracks with 'V' groove up to 15mm to 20mm depth.
- Clean the 'V' groove surface with water.
- Then apply the polymer mortar with metal embedded on it.
- This metal embedded mortar should be covered with proper chicken wire mesh with over lapping of 6 inch over brick work / Block work and 6 inch overlap to the R.C.C member (beam / Column).
- Apply the plaster according to the manufacturer's specification.

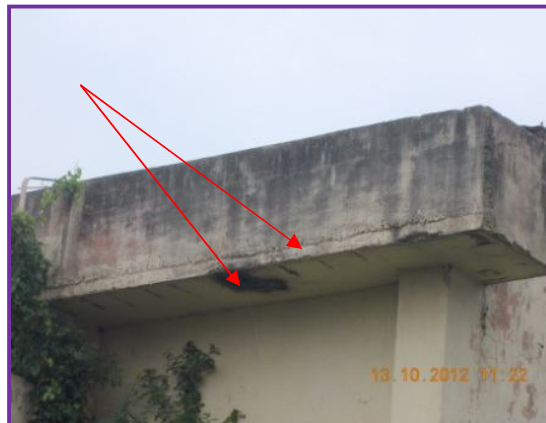
North side external observations:-

- Separation crack noted between the projected slab and parapet wall, discoloration of paint, localized exposed reinforcement and delamination of cover concrete noted at the soffit of projected slab as shown in the photograph below.

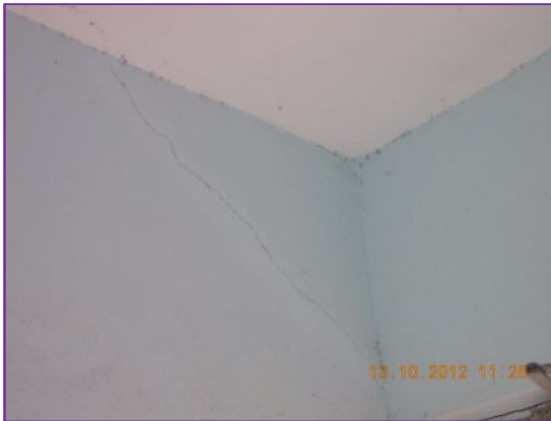
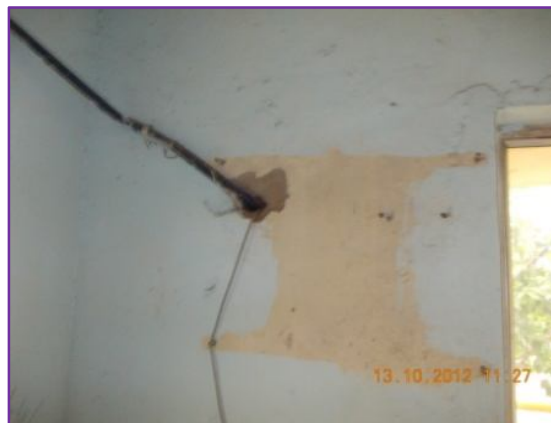
Control room-

- Separation crack noted between RCC beam and masonry wall. Also noted diagonal cracks on wall and unfinished cut-out made to masonry wall for passing cable line. Slab area inspection could not be possible due to false ceiling.

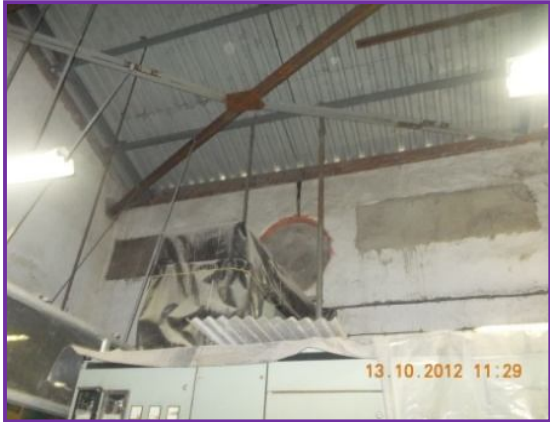
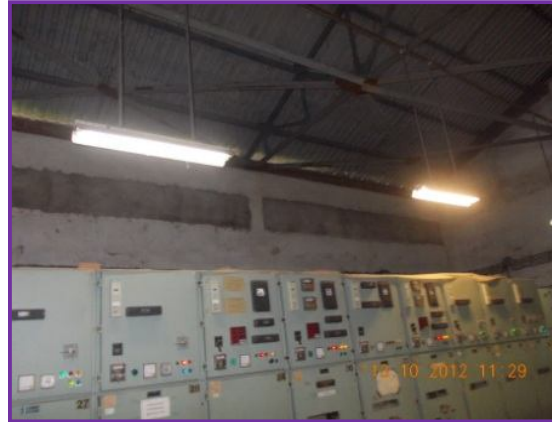
Electrical sub-station of panel room-

- All external openings are closed with masonry and also noted cracks in the closed area.

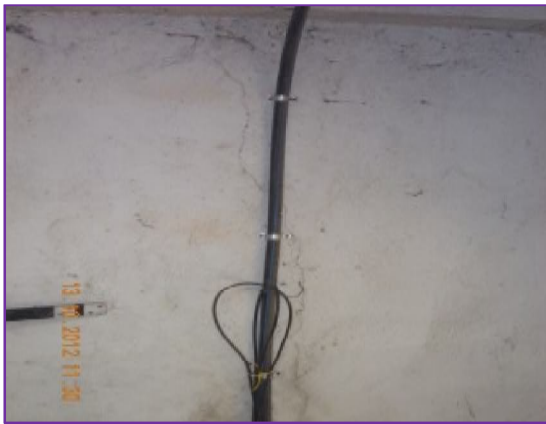
- Separation crack noted in between the RCC and masonry wall at some locations.

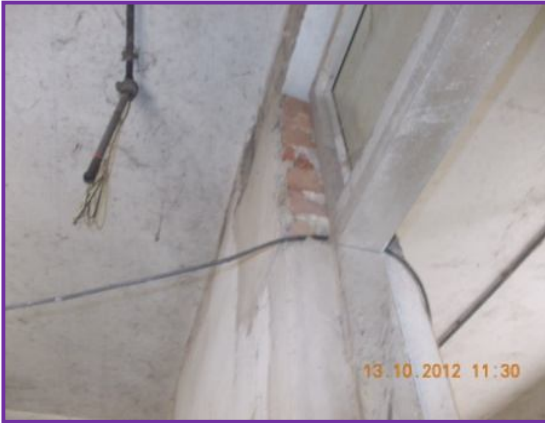
- Unfinished plaster noted on the brick masonry wall on West and North side wall as shown in the photographs below.

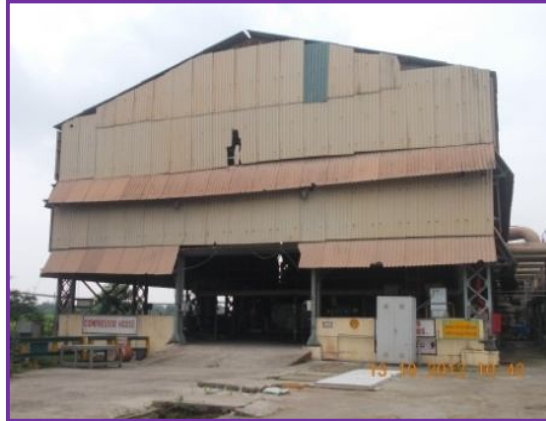
- A.C sheets at cladding noted damaged / broken and noted holes on North side elevation.

- Damaged sheets at roof & cladding shall be removed; locally; and replaced with similar type of materials.
- This is the broad assessment of the structural health at this stage.

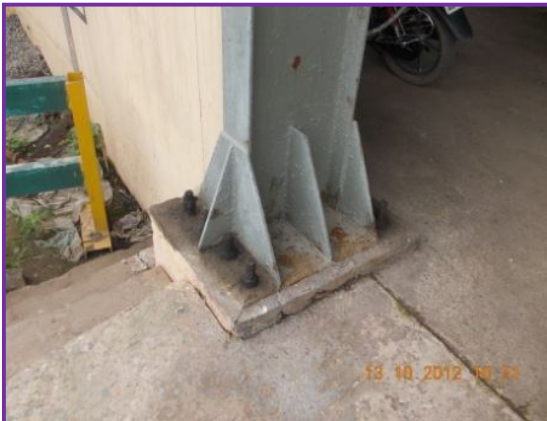
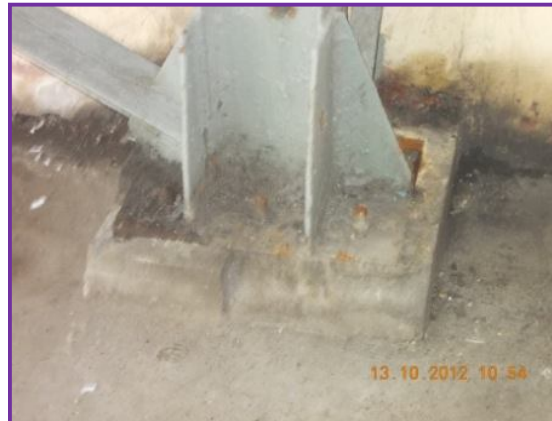
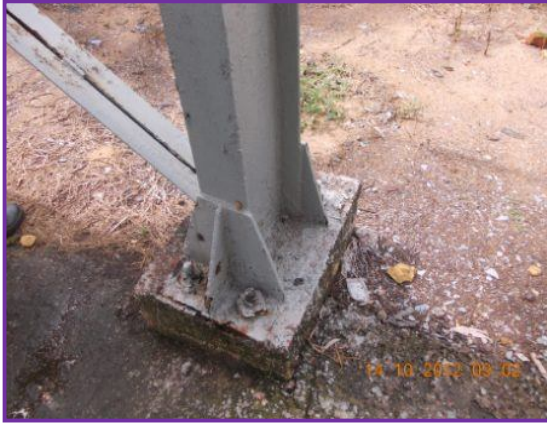
- Severe corrosion, scaling noted in base plates & foundation nut bolts of steel columns at many locations.

- Localized replacement of the deteriorated steel elements as also further strengthening has to be done and need to be followed for the proposed rehabilitation work. However, the said strengthening work shall be done according to the design.

- Few General distresses like Existing corrosion of the steel members shall be removed as per standard method and all the Structural Steel members shall be treated with application of 3 coats of 'SUNPUGUARD' (a high quality Anti corrosive two component Polyurethane coating) or equivalent as per Manufacturer's recommendations. Proper surface preparation of all Structural Steel members shall be done before application of SUNPUGUARD or equivalent, as per manufacturer's recommendations.

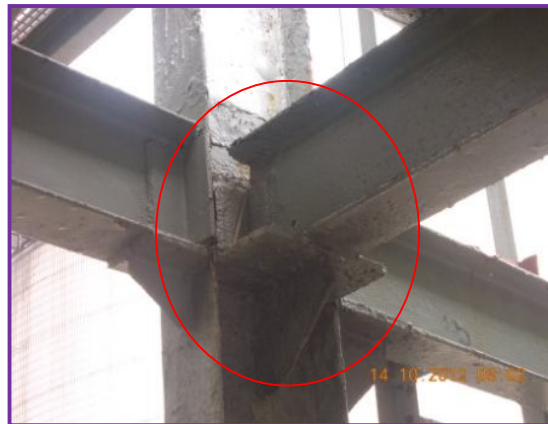
- Inadequate connections in the form of small cleats provided as also corrosion in the steel elements of connections etc. noted as shown in the photograph below.

- The gap between concrete and top finishing layer (in RCC pedestals) shall be finished with suitable grouting as per existing system/method.
- Most of the distresses related to the inadequate connection details need be re-done with providing ideal connection details as can be best designed with improved specifications.

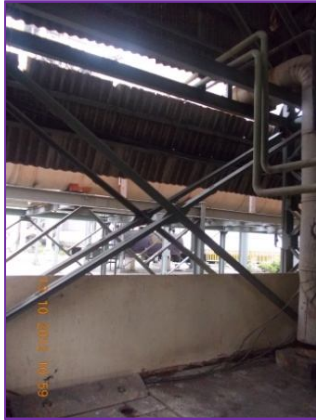
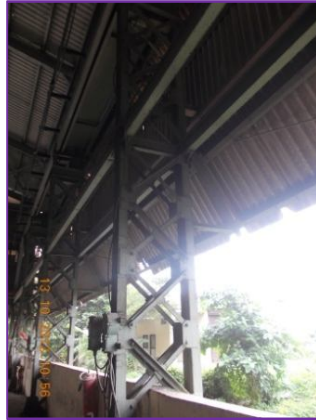
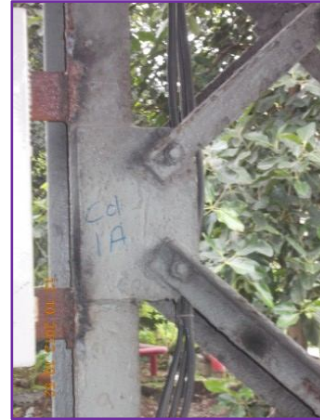
- Corrosion noted in all the steel elements like columns, cross bracings, side gusset plates, central gusset plates and steel beams etc.

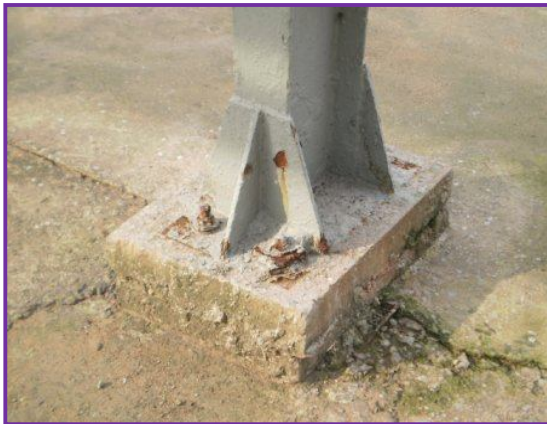
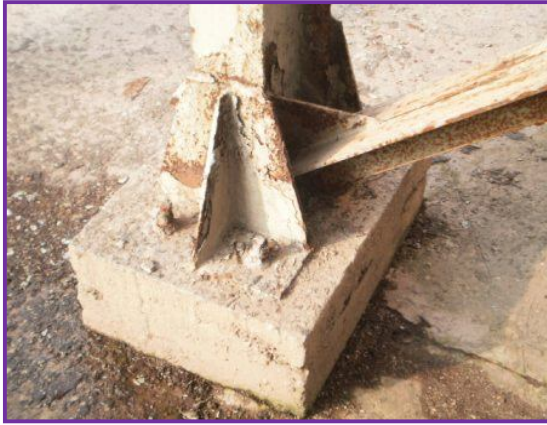
- Cracks noted on top finishing layer of RCC pedestals. Also, corrosion, scaling and pitting noted in the steel elements (of connection system) like nut bolts, base plate, and gusset plates etc. at many locations. Corrosion also noted in the main steel members like columns, beams, cross bracings and tie beams etc. Please refer typical photographs below.

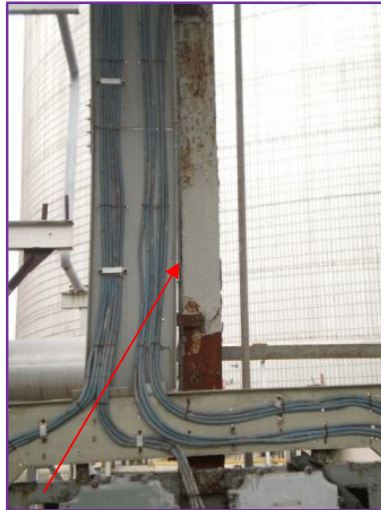
- Deflection noted in the steel column no-14 at a location as seen in the photograph below. This might be the original construction deficiency however the area needs monitoring for further development; if any.

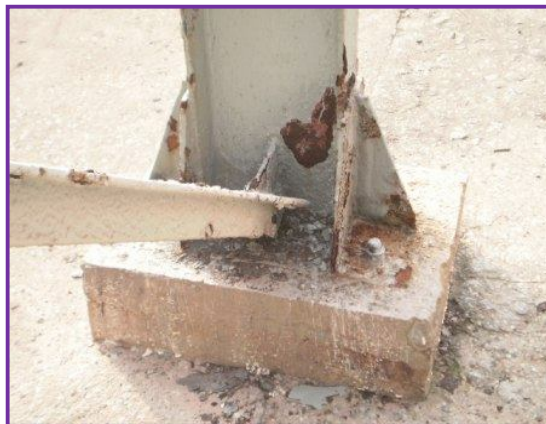
- Severe corrosion, scaling noted on base plate, foundation nut bolts, bottom section of steel column etc. Also, stiffener plate noted bent at the area connected with cross bracing as shown in the photograph below.

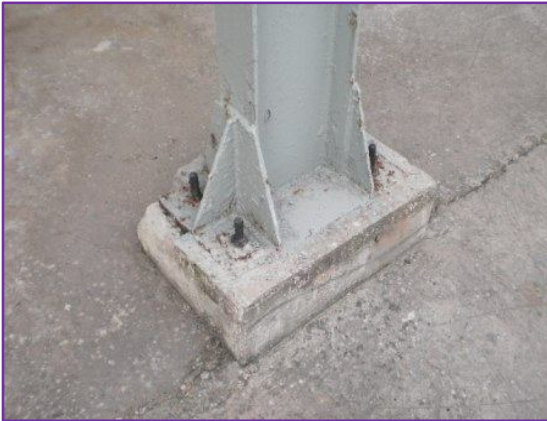
Ammonia condensate structure-

- Structural steel elements of this structure noted with corrosion at some locations. However, severe corrosion and scaling noted on base plate, foundation nut bolts at almost all locations. Please refer typical photographs below.

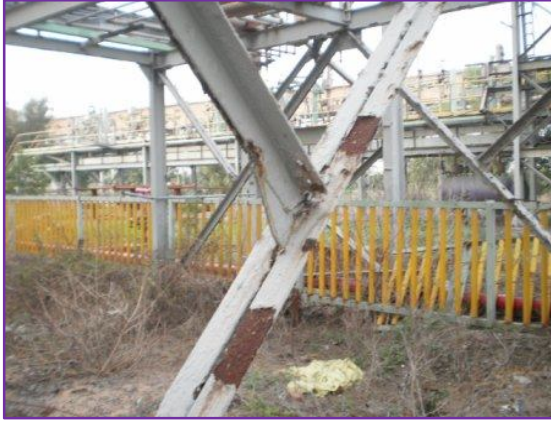
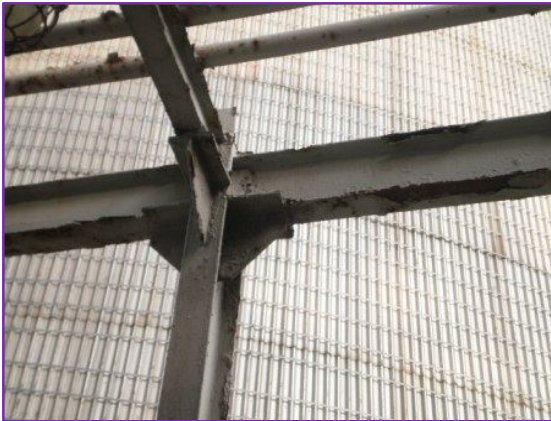
- Severe corrosion noted in the steel elements like base plate, foundation nut bolts, central gusset plate and cross bracings etc.

- Localized replacement of the deteriorated steel elements as also further strengthening has to be done and need to be followed for the proposed rehabilitation work. However, the said strengthening work shall be done according to the design.

- Few General distresses like Existing corrosion of the steel members shall be removed as per standard method and all the Structural Steel members shall be treated with application of 3 coats of 'SUNPUGUARD' (a high quality Anti corrosive two component Polyurethane coating) or equivalent as per Manufacturer's recommendations. Proper surface preparation of all Structural Steel members shall be done before application of SUNPUGUARD or equivalent, as per manufacturer's recommendations.

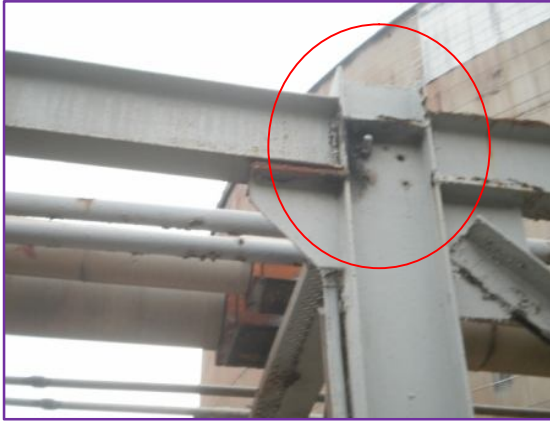
- Inadequate connections in the form of cleat angles missing in one side noted at every connection. Please refer typical photographs below.

- The gap between concrete and top finishing layer (in RCC pedestals) shall be finished with suitable grouting as per existing system/method.
- Most of the distresses related to the inadequate connection details need be re-done with providing ideal connection details as can be best designed with improved specifications.

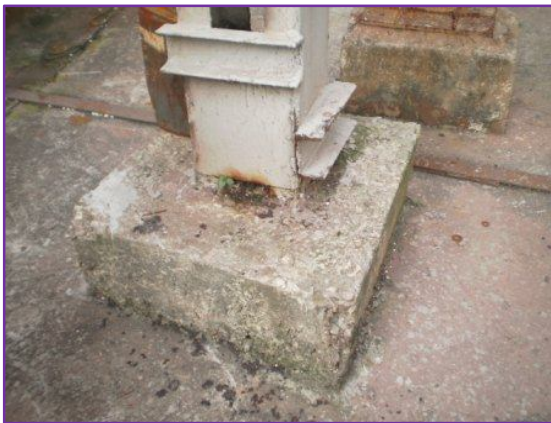
- Vegetation growth noted at junction of the steel column and RCC pedestal as seen in the photographs below.

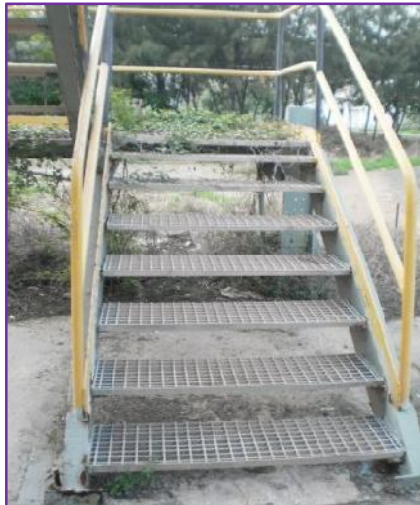
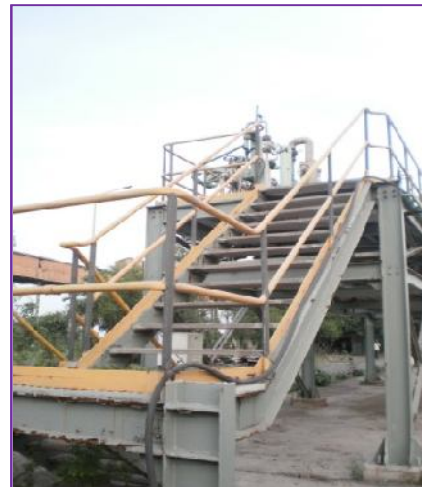
- Corrosion, pitting and scaling noted on the steel members supporting staircase and M.S grating as seen in the photographs below.

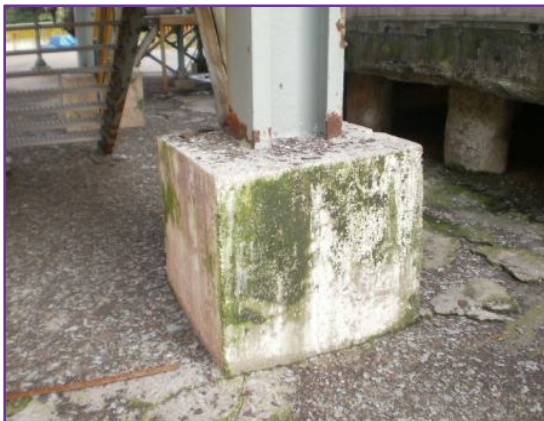
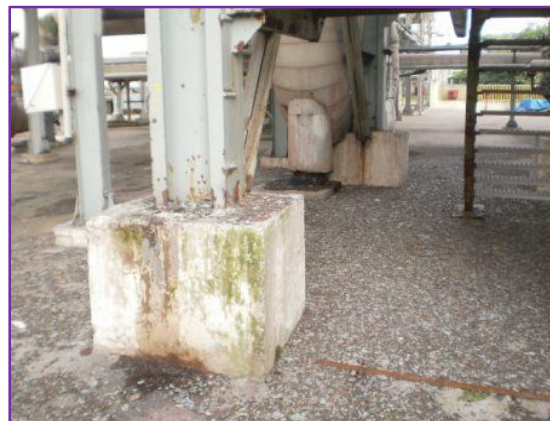
- Moss growth noted on the RCC pedestal, also corrosion and pitting on vertical steel column noted as shown photographs below.

- Localized replacement of the deteriorated steel elements as also further strengthening has to be done and need to be followed for the proposed rehabilitation work. However, the said strengthening work shall be done according to the design.

- Few General distresses like Existing corrosion of the steel members shall be removed as per standard method and all the Structural Steel members shall be treated with application of 3 coats of 'SUNPUGUARD' (a high quality Anti corrosive two component Polyurethane coating) or equivalent as per Manufacturer's recommendations. Proper surface preparation of all Structural Steel members shall be done before application of SUNPUGUARD or equivalent, as per manufacturer's recommendations.

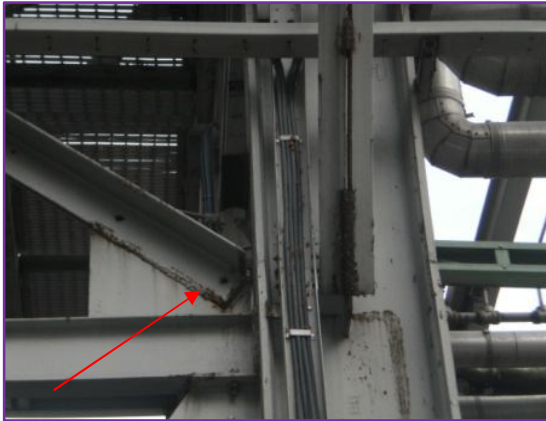
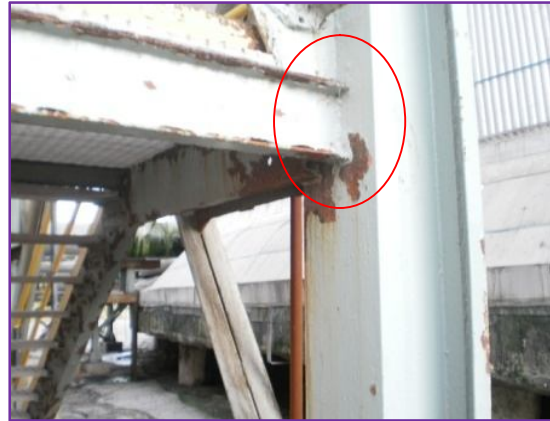
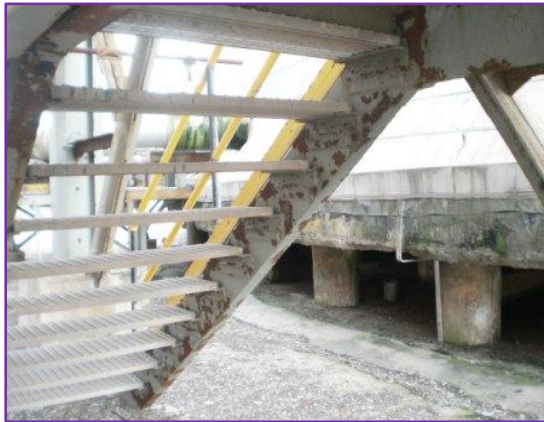
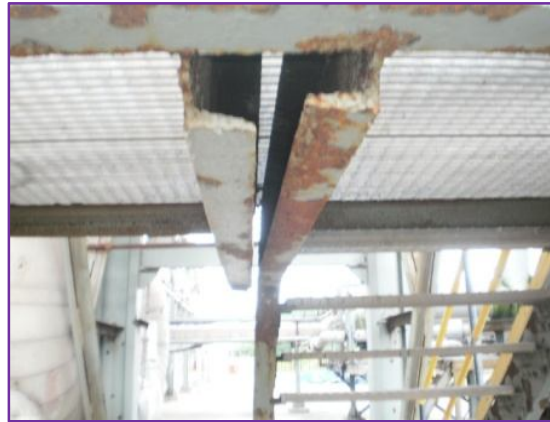
Scaling and pitting on steel members

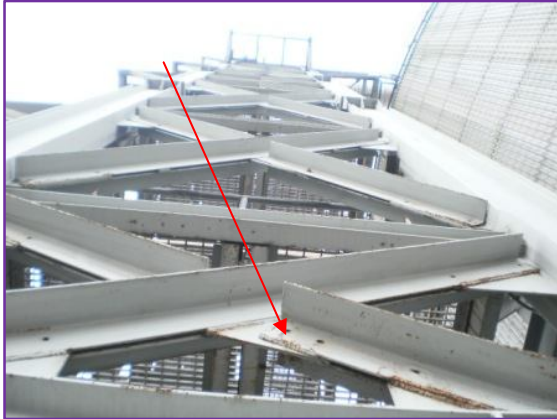
Corrosion, scaling and pitting

Corrosion, scaling and pitting on weld connection and steel members

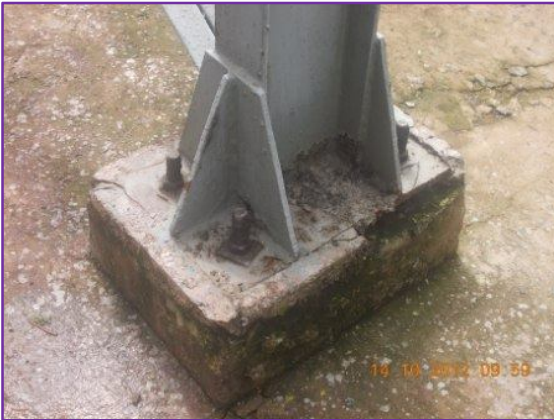
- Severe corrosion, scaling and pitting noted in the base plate, stiffener plate and steel column at some locations as shown in the photographs below.

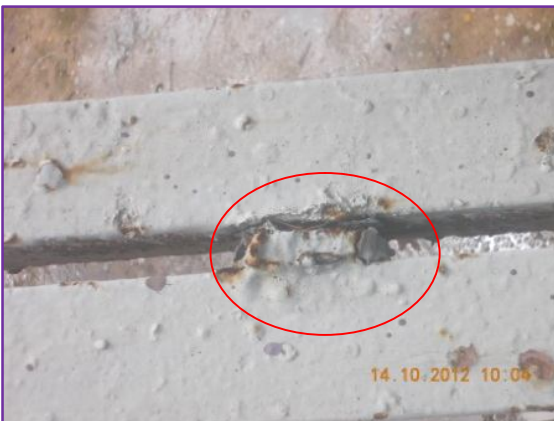
- Weld joint opened out noted on the cross bracings at few locations due to severe corrosion and scaling as shown in the photographs below.

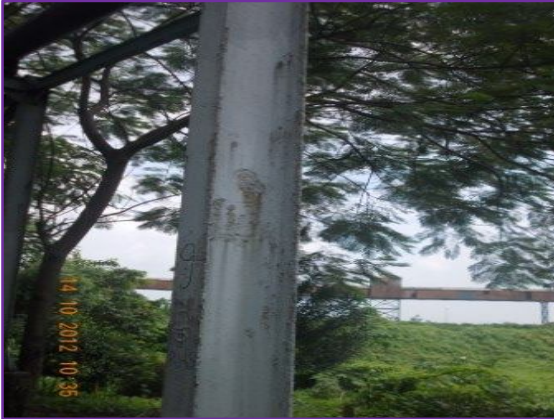
- Corrosion noted in the steel elements like longitudinal, horizontal, vertical members of the supporting system of pipes at many locations as shown in the typical photographs below.

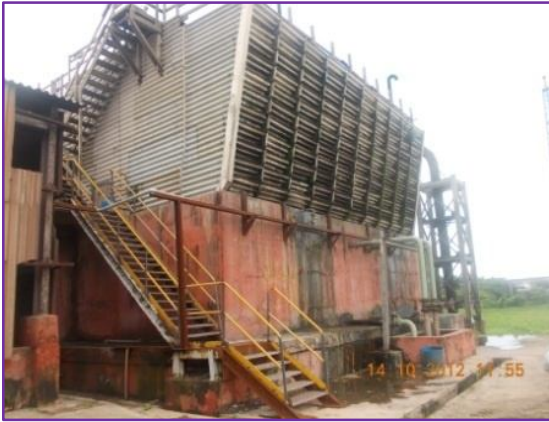
- Moss growth on entire structure, vegetation growth, crack / gap between RCC wall and slab noted as seen the photographs below. Also, note corrosion in the steel elements of staircase.

Moss growth and corrosion in steel elements of staircase

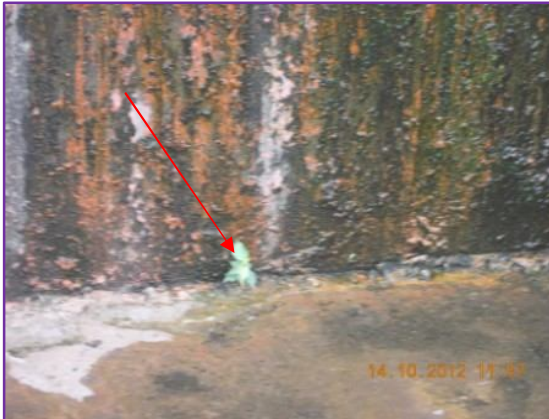
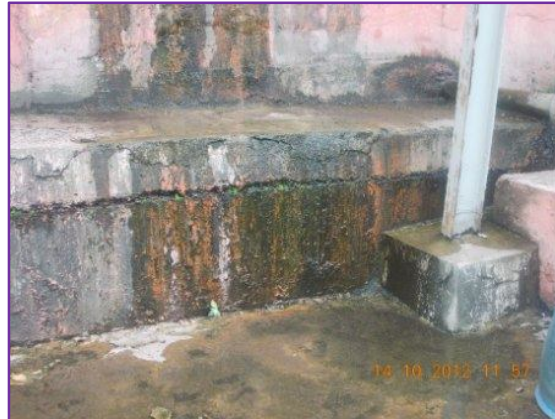
Moss growth, vegetation growth and crack/gap between RCC wall & slab

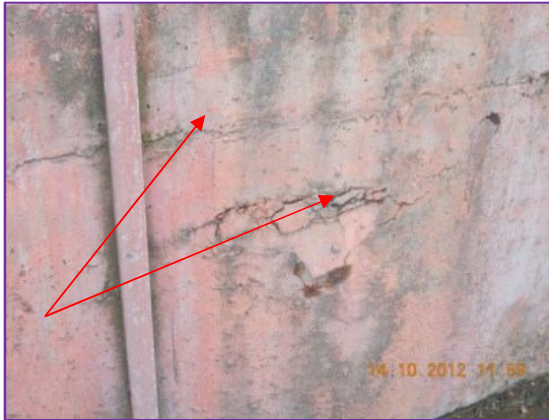
- Bulging of concrete noted at some locations especially at the construction joints/subsequent concrete pours as seen in the photographs below.

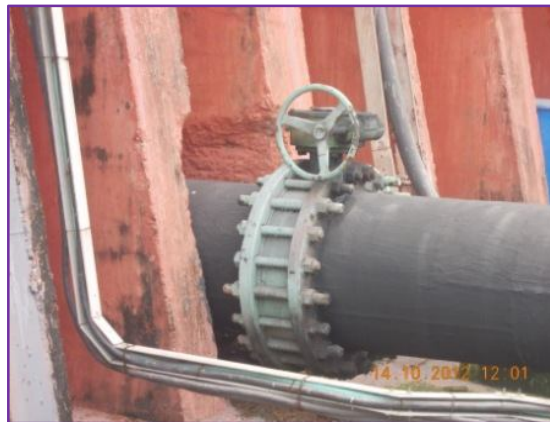
- RCC abutments /columns noted physically cut as seen in the photographs below so as to accommodate process pipe.

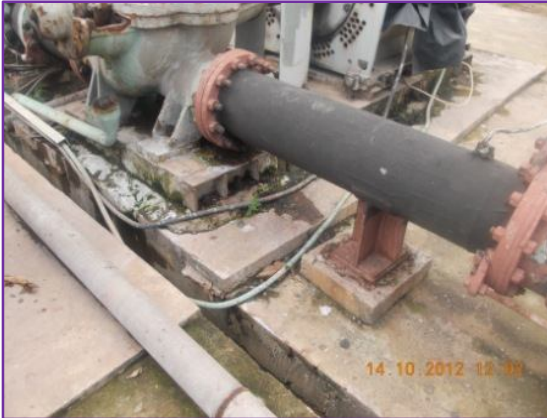
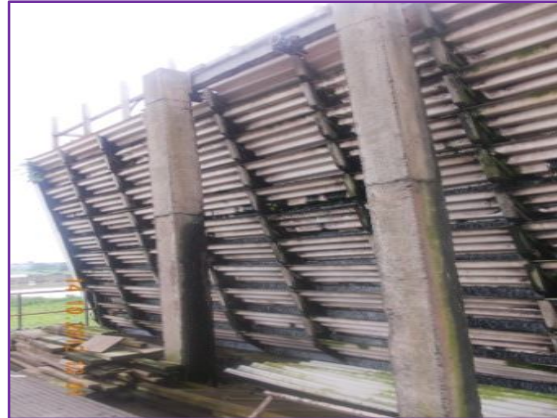
- Water logging noted on top level of cooling tower also moss growth, vegetation growth and fungus noted at surrounding pump foundation as shown in the photographs below.

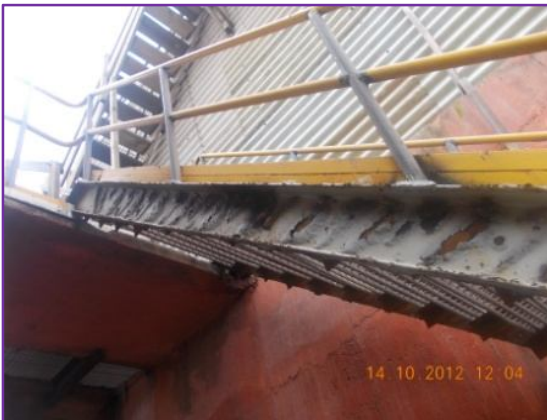
- Severe corrosion, scaling and pitting noted in the steel elements of staircase as shown in the photographs below.

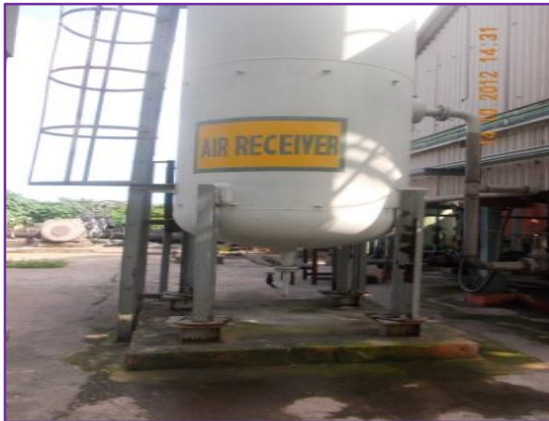
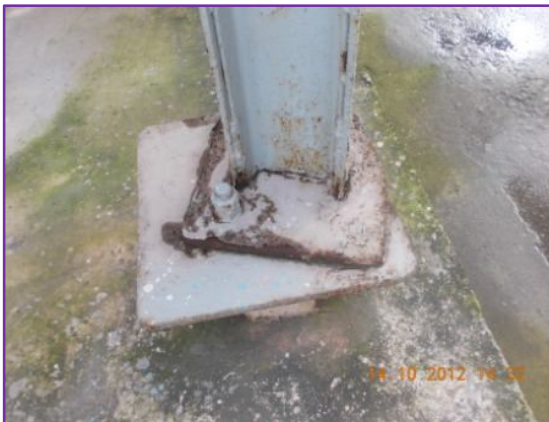
- Severe corrosion, scaling and pitting noted on the structural steel column, base plate and foundation nut bolts of air receiver tank near the ammonia cooling tower. Also, two vertical columns directly rest on steel plate without any fixtures as shown in the photographs below.

Severe corrosion and scaling on base plate and nut bolts / vertical steel column directly rest on steel plate.

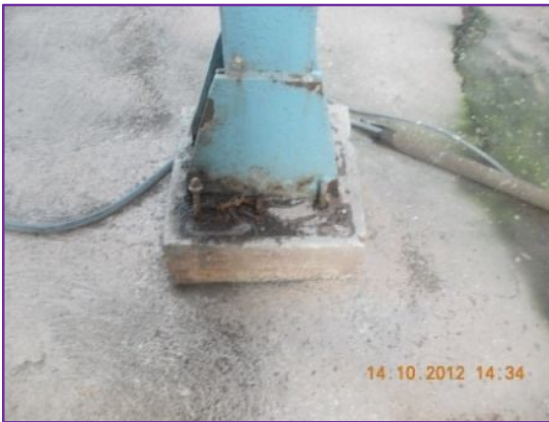
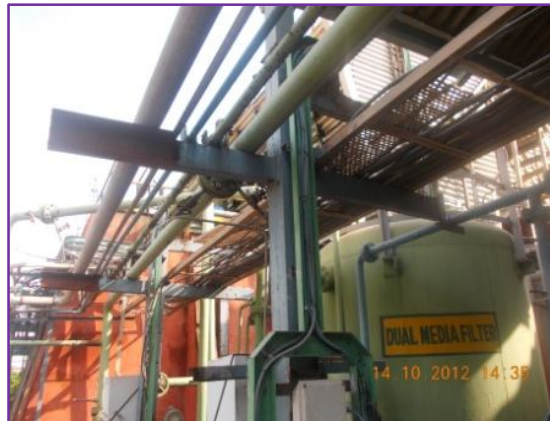
- Severe corrosion, scaling and pitting noted on the structural steel column, base plate; horizontal and vertical steel members etc. as shown in the photographs below.

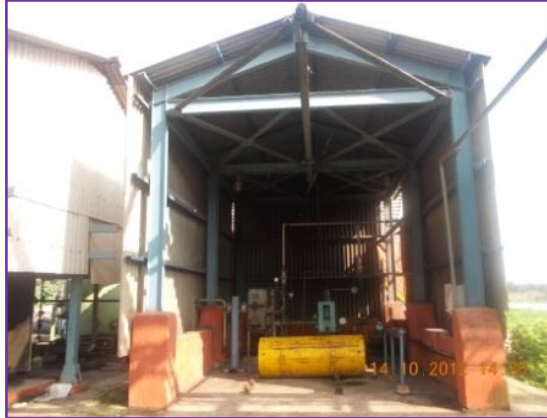
- Structure seems recently painted hence visible distresses are covered.
