OIL SEPARATOR EXPLOSION IN AN AIR-SEPARATION PLANT

John J. Rendos
Air Reduction Sales Co.
Plainfield, N. J.

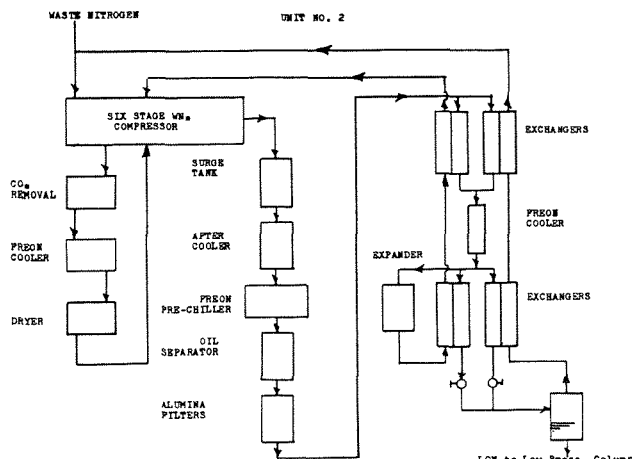
Figure 1. Simplified Flow Sheet.

The present opinion is that ignition of the lubricating oil started in the sixth stage cylinder of the compressor while the compressor was handling a waste gas containing 18 to 19% oxygen. Ignition was caused either by excess friction in the cylinder (as indicated by the condition of the cylinder and moving parts) and in addition, possibly, unbalance in the last stages which led to high compression ratios and excessive heating. This ignition started a "fire" and a simultaneous "explosion wave."

The explosion wave then progressed through the discharge piping, the surge bottle, the aftercooler, the refrigerated chiller and to the separator. An inspection of the visible internal parts of the system indicated very little, if any, presence of oil. This is a very unusual condition as these lines should normally have an oil film. The fact that there was very little oil present would bear out the progressive combustion theory.

Downstream of the oil collection in the sixth stage aftercooler separator end, the nitrogen oil separator bottle was the first point in the discharge piping where appreciably large quantities of oil and vapor could collect. The explosion wave, upon reaching the separator, ignited the vapors with explosive violence and shattered the separator bottle into more than 25 pieces. Of the several pipes and vessels downstream of the compressor sixth stage, the separator had the lowest rupture strength. In the aftercooler and the chiller, the tubes were bulged and ruptured. Possibly, the "explosion wave" also caused local detonations at locations where there were lube oil collections. The internal damage to the high-pressure nitrogen system is attributed to the explosion in the separator. It should be noted that some difference of viewpoint exists on whether a pool of oil is needed as a fuel source. Some are of the opinion that an explosion can occur if only a film of oil or oil vapor is present.
