Urea-ammonium nitrate solutions: Are they safe?

Explosion in the mixing installation of a fertilizer plant points out the potential hazards. Avoid contamination or conditions of temperature and concentration that result in explosive mixtures.

L. G. CROYSDALE,
W. E. SAMUELS,
and J. A. WAGNER

Farmers Chemical Assoc., Inc.
Tyner, Tenn.

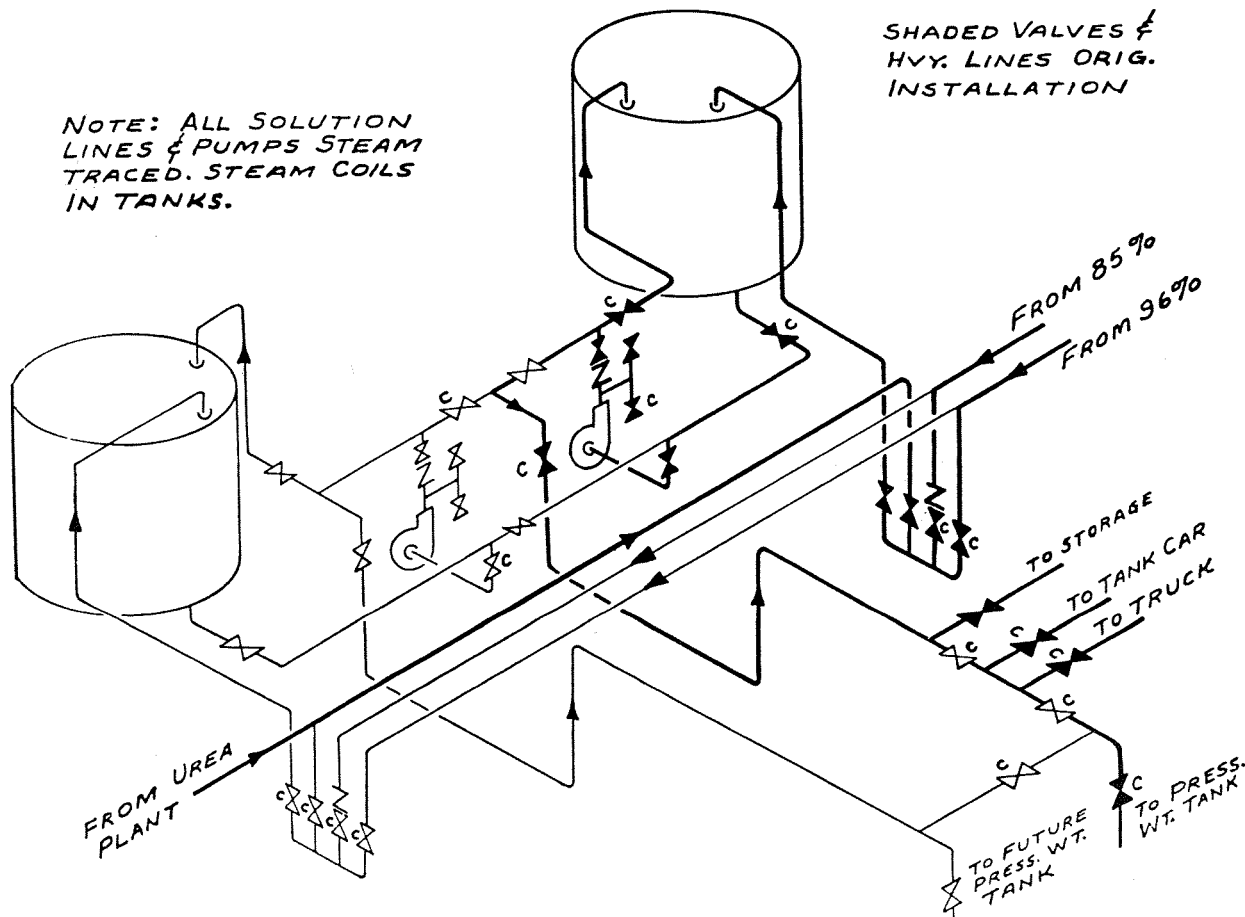
Figure 1. Schematic of solution blending installation.

The heavy lines and solid valves of Figure 1 show the original mixing solution installation (atmospheric pressure). The lighter lines and valves indicate the revised layout installed to increase the plant capacity. Basically, the unit was being mirrored; however, this was not the case from an operational viewpoint. Normal economical operation requires a minimum of switch operations; once a setup arrangement is made, an operator would open and close a minimum number of valves. Operators were well trained and thoroughly familiar with the original installation and did not entirely block in the system. With the increased isolation valves, it was quite easy to block in the system. At the time of the explosion, valves with a "C" beside them were closed and all the 85-lb. steam tracing systems and steam coils were in service. Specific revisions in operating procedures had not been considered necessary. In other words, safe procedures may have been violated as a result of the expansion and, as so often happens, not realized until after the incident. Unfortunately, this
