FABRICATION PROBLEMS WITH HEAVY PRESSURE EQUIPMENT FOR LARGE AMMONIA PLANTS

The trend to large, single-train plants has resulted in several serious problems involving fabrication; both construction schedules and plant reliability are affected.

G.P. Eschenbrenner, C.A. Honigsberg, and A.M. Impagliazzo
M.W. Kellogg Co.
New York, N.Y.

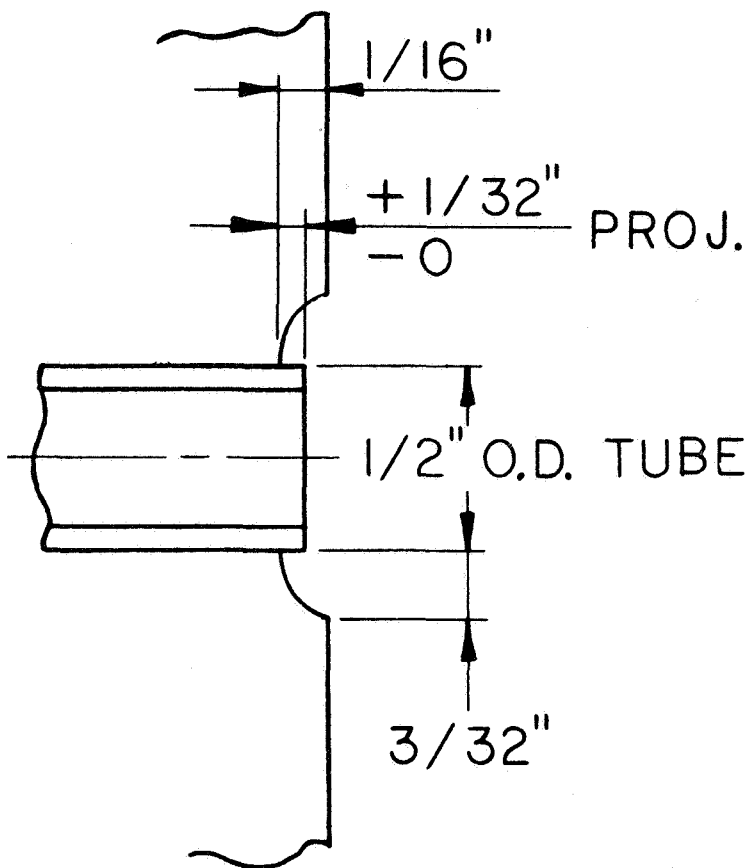
Figure 13. Tube joint preparation.

Figure 13 shows the tube joint geometry. The welding was performed in two passes using the T.I.G. process with filler metal. The tube joints were welded before the welding of the pass partition plates and the reverse flange to the channel barrel.

These were repaired and when tight under shell side pressure, another tube side hydrostatic test was applied. Again tube leakage was indicated. The channel cover was removed once more and surface examination again showed that leakage was due to subsurface porosity which had been cracked open by hydro testing.

This exercise proved futile, for on applying a 200 lb./sq.in. gauge air test to the shell and soap suds to the tubesheet face, more than a hundred leaks appeared. Surface grinding again disclosed the presence of subsurface porosity.

At this point, it was agreed by both the exchanger manufacturer and the engineering contractor that further attempts at repair would be useless. The tube joints were obviously contaminated to such an extent that welds free of porosity could not be produced without a fresh start. Contamination could have been caused by inadequate initial cleaning, by lubricants during the tube expanding process, by the numerous hydrostatic tests, and possibly simply from the cumulative effect of ordinary shop dirt during the long period the tube joints were being welded and repaired.

In order to minimize delay in delivery, it was decided to salvage the exchanger by cutting off that portion of the tubes which had been expanded into the tubesheet, and rebuilding the exchanger with the shortened tubes. This would reduce the effective tube length by about 2-1/4 in., a negligible amount. All welding on the tubesheet face was removed by end milling. This resulted in reducing the tubesheet thickness by 3/16 in. but fortunately there had been an excess and the remaining thickness was still adequate for the design conditions.

is *not* possible to produce consistently satisfactory joints between typical heat exchanger tubes and their tubesheet without first thoroughly cleaning all components, and then keeping them clean and dry throughout the welding, testing, and subsequent repair welding operations, if any. Among other things, this means that there must be no hydrotests until all joints have been proven tight by suitable pneumatic tests.
