# LARGE PLANT OPERATION

The larger plants have had their share of problems, but experience has been gained and is being engineered into the new plants to make them operate better and safer

Hays C. Mayo  
M.W. Kellogg Co.\*  
New York, N.Y.

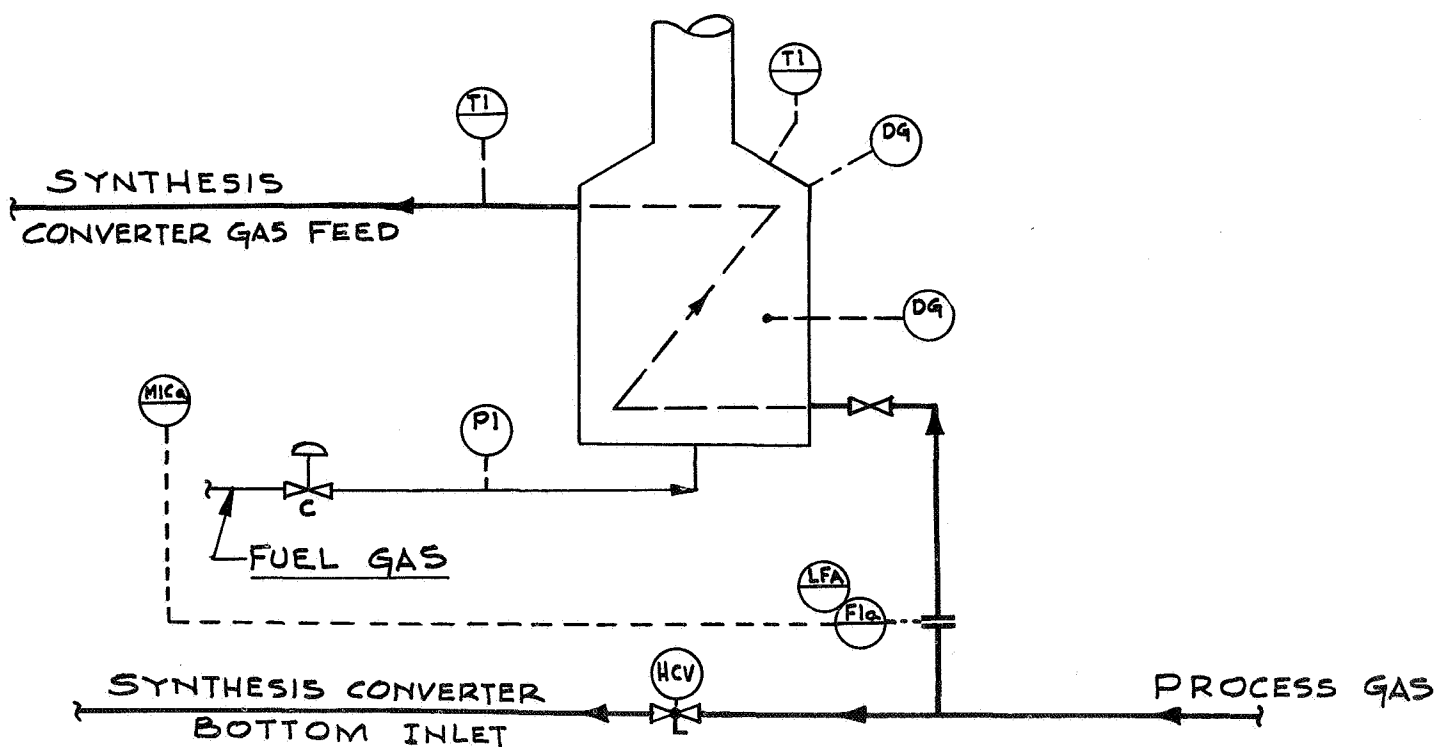
Figure 5. Standard startup heater instrumentation.

There have been two instances of explosions in synthesis converter startup heaters. The first blew the stack off, but the heater remained operable. This incident is attributed to improper purging prior to lighting.

Figure No. 5 shows the standard start-up heater instrumentation. It should be noted that a flow indicator and low-flow alarm are provided in the control room to warn of low flow.

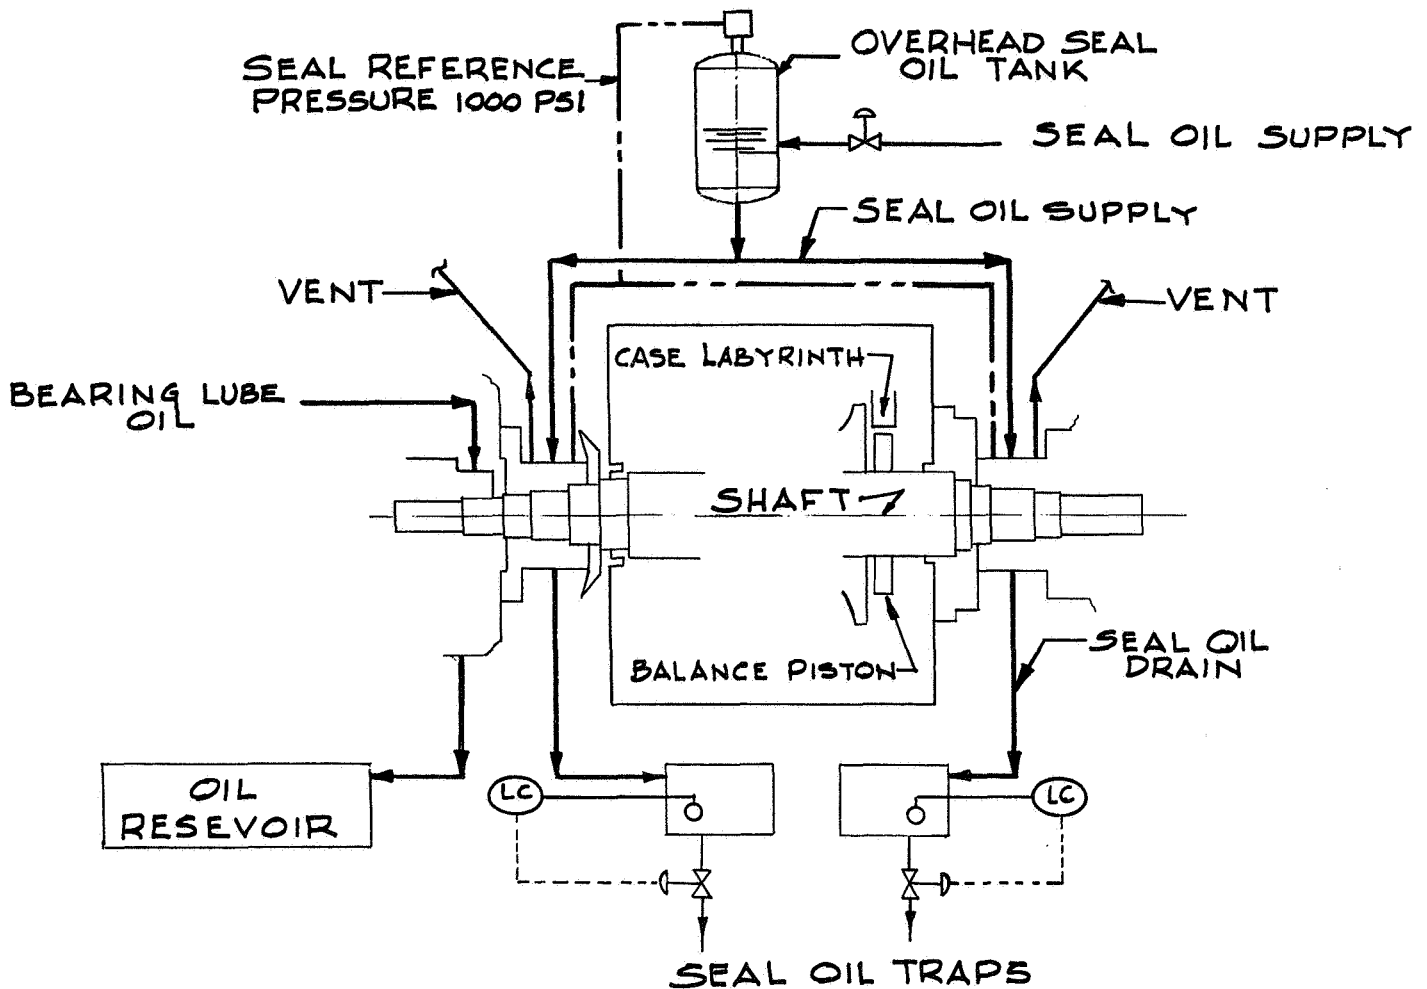
Figure 9. Schematic diagram of the seal oil system.

Figure No. 9 shows a schematic diagram of the seal oil system. Steps are being taken to add venting capacity to the lube oil reservoir and strainers are being added to the suction lines of all machines.
