Reformer Manifold Cracking

Unusual cracking of manifold tubing welds in ammonia plant reformer may alert operators to possible malfunctions in other units.

G. Kobrin, E. I. DuPont de Nemours & Co., Beaumont, Tex.

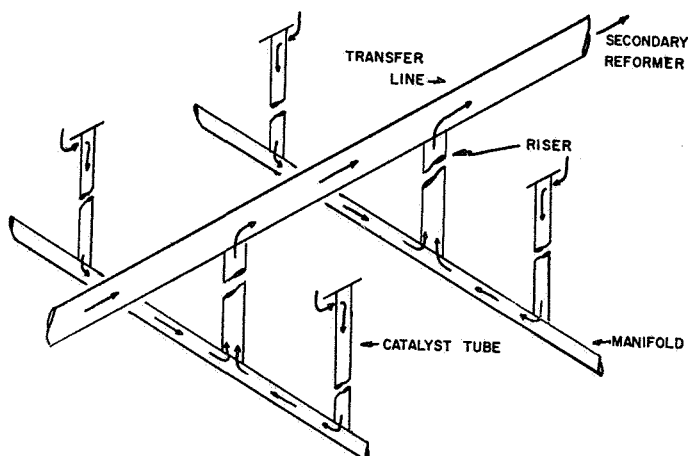
SYNTHESIS GAS FOR AMMONIA MANUFACTURE is made in a direct natural gas fired furnace by reforming a steam/methane mixture over nickel catalyst. The preheated mixture enters centrifugally cast HK-40 alloy catalyst tubes through pigtails, flows down through each tube and is collected in Incoloy 800 alloy tubing manifolds on both sides of an HK-40 riser. Partially reformed synthesis gas flows up through the risers into a transfer line and on to the secondary reformer. This primary reforming furnace contains eight rows of 42 catalyst tubes each. A schematic of the furnace arrangement is shown in Figure 1.

Figure 1. Schematic of primary reformer arrangement.
